ALARM - Automatic Location of Arc-faults through Remote Monitoring

Results and Learning from the Phase One Monitoring Period

September 2020

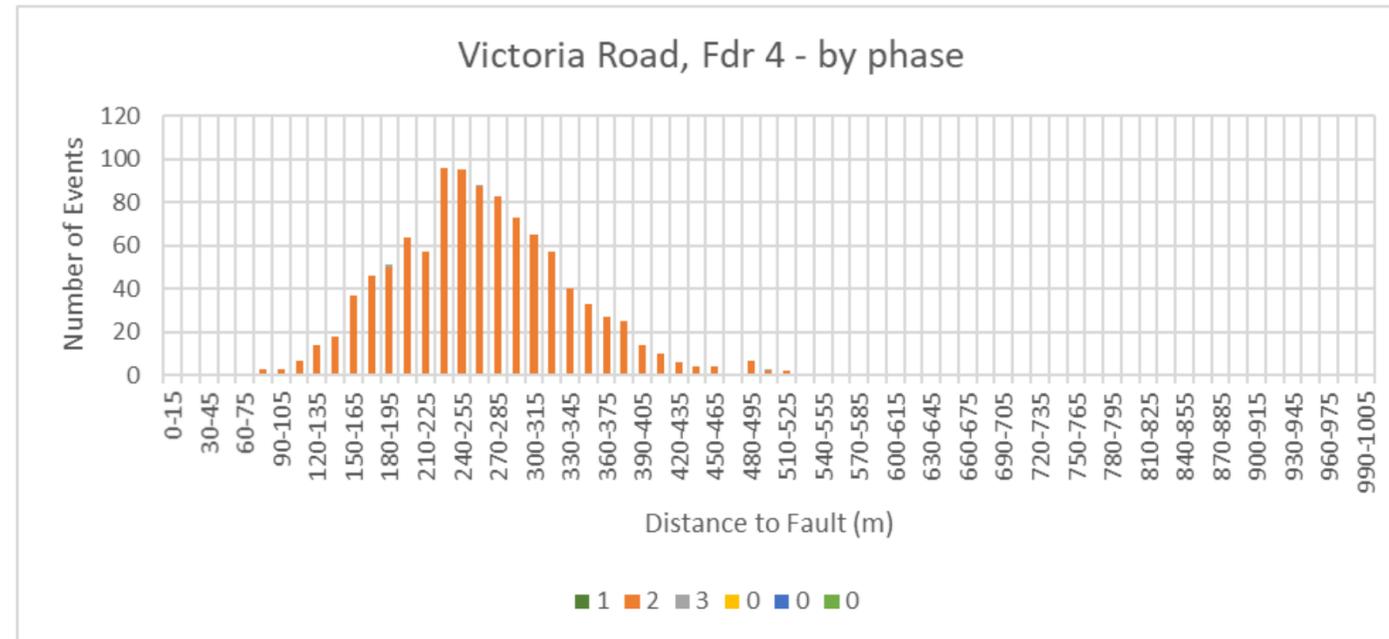
Indicated Location

Most frequent DTF (96 events) = 225-240m; Mean DTF (1040 events) = 266m
SD = 80m

These results are currently interpreted as a defect located at ~266m, adjacent to 19-21 Paddock Way.

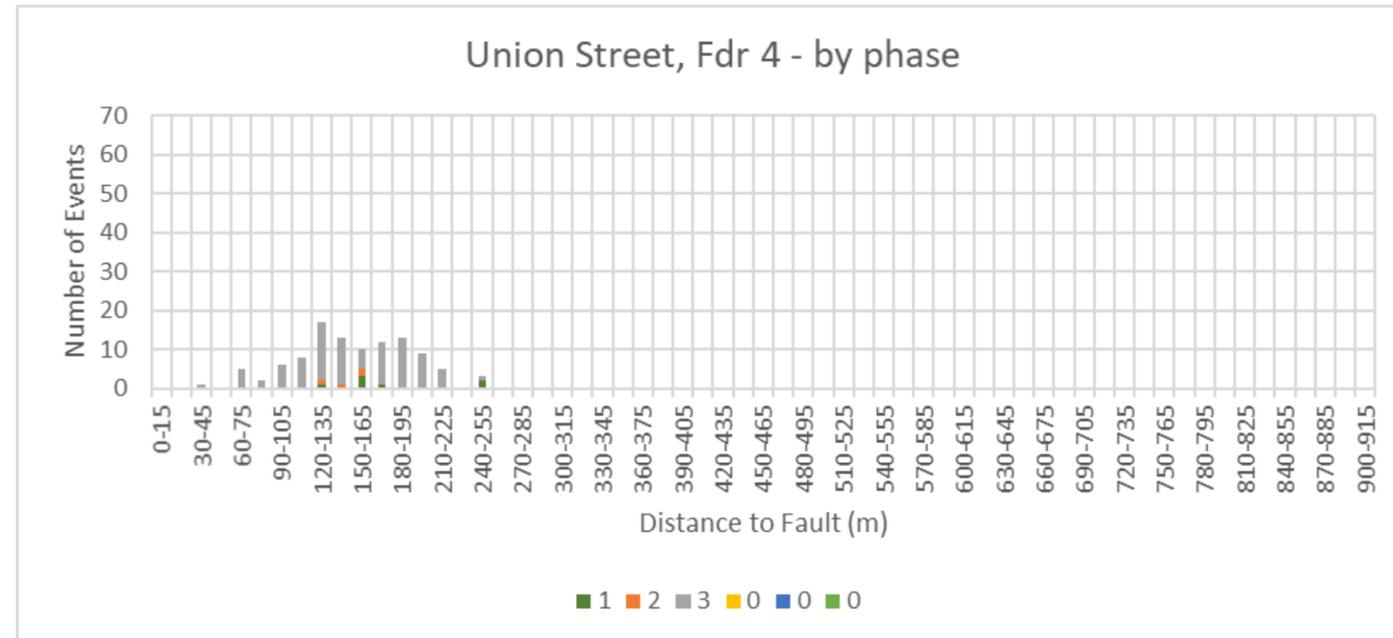
Indicated Location

Most frequent DTF (15) = 120-135m; Mean DTF (130 events) = 150m; SD = 45m

Most events involve L3 alone.

These results are currently interpreted as a defect located at ~153m
~160m is indicated on the network maps (shaded area).

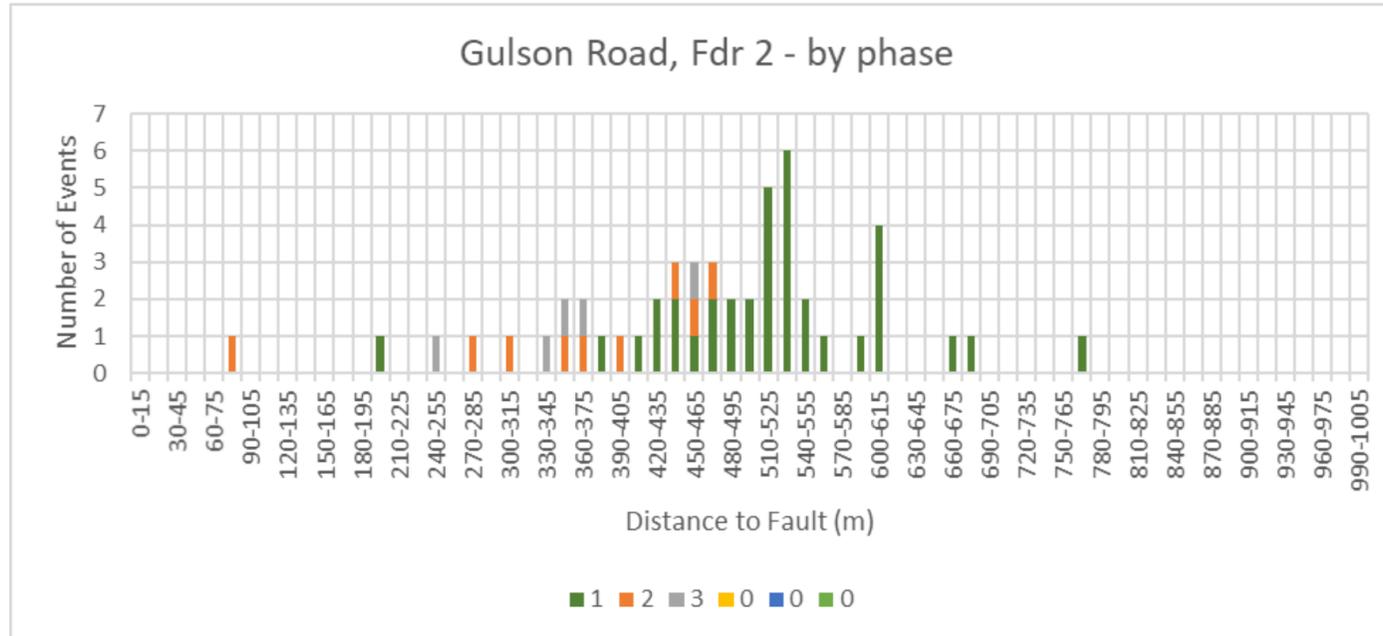
Most frequent DTF (6 events) = 525-540m; Mean DTF (50 events) = 473m; SD = 124m

A location at around 510m was offered to the local team after 20-22 May events, and this remains a reasonable view. 510m is located adjacent to 28 King Richard Street (red cross). The wider potential location is shown in orange shading, from the branch adjacent to 22 King Richard Street, along to 36 King Richard Street.

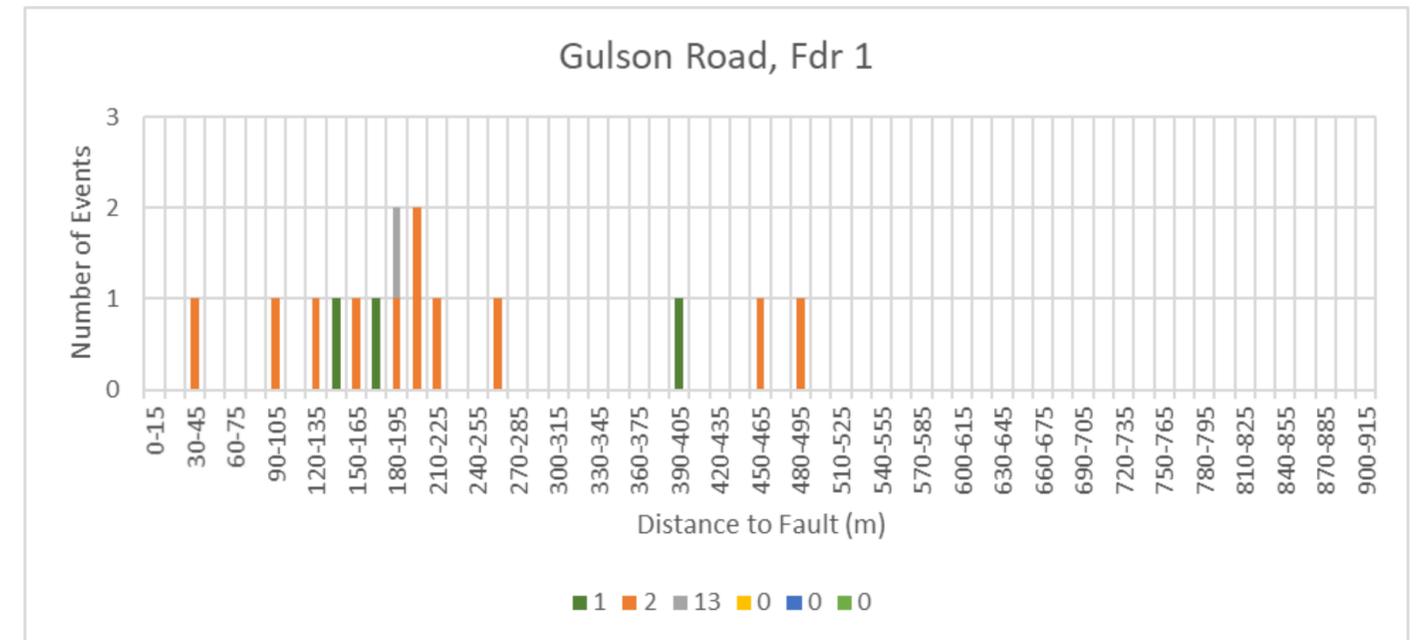
Field fault location and repair took place on Sat 18th April, before any ALARM location data was analysed.

The actual repair location was ~200m (average of all pecking events up to and including 18/04 was 183m)

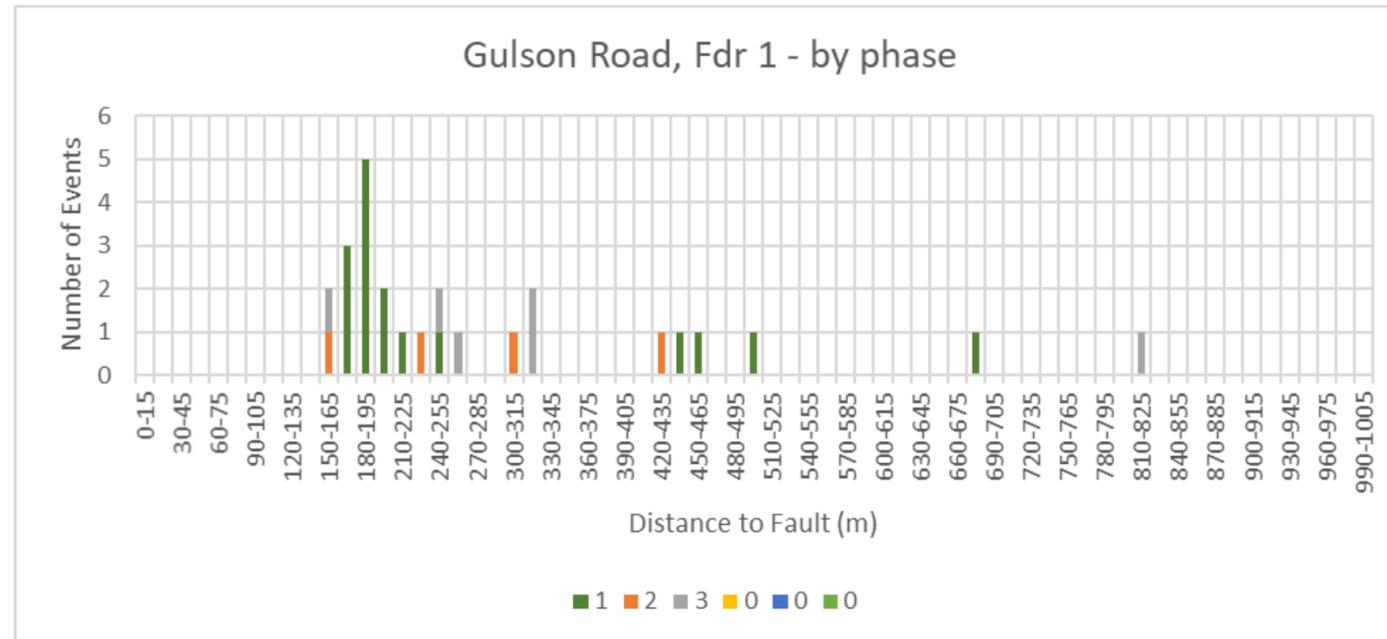
Indicated Location (post 18/04/2020)

Based on 26 events since 18th April when a repair was completed on Feeder 1 at ~200m:

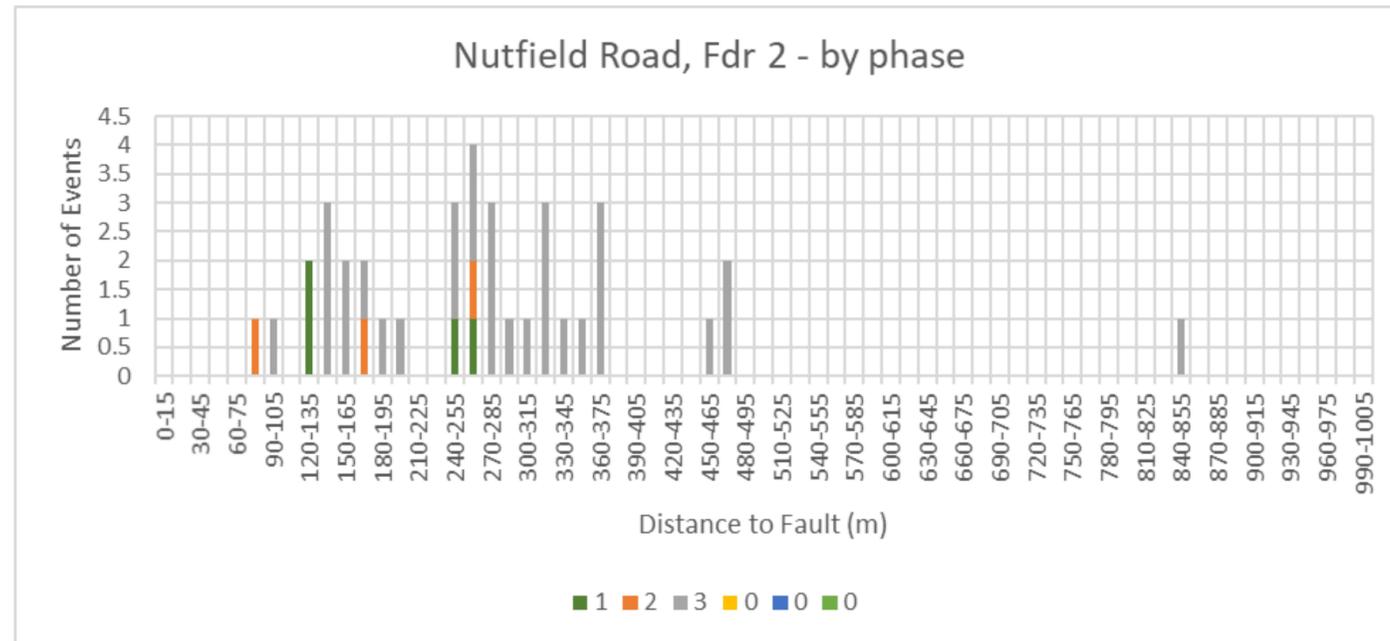
Indicated Location

Most frequent DTF (4 events) = 255-270m; Mean DTF (37 events) = 274m; SD = 139m

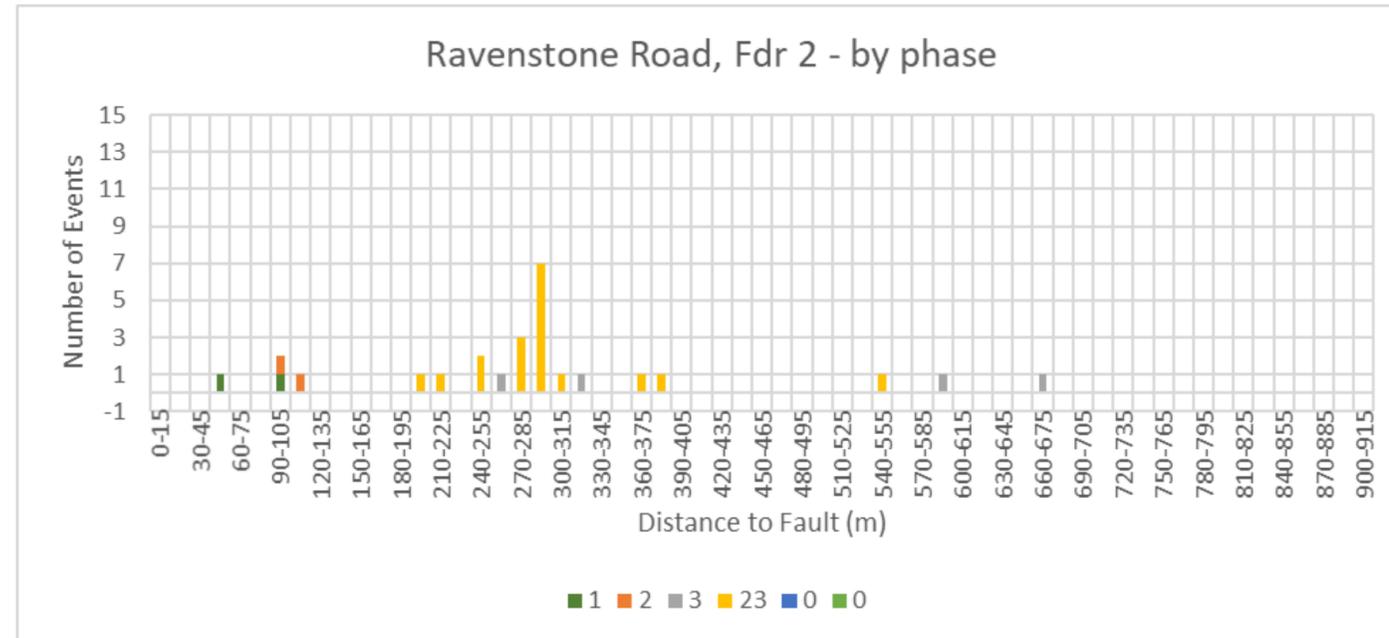
Indicated Location

Most frequent DTF (6 events) = 285-300m; Mean DTF (30 events) = 292m; SD = 140m

These potential locations have been shared with the local team, following the fuse operation on 13/07/2020.

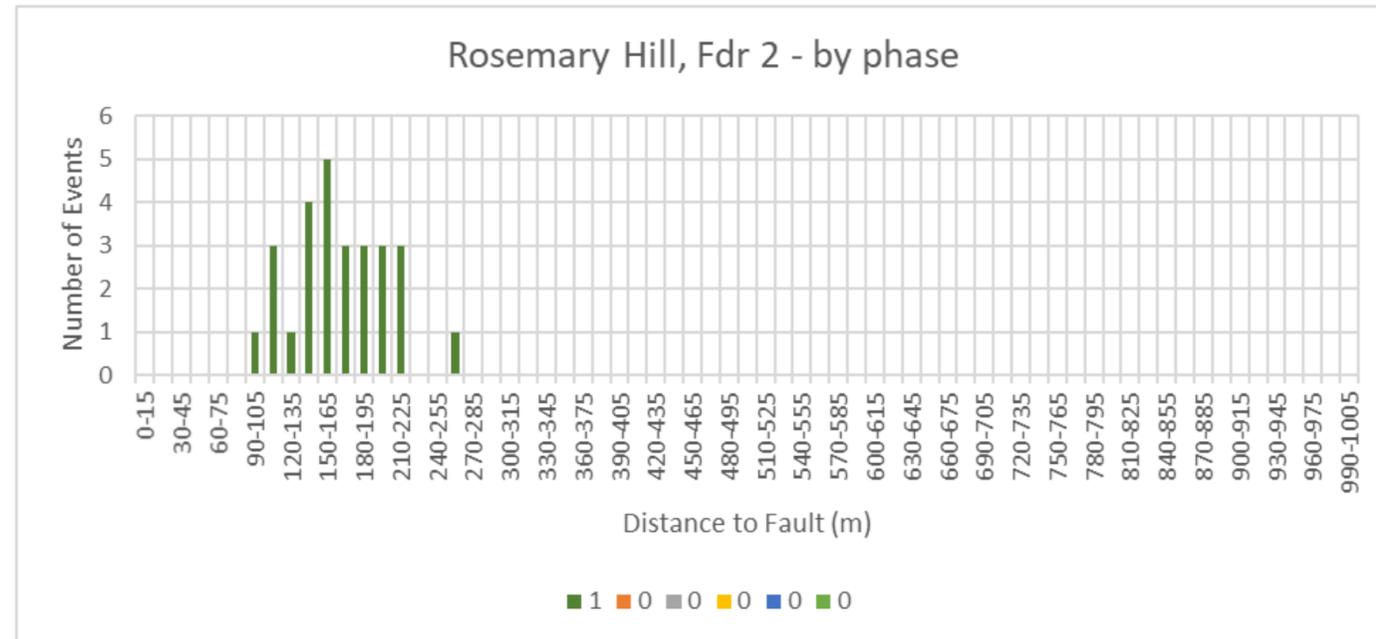
Indicated Location

Most frequent DTF (5 events) = 150-165m; Mean DTF (27 events) = 168m; SD = 39m

These results are currently interpreted as a possible defect located at ~168m. The joint at ~161m is shown on the network schematic.

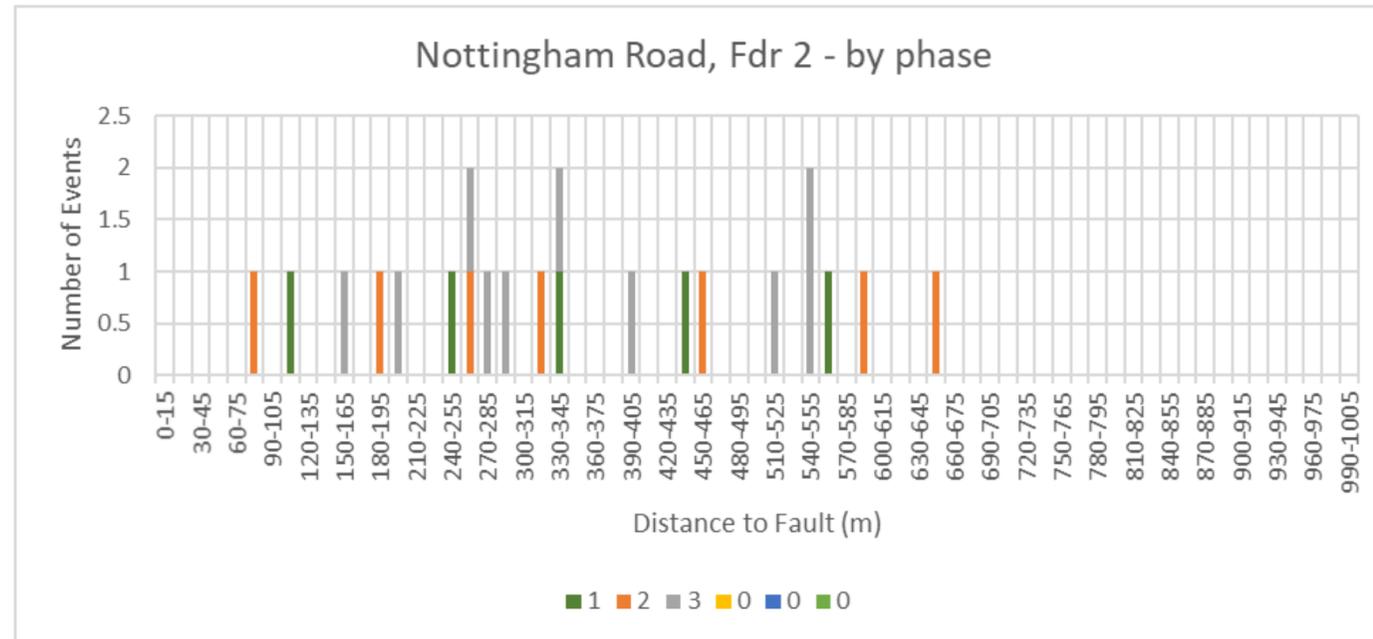
Indicated Location

At present, this data does not provide a clear indication. Further assessment of this feeder will be undertaken in Phase 2 with the enhanced hardware.

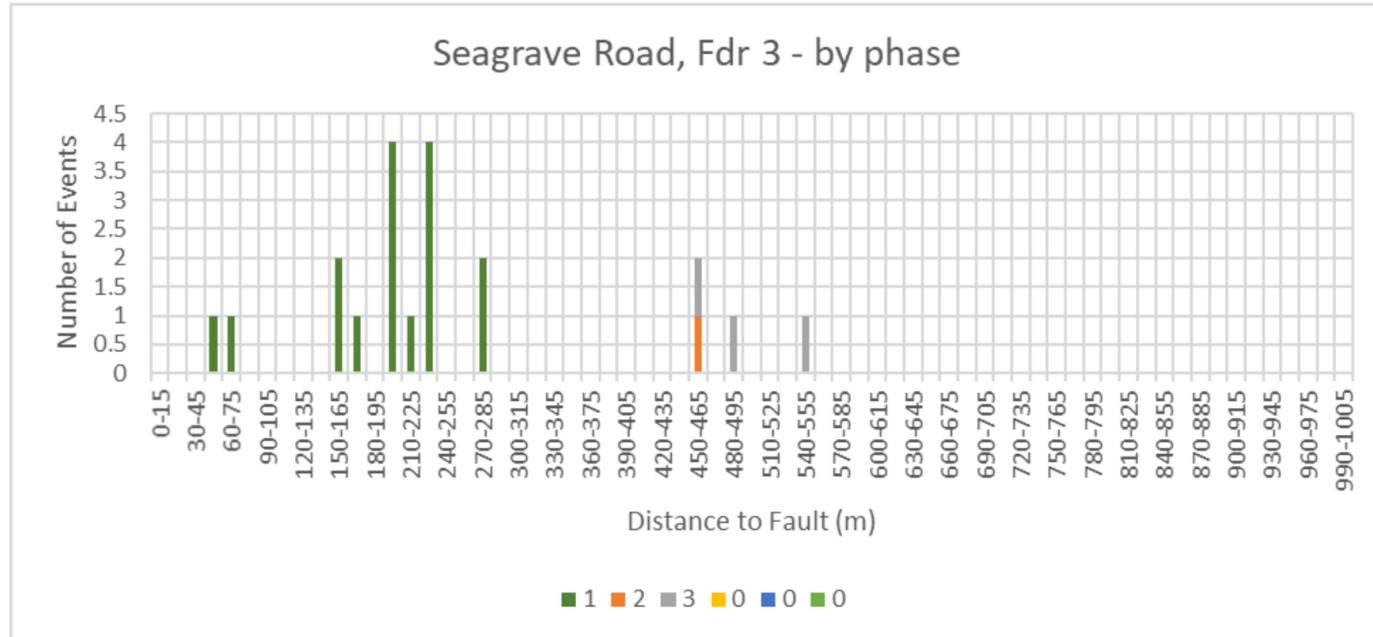
Indicated Location

At present, this data does not provide a clear indication. Further assessment of this feeder will be undertaken in Phase 2 with the enhanced hardware.

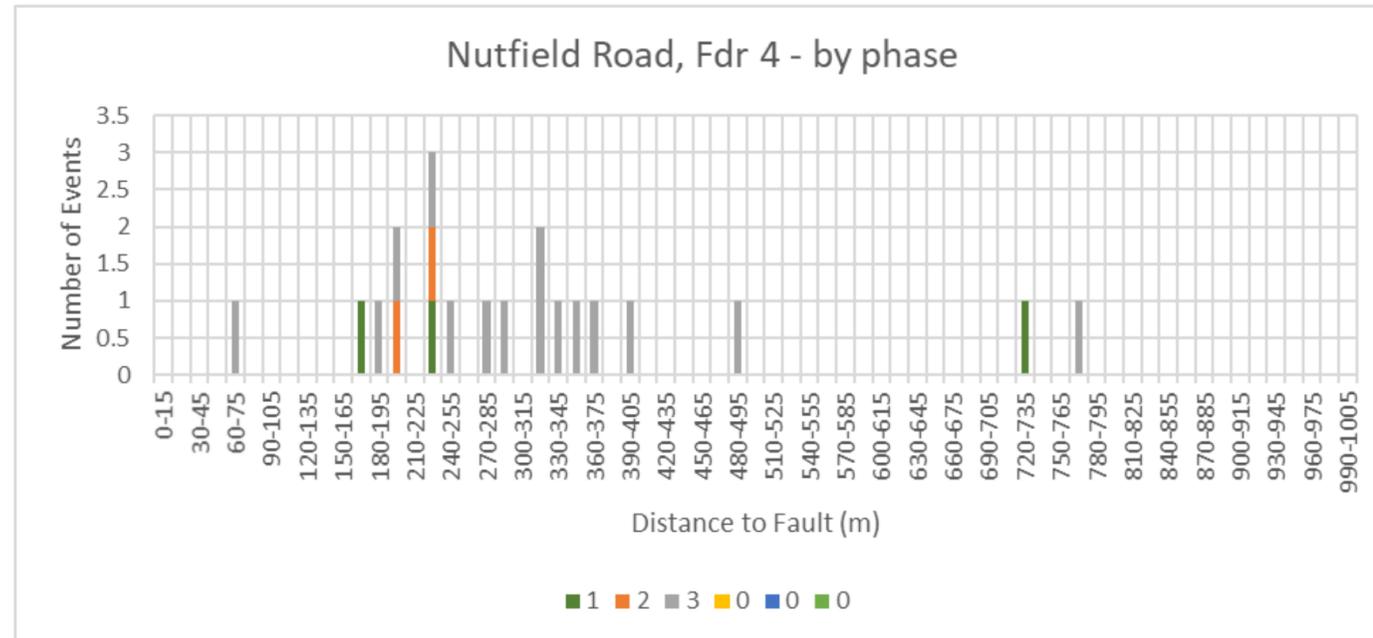
Indicated Location

At present, this data does not provide a clear indication. Further assessment of this feeder will be undertaken in Phase 2 with the enhanced hardware.
