STDL – Smart Grid – Energy Automation
So-La Bristol (Western Power Distribution)

SoLa BRISTOL – Domestic Property Visits 15.11 – 18.12

6.1 Visit Report – Sola BRISTOL Property Visit – 15.11.13

6.2 Visit Report – Sola BRISTOL Property Visit – 04.12.13

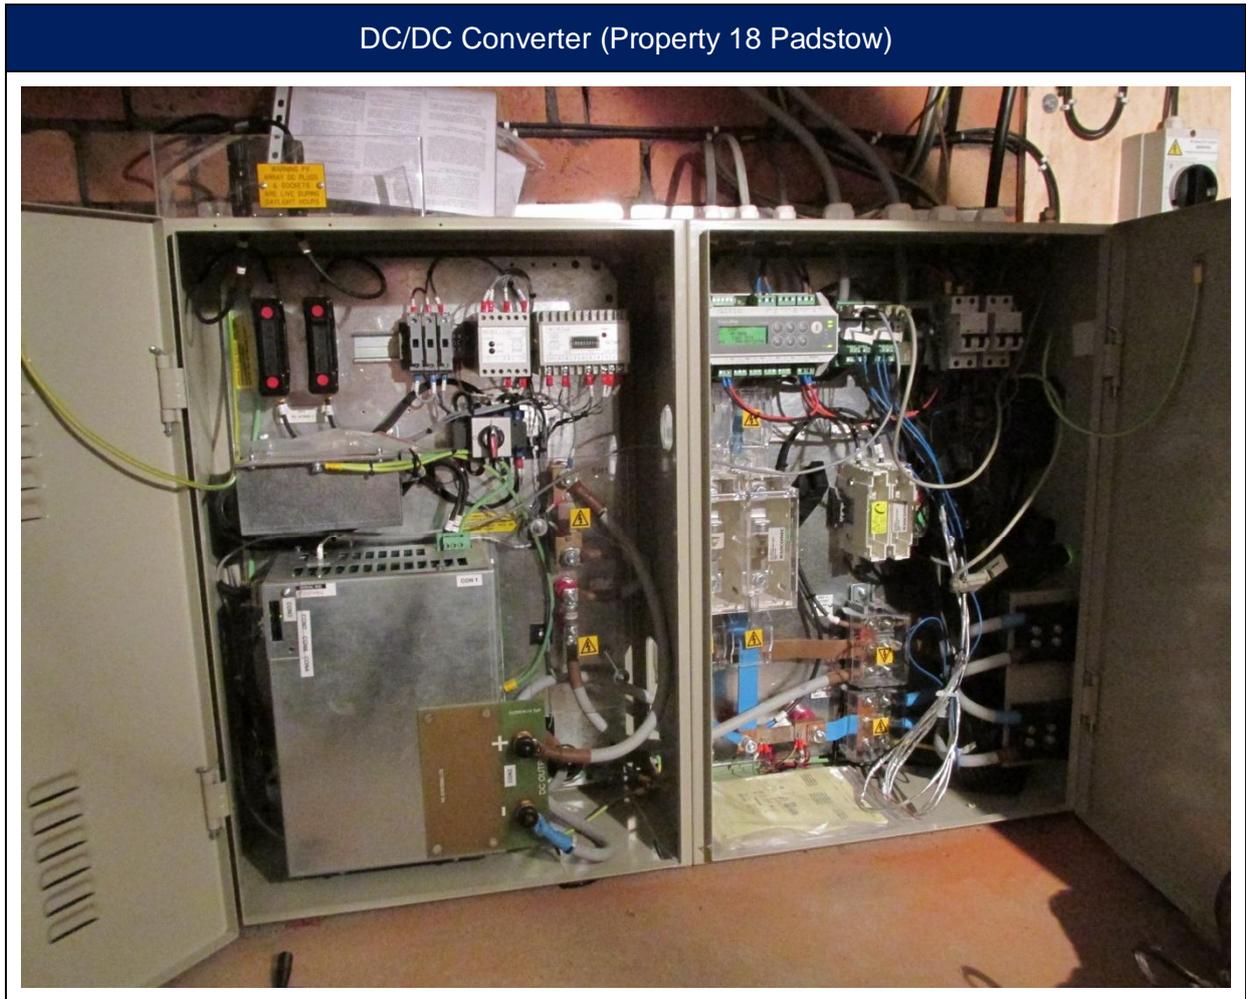
SW opened the DC/DC converter boxes and noted that the DC/DC converter had a Green LED illuminated which showed that the battery was at or above float voltage, with no DC current being output from the DC/DC converter. The PV voltage was measured at 275V to 280V.

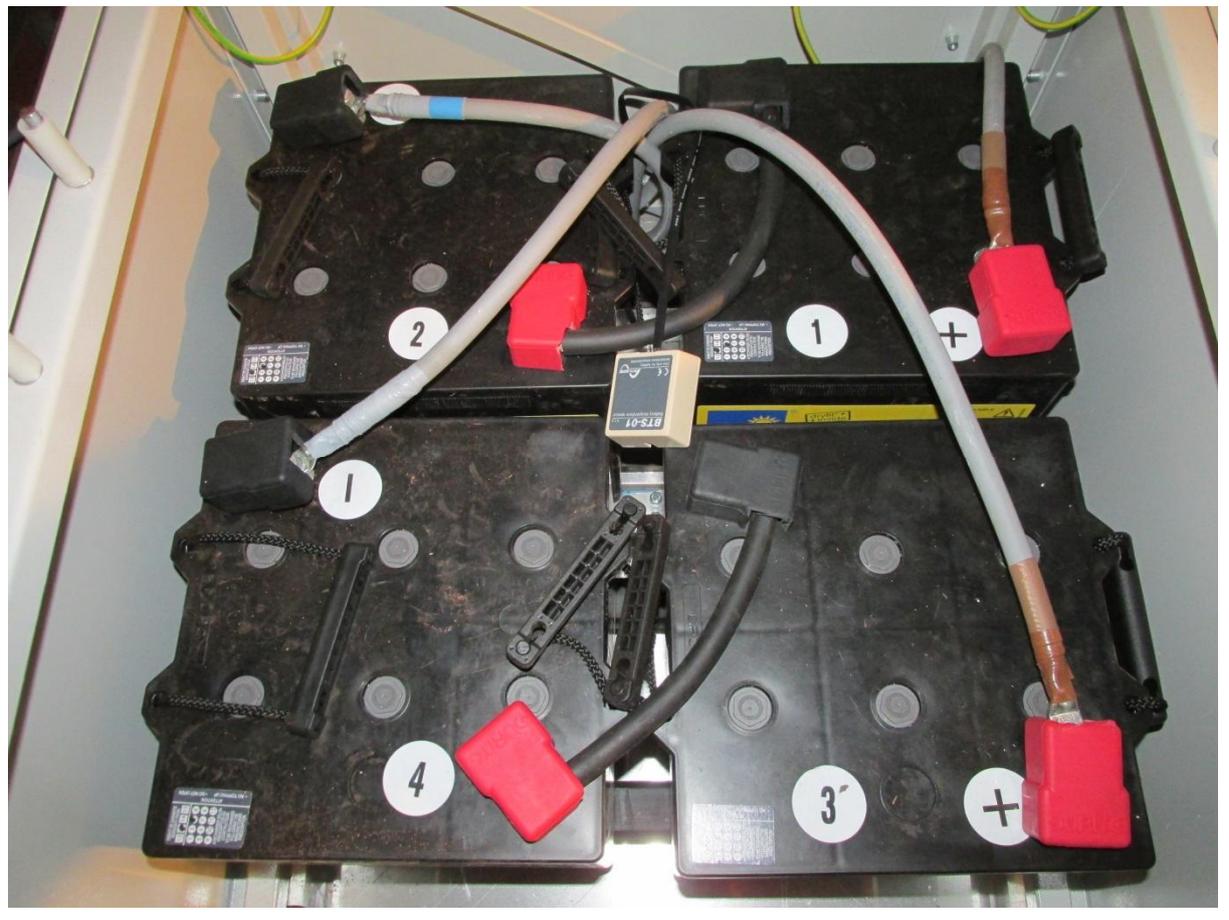
Battery (Property 18 Padstow)

Table A – Battery check (Property 18 Padstow)	
Visual Inspection :- 4 x GNB Sonnenschein Solar Block No sign of excessive gassing/liquid marks around the vents BTS-01 mounted between middle blocks Ventilation around blocks good	
Ambient Temp	14°C
Total Battery (Voltage / VPC / Surface Temp)	28.25V / 2.35VPC / 14°C
Block #1 (Voltage / Surface Temp)	14.18V / 14°C
Block #2 (Voltage / Surface Temp)	14.07V / 14°C
Block #3 (Voltage / Surface Temp)	14.11V / 14°C

Block #4 (Voltage / Surface Temp)	14.14V / 14°C
-----------------------------------	---------------

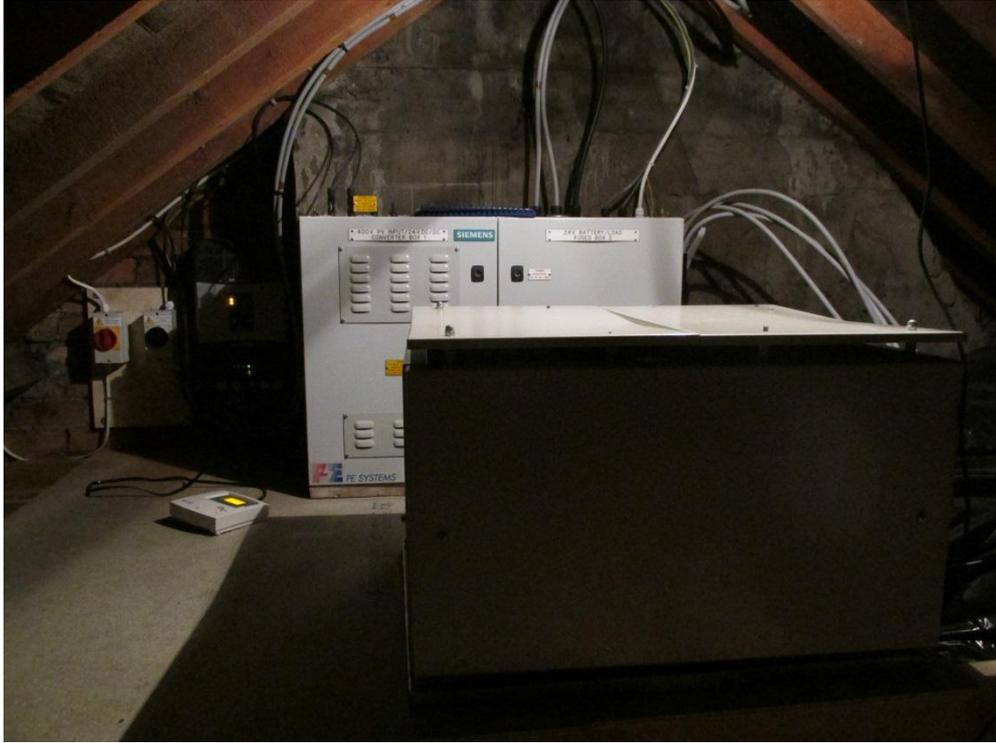
DC/DC Converter (Property 04 Broadbury)

SW opened the DC/DC converter boxes and noted that the DC/DC converter had a Yellow LED illuminated which showed that the battery was below float voltage. However, no DC current was being output from the DC/DC converter as the PV voltage was measured at only 165Vdc. The LED on the DC/DC converter power module was occasionally going off indicating that the PV voltage was dropping below 150Vdc which is the lowest working voltage for the DC/DC module.

When SW subsequently interrogated the configuration of the DC/DC converter it was noted that the configuration was set to 6 panels, as this is the number of panels installed at the property. This gave a MPP control voltage of 180V (6 x 30V) which is close to the PV input voltage low threshold of 160Vdc.

It was also noted that the battery case had been installed directly in front of the DC/DC converter (as opposed to Property 18 where it was at the side) due to space restrictions and subsequently the doors to the 2 boxes could only be opened to approximately 45°. Whilst this was not an immediate problem for the work which was to be carried out it may become an issue in subsequent visits if full access is required to the DC/DC converter for maintenance or repair work, which would probably necessitate removal of the doors, if access to the hinges was available.

1. DC/DC converter firmware to be updated to SC2.07.0 on subsequent visit when LVD hardware configuration has been confirmed
2. SK (U of B) to provide report on Studer configuration at both properties and any parameters which required changing and what the old & new values were (i.e. what were the EQLS & ABS levels within the Studer and had they played any part in the over voltage events?)

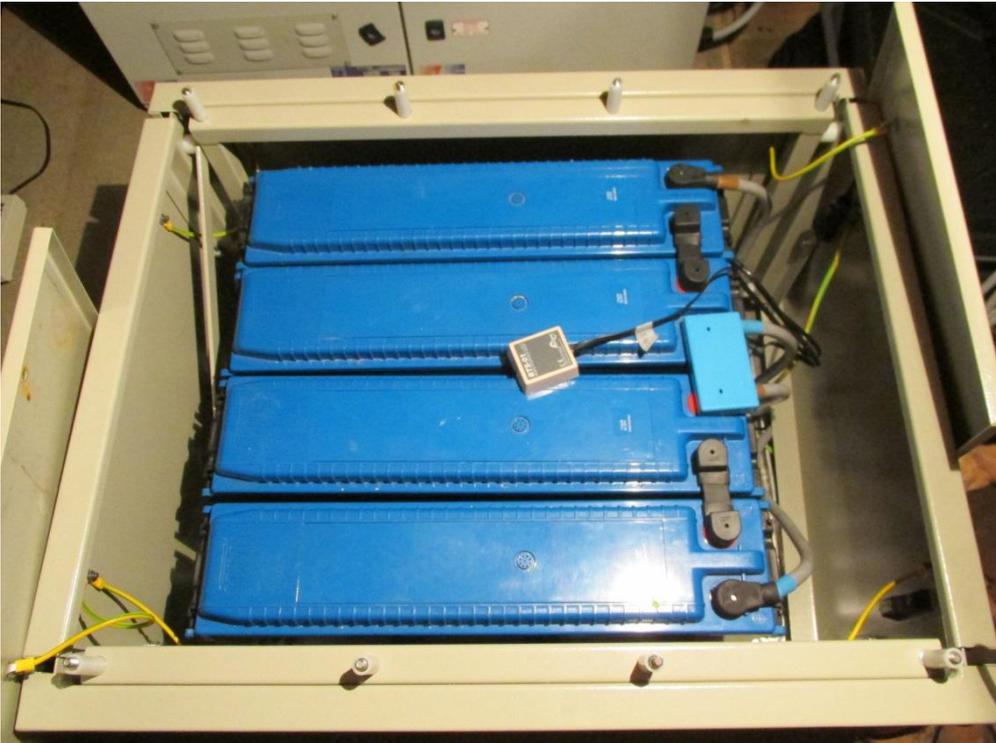
Battery (Property 04 Broadbury)

Visual Inspection :- 4 x FIAMM Block No sign of excessive gassing/liquid marks around the vents BTS-01 mounted between middle blocks Ventilation around blocks good	
Ambient Temp	15°C
Total Battery (Voltage / VPC / Surface Temp)	25.25V / 2.10VPC / 15°C
Block #1 (Voltage / Surface Temp)	12.61V / 14°C
Block #2 (Voltage / Surface Temp)	12.65V / 15°C
Block #3 (Voltage / Surface Temp)	12.62V / 15°C
Block #4 (Voltage / Surface Temp)	12.62V / 14°C

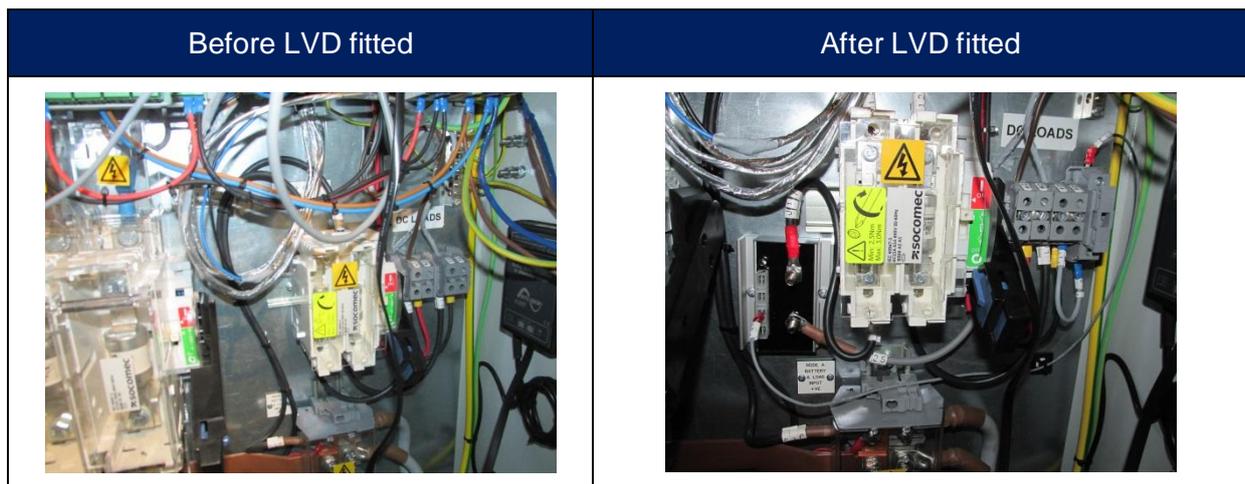
SW removed the door from Box 1 of the DC/DC equipment to allow better access to the wiring as the battery case was blocking full access. SW then fitted the Studer Battery Guard MBW40 (LVD) equipment to Box 2 (see pictures).

The LVD device has been configured to open the DC load connection to the battery when the DC voltage has been below 21V (1.75 VPC) for above 90 seconds. The LVD device will then reconnect the DC loads to the battery once the DC voltage has reached 24V (2.00 VPC) or over. There is an LED on the LVD device which is ON when the connection is

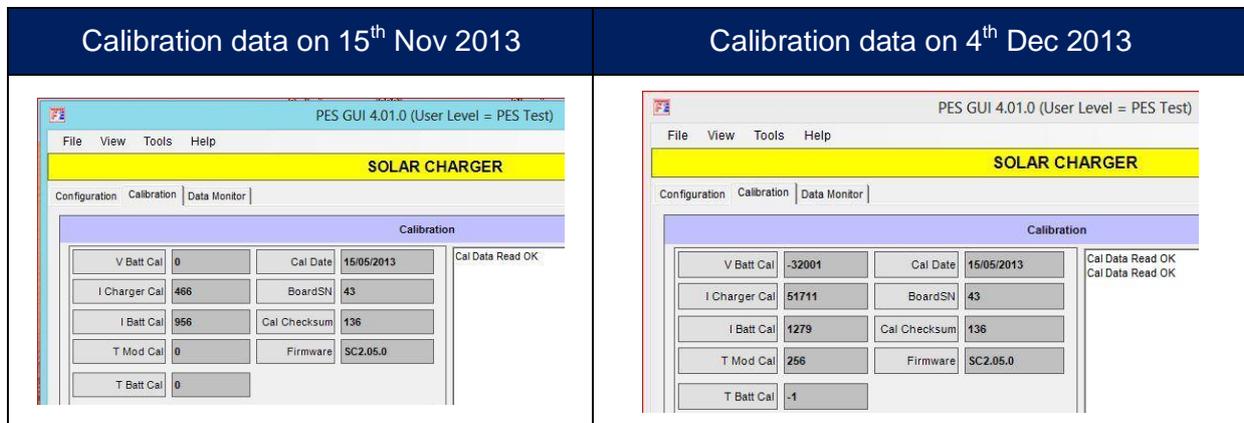
It could be seen that the calibration data had been corrupted. This behaviour had been witnessed previously when equipment had been on test at NaREC and the battery had been heavily discharged to a level below 5Vdc.

The area of memory which is corrupted is accessible via the Modbus comms bus and could be potentially overwritten by comms traffic accessing the correct address locations. The corrupt data is then loaded into running memory once the micro in the DC/DC converter is powered off then back on. This sequence would only occur when the battery voltage dropped below 5Vdc and was subsequently restored.

Therefore, whilst the DC/DC converter would not have been converting any PV power since November 29th, when the battery discharge event occurred, this would have been a symptom of the battery discharge and not a cause.

The new firmware (SC2.07.0) has had routines added which will prevent any unsolicited access to the calibration data. A “double key” method has been implemented which the Modbus user must utilise to open access to the calibration data. Therefore, once the new firmware had been loaded into the DC/DC converter this issue will be removed.
