OHL Power Pointer - Report on Method 3

Method 3: Detection of Auto-Recloser Operations

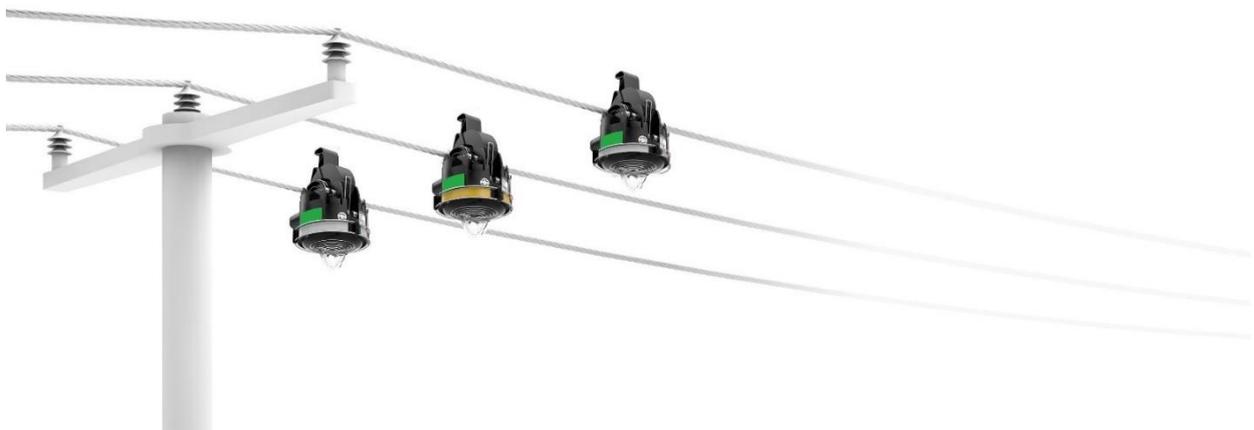
Figure 2-1: Rendered Illustration of a set of Smart Navigator 2.0 sensors

Smart Navigator 2.0 sensors clip onto overhead lines (operating at voltages from 11kV to 132kV) and sample the voltage and current waveforms (multiple times per cycle) to determine the real-time power flow direction at that point in the network. The devices weigh less than 1kg, harvest power from the overhead line for self-sustaining operation and can be readily ported between sites for redeployment. Using encrypted DNP3 communications over mobile networks, the devices transmit power flow data from remote sites to a central system (for example, iHost or PowerOn). The sensors support over-the-air upgrades, which means their functionality can be reconfigured remotely without the need for multiple site visits.

A rendered illustration of a set of Smart Navigator 2.0 sensors installed on a three-phase overhead line is presented in Figure 2-1.
