EDGE-FCLi

6 Monthly Report

October 2021 – March 2022

The Embedded Distributed Generation Electronic Fault Current Limiting interrupter (EDGE-FCLi) project is funded through Ofgem's Network Innovation Allowance (NIA). EDGE-FCLi was registered in September 2018 and is due for completion by March 2022.

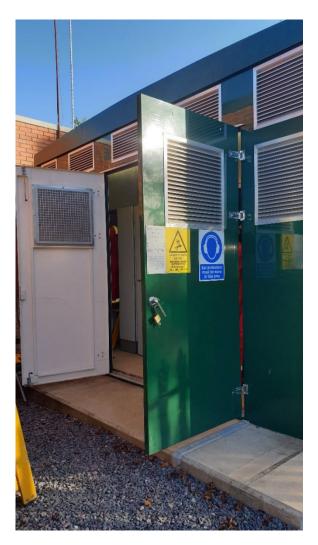
Figure 2-3 and Figure 2-4 show the EDGE-FCLi undergoing the remedial site works on 22 November 2021.

Figure 2-3 Image showing EDGE-FCLi during remedial work site visit Figure 2-4 Image sh

GridON attended a site visit at the University of Warwick on 22 November 2021 to install and configure the remedial works as described in site work plan provided to WPD for approval prior to the site visit. In addition to the updates described above, GridON performed routine maintenance on the device as per their operation and maintenance manual. This included a full visual inspection of the internal phase compartments, low voltage cubicle and HV cable termination cubicle. The filters locating in the air intake ducts on the external GRP housing were also replaced by the GridON team.

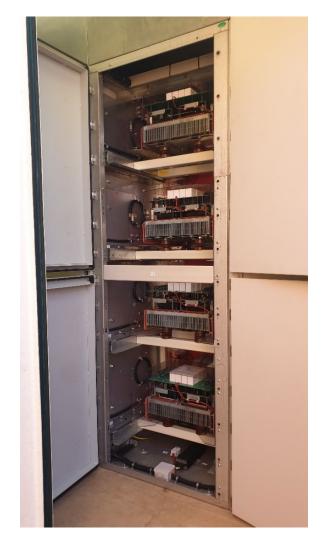
Figure 2-4 Image showing IGBT modules during visual inspection

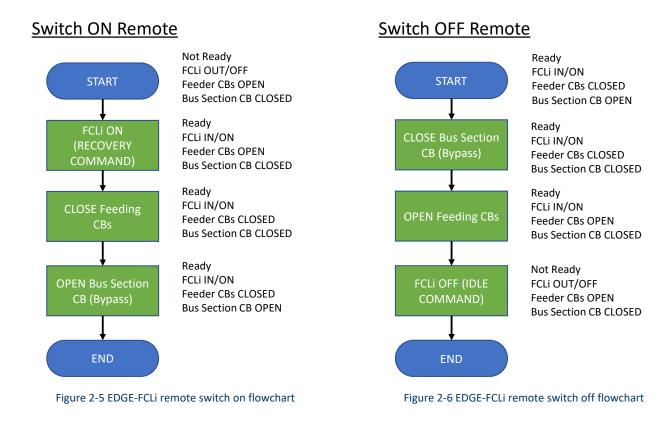
Figure 2-5 and Figure 2-6 below show examples of the simplified control flowcharts that were used to guide the redefinition of the operational modes.

To improve the telecontrol functionality, a set of simplified operational flow charts were produced based on the existing EDGE-FCLi's operational modes. These flow charts were then shared and refined based on the feedback received from control. The EDGE-FCLi has two main operational modes that can be executed from the control centre. The first is "RECOVERY" mode, which closes the IGBT switches in the device, making it ready to be energised at 11kV. The second original telecontrol was the "IDLE" mode, which opens the IGBT switches in the device and puts the device into a 'sleep' state. We have now redefined these modes as "ON" and "OFF" respectively, to make it clearer and simpler for the control engineers to interpret the function of the modes.

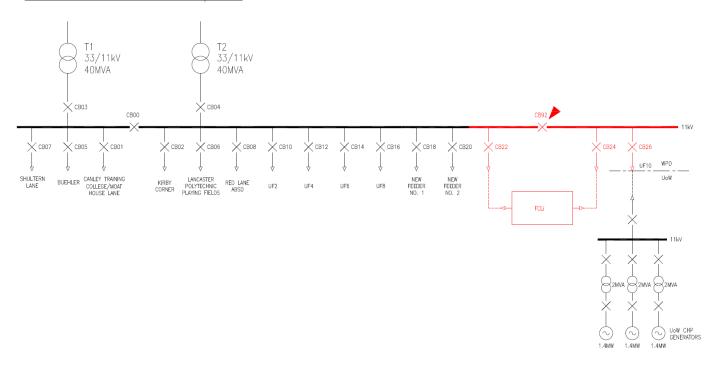
Figure 5-1 Final single line diagram of 33/11kV UoW substation

When the project team was carrying out the remedial works discussed in Section 2.2.2, it was observed that the automatic tripping of CB26 was an unnecessary action, especially when cycling the LV auxiliary supply to the EDGE-FCLi during testing and commissioning activities. There is a risk that the CHP generators can be accidentally disconnected unnecessarily leading to a customer outage. After a review of the protection scheme, the tripping of CB26 does not serve any identifiable technical purpose and therefore the decision was made to remove the associated trip links from the circuit breaker trip circuit.
