WPD ALARM Phase 2 Further Findings

Project Deliverables 7 and 8 combined

Author: Vincenzo Piazza, Ray Burn
Approved: Stuart Fowler (WPD), Mark England (Sentec), Paul Beck (Lucy Electric)
Date: 18th September 2021
Revision: D2.03
Reference: 21169RPT21

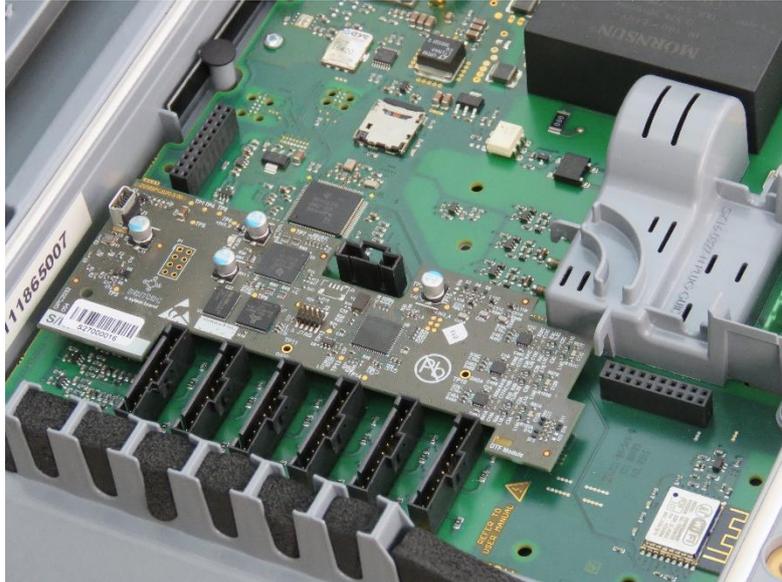
Phase 1 successfully demonstrated that it is possible to capture the relevant data from the waveforms. In phase 2 a daughter board was fitted into the MCU318 to measure the voltage and current with a greater resolution in time, higher bandwidth and greater dynamic range, thereby increasing the accuracy of the waveforms captured, with the expectation that this will lead to more accurate calculations. It is worth mentioning that – similarly to Phase 1 – also in Phase 2 the transient current waveforms are not captured on a per-feeder/per-phase basis. In fact, to simplify the architecture of the system, the transient currents measured are summed per phase across all connected feeders. A captured event therefore contains three voltage and three current waveforms, corresponding to the three phases. It is believed that this choice will not affect the accuracy of the distance predictions, since only one feeder is expected to create transients at any one instant. The allocation of a transient to a particular feeder is achieved using the on-board current measurement capability on the base board of the MCU318. The picture below shows the MCU318 with the high resolution capture daughter board fitted.

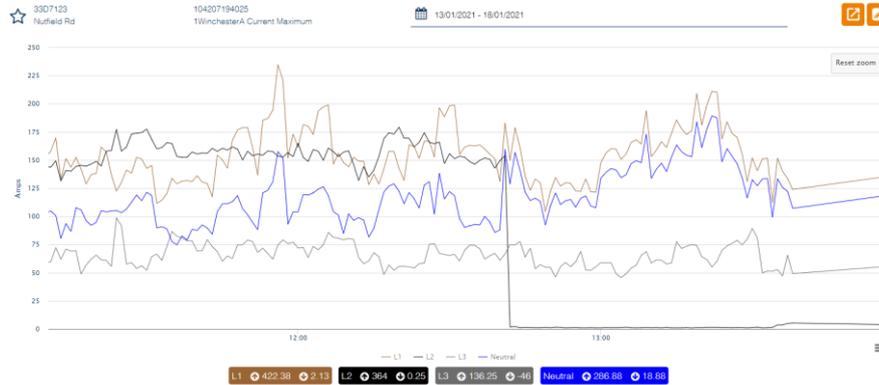
A fault developed on Nutfield Rd on 14-Jan-2021. The maximum-current trace recorded by the GridKey unit, reported below, did not show any significant spike before the fuse operation:
