Automatic Location of faults through Remote Monitoring (ALARM)

NIA Closedown Report

September 2021 – May 2022

**Electricity
Distribution**

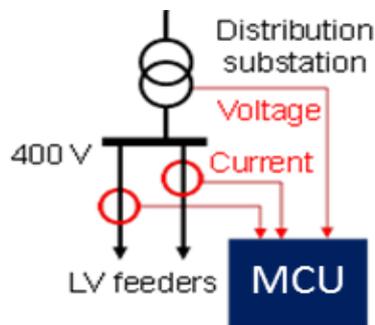
Figure 1 Schematic for the connection of LV monitors for distance to fault assessment

The project installed 26 LV substation monitors within the East Midlands region of WPD. Each monitor consisted of three Rogowski Coil based phase-current sensors per LV feeder (for up to five LV feeders) together with voltage taps, connected to a GridKey Metrology and Communications Unit (MCU) which processed the sensor data and generated and logged substation loading and condition parameters. Rogowski coil sensors were used (rather than Current Transformers) as they were very easy to retrofit to a wide range of existing LV boards and the technology allows an almost unlimited range of current measurements – the size of the transient faults can exceed 20kA in certain cases.

Each monitor captured and retained voltage and current waveforms from the monitored LV feeders when pre-set triggers were activated (e.g. rate of change of voltage or phase current). Three cycles were acquired – the one before the event, the cycle where the event actually happened and the cycle afterwards. These captured waveforms were forwarded via a GPRS/mobile data connection to a processing data centre where inductance values for the faulting network were estimated which was then used to establish a distance to fault estimate.

The monitoring devices were connected at distribution substations as outlined in Figure 1.

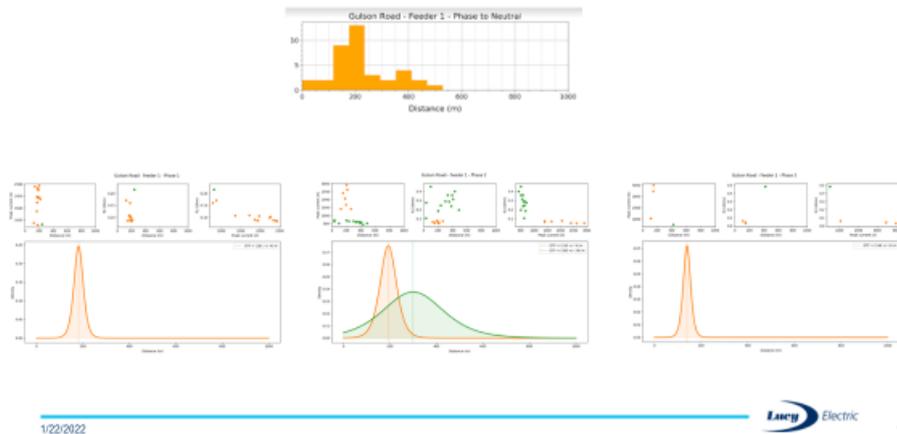
Fig 9-1: Example Multi fault location analysis

In some instances where there appeared to be a broad distribution, we found that a single feeder could have more than one fault on it at different locations. These faults were initially displayed just as a single fault but due to the multiple locations this gave a large position of uncertainty. As a result GridKey introduced a clustering algorithm to separate out events associated with different locations on the same feeder, and to analyse the statistics of these separately to give multiple sets of location information.

An example of this is shown in the figure below from Gulson Road in Coventry where there were actually faults on all three phases and two faults on the black phase.

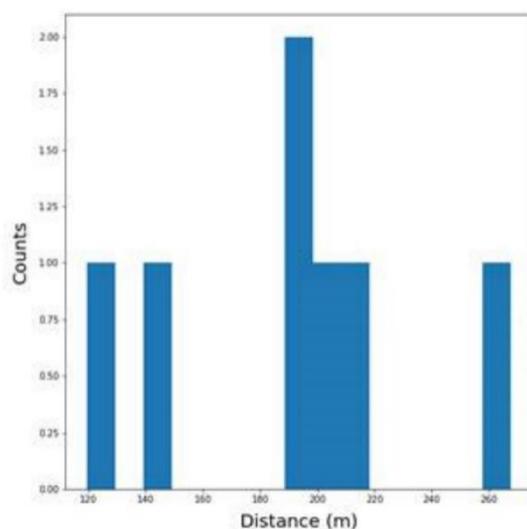
Figure 9-2: Histogram for Gulson Road

When this fault happened, the project was still in its early stages and only a limited number of waveforms preceding the fault were collected, as shown in the following histogram:

A distance assessment was undertaken after the fault was repaired using available data from before the 18/04. The analysis suggested the most frequent pecking fault analysis distance of 190-210m, and that three additional events were also captured at 120 m, 140 m, and 260 m. The waveforms corresponding to the 120-m distance, yielded a very good fit, with low residuals. That distance was also offered to the repair team as a possible location.

The repair team confirmed that the repair took place at a location of that was 200m from the substation. This agreed with the most frequently observed location as shown in the histogram fig 9-2 above.

A fuse operation occurred on Sat. 18th April, 2020 and the fault was classed as a permanent fault as the replacement fuses blew immediately. Repair work was carried out the same day to repair the fault.

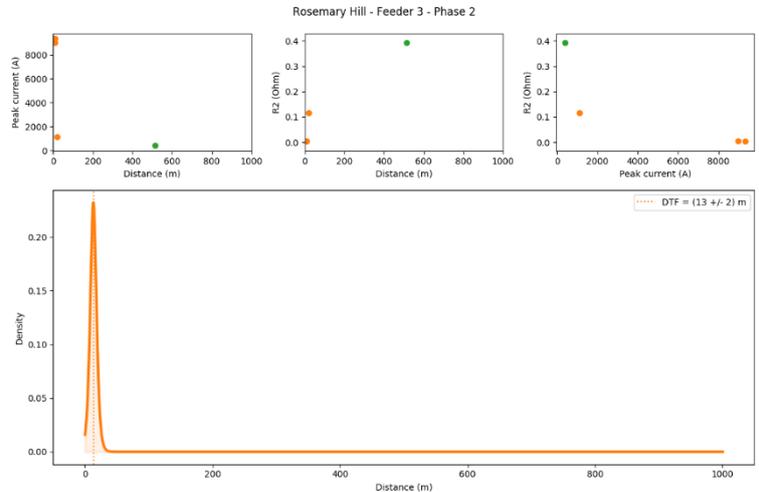
Figure 9-3: Histogram for Rosemary Hill

A fault occurred on 22/03/2020 on Feeder 3 at Rosemary hill substation. The ALARM system recorded a limited number of waveforms with peak currents in excess of 8 kA which were all captured prior to the fuse operation.

Notwithstanding the small data set (3 waveforms), the small spread in the data allowed us to estimate a fault distance of just 13 m from the substation with an uncertainty of ± 2 m.

Feedback from the repair team indicated that a location of c.13m from the substation.

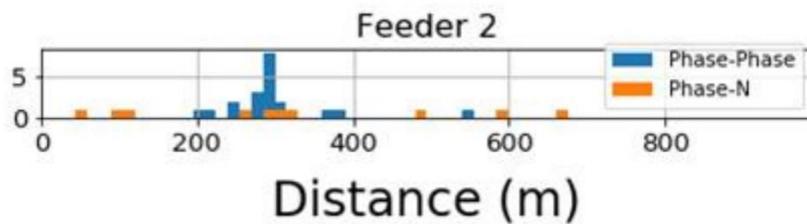
Figure 9-3: Histogram for Ravenstone Road

A fuse operation occurred on Mon. 13th Jul, 2020 and the fault was classified as permanent as the new fuses tripped immediately after replacement. Most events recorded before the fault were phase-to-phase (L2-L3). The analysis of the data available to that date indicated a most-likely distance-to-fault of 280 m ± 20 m as can be seen in the figure below.

Feedback from the repair team indicated that a location of c.280m from the substation.

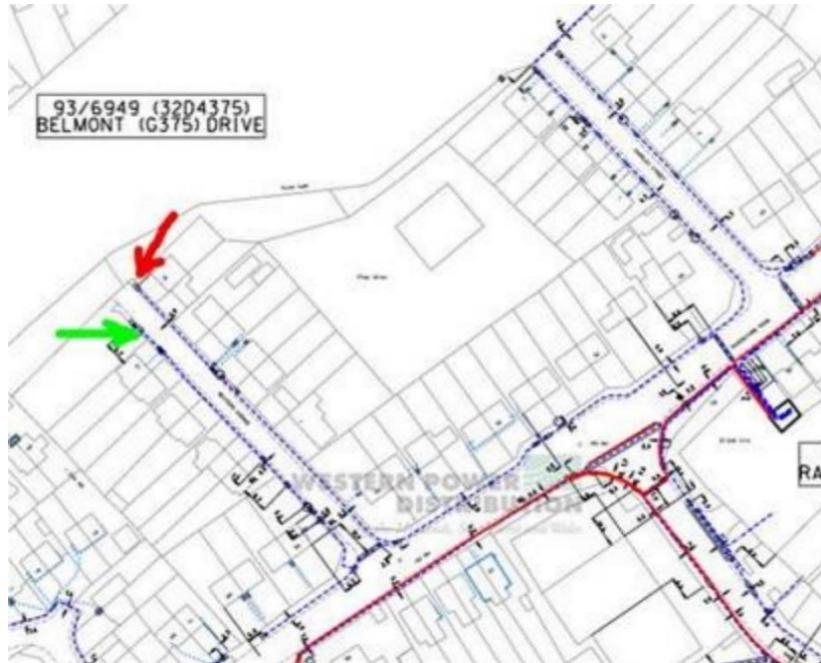
Figure 9-4: Location of Ravenstone Road

Applying this to the branched structure of Ravenstone Road, as shown in Figure 9_4 below, Feeder 2 (Western Ave), and a distance from the substation of 280 m suggests that the fault is at the end of one of the branches running down Western Avenue (red and green arrows in the figure below, (red arrow=264m, green arrow=271m).

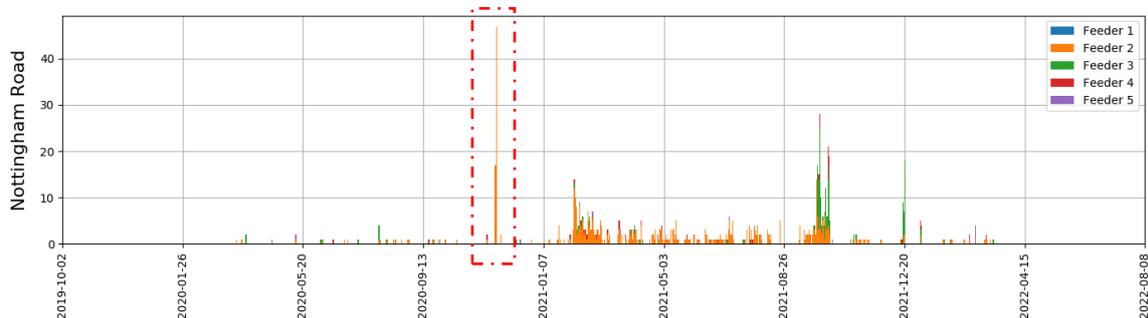
Fig: 9-5 Histogram for Nottingham Road

A fuse operation occurred on 22/11/2020 and the replacement fuses tripped immediately. This was an example of a site where there was a long period with little or no fault activity and then a burst of events as can be seen below. Many of the events captured by the GridKey system relative to feeder 2 happened between the 21st and 22nd of November, highlighted by a dashed rectangle in the figure 9-5 below.

The analysis of those events yielded an estimated distance of $70 \text{ m} \pm 2 \text{ m}$. The fault was located and repaired at approximately 80 m from the substation.

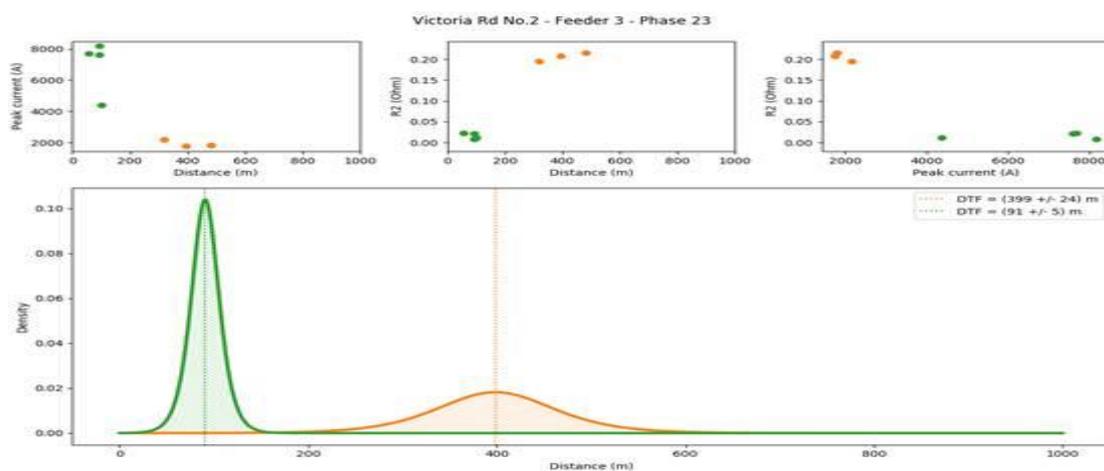
Fig: 9-7: Histogram for Victoria Road

This feeder developed a fault on 31/07/2021. The temporal evolution of this was significantly different from that of Nottingham Rd., feeder 2, being characterised by a number of high-current “bursts” of events around the following dates preceding the actual fault: 09/11/2020, 07/02/2021, 24/05/2021, 19/07/2021.

The analysis yielded a distance to fault of 91 m ± 5 m as shown by the green curve on Figure 9_7 below. We believe there is also a second fault on the cable (as shown by the orange curve) which is also starting to be detected

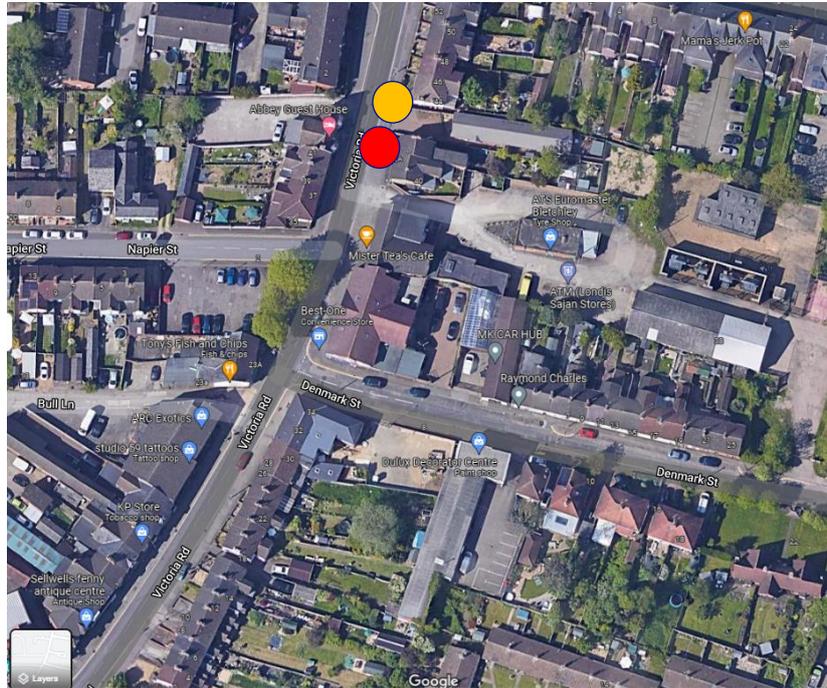
Fig: 9-8: Location of Fault in relation to ALARM system calculation

The actual fault was located at approximately 74 m from the substation.

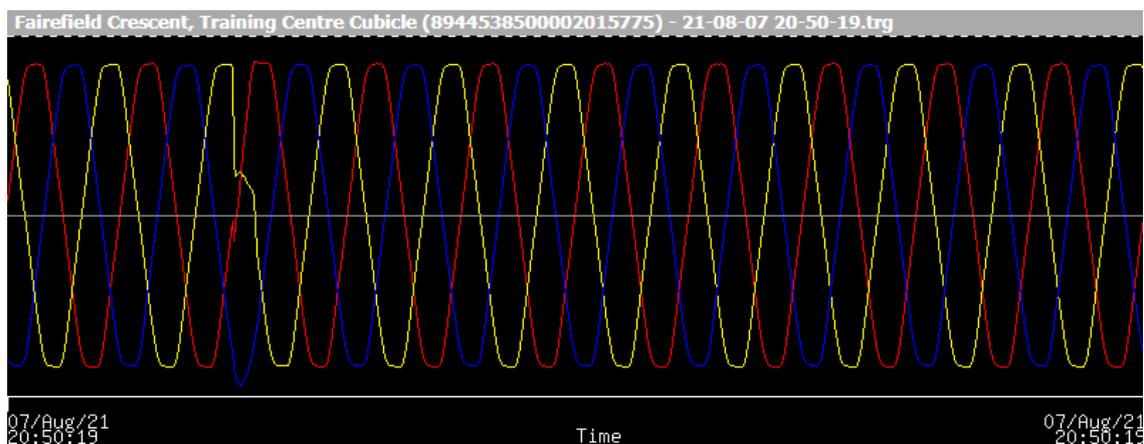
Diagram 10-2: Frequently occurring transient Y phase fault

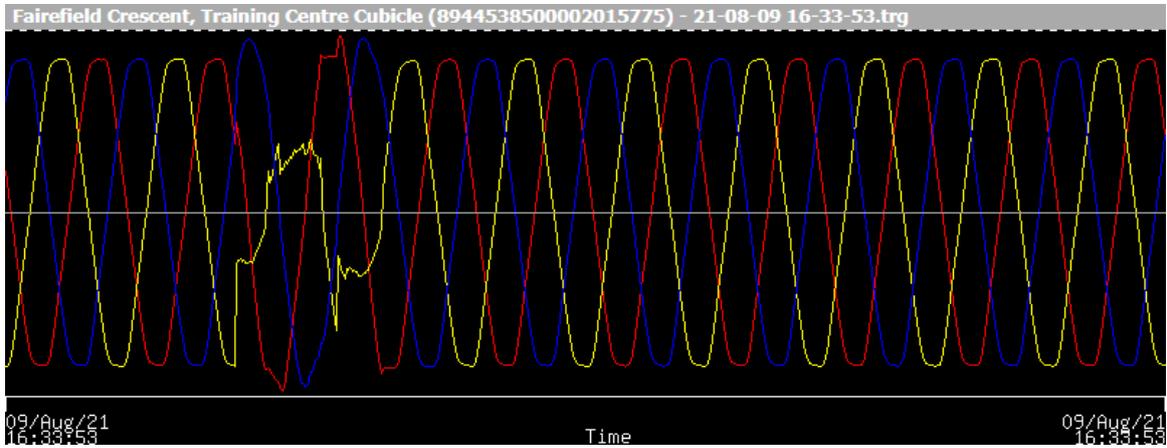
Diagram 10-3: Occasional multi cycle duration transient Y Phase fault

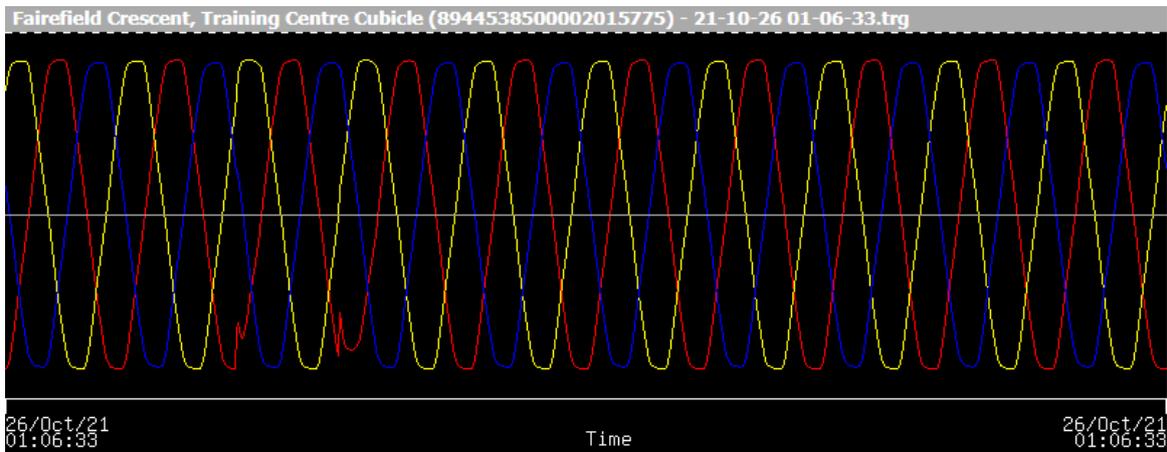
Diagram 10-4: Transient R phase fault elsewhere on system after removal of branch supplying old streetlamp

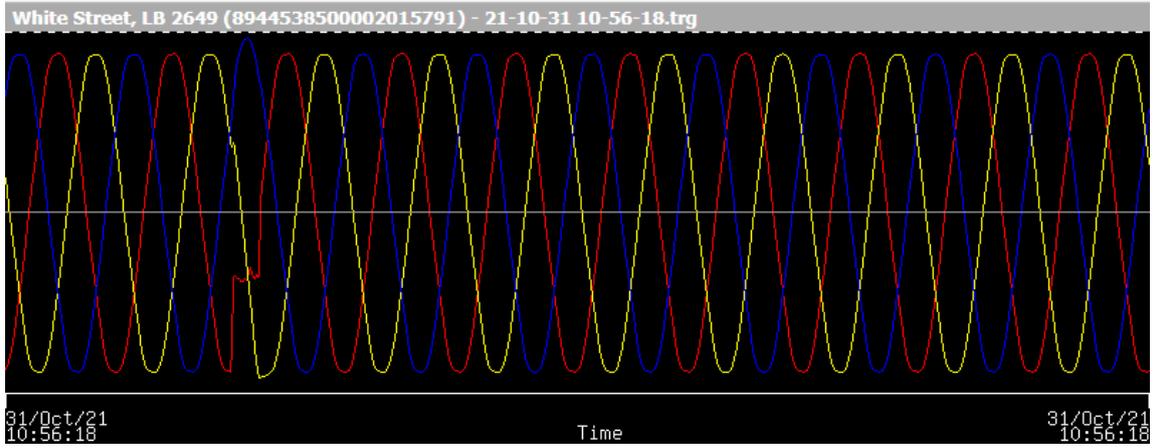
The T-P23 installed on this circuit captured 43 event triggers over a 3 month period, examples of which are shown below. These correlated well to the data seen from the Lucy GridKey devices:

Diagram 10-5: Example of close-up R phase transitory fault showing constant 'arc' voltage drop

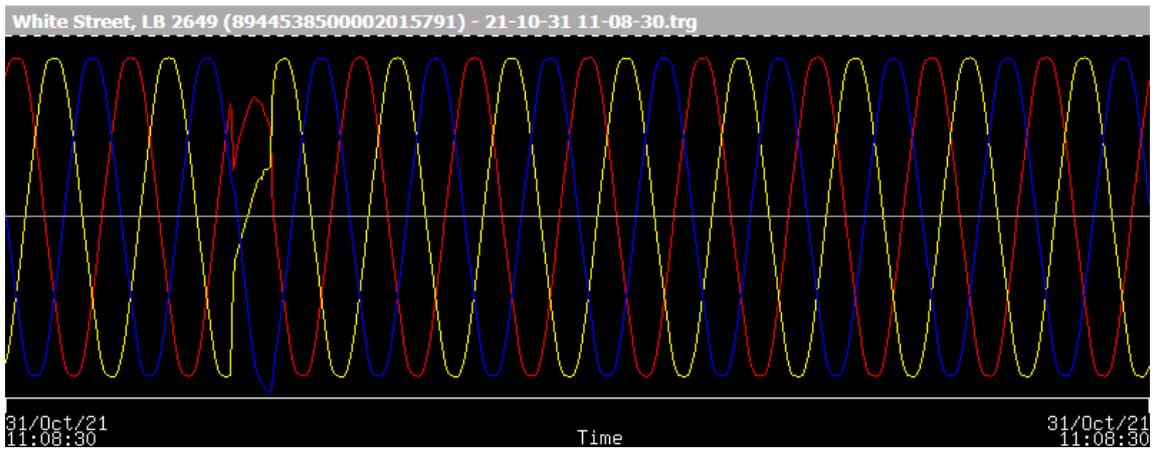
Diagram 10-6 Example of close-up R-Y phase transitory fault

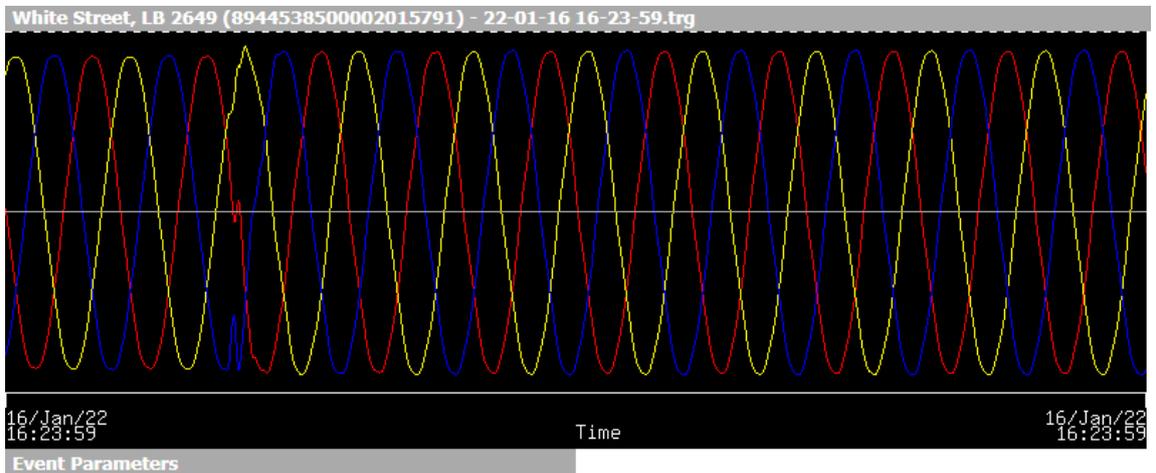
Diagram 10-7: Recent disturbance due to switching of 3 phase load

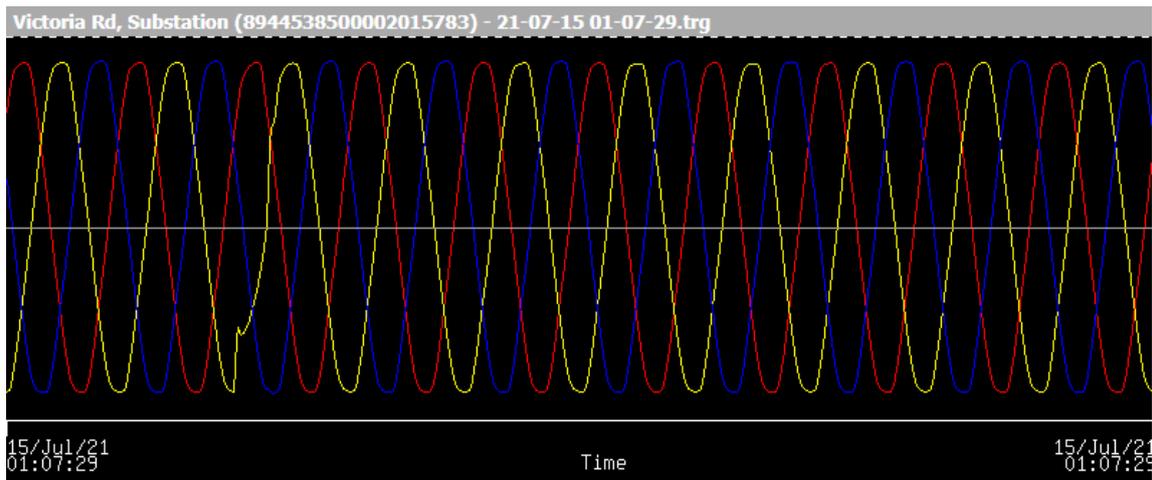
The T-P23 installed on this circuit has captured 53 event triggers over a 6 month period, examples of which are shown below. . These correlated well to the data seen from the Lucy GridKey devices:

Diagram 10-8 Transitory Y phase fault some distance away from substation

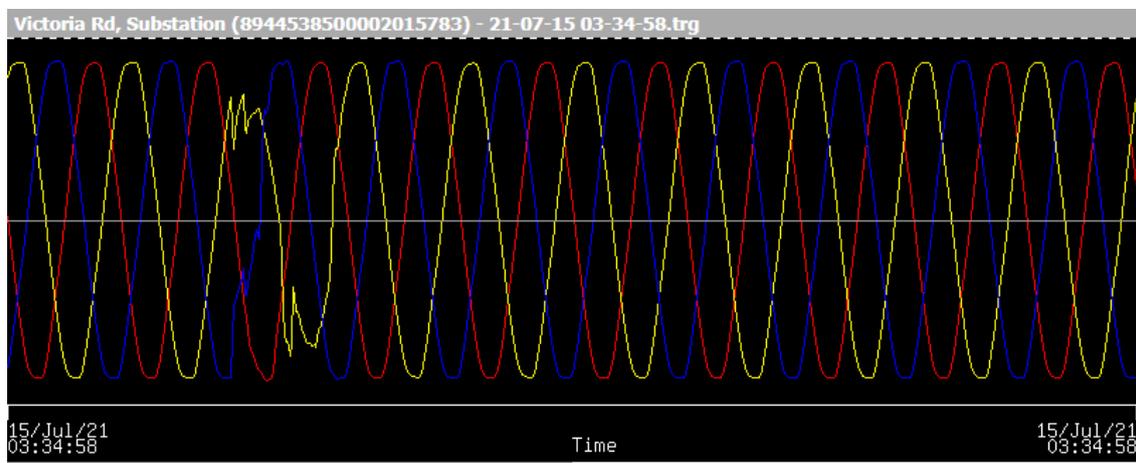
Diagram 10-09: Transitory unstable Y-B phase fault some distance away from substation

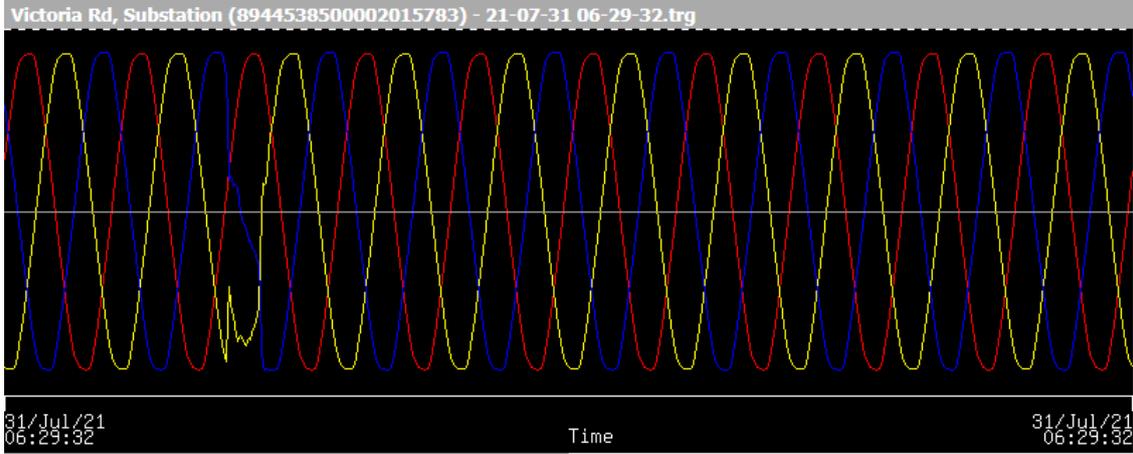
Diagram 10-10-11: Transitory stable Y-B phase fault some distance away from substation

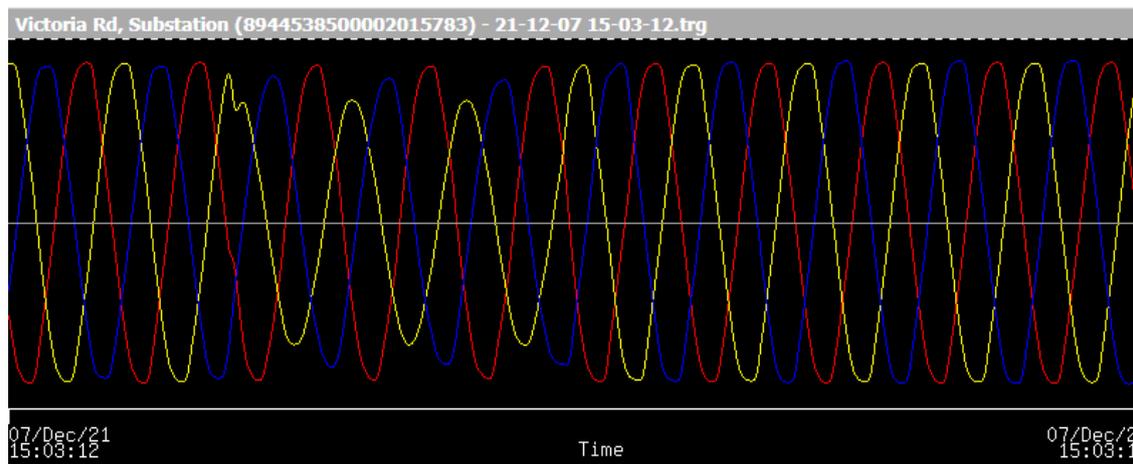
Diagram 10-11 Transitory HV system fault on Y phase

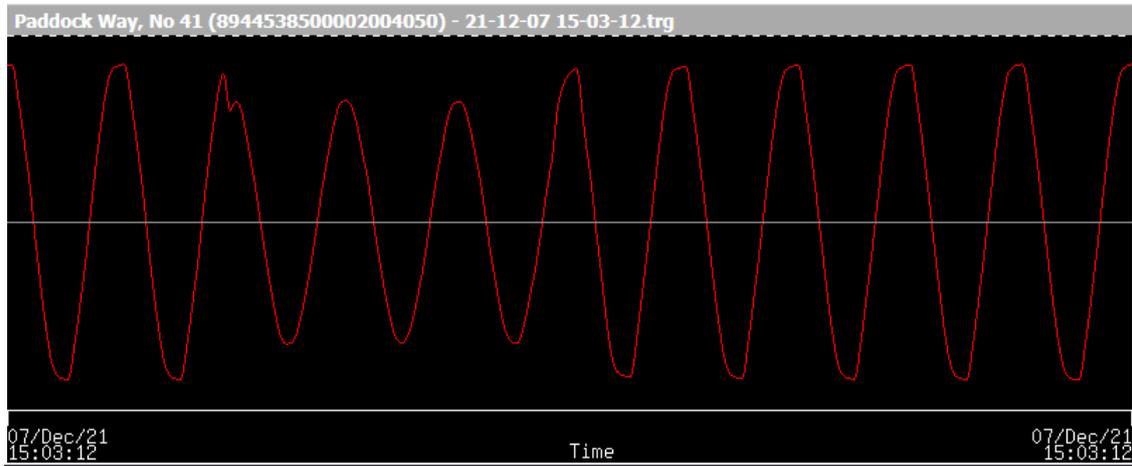
This unit was connected to a single phase consumer cut-out early in December and collected 6 triggers, the earliest of which corresponds to the Y phase HV trigger at Victoria Road, where we had installed the GridKey unit.

Diagram 10-12 Transitory HV system fault on Y phase
