# Arc Aid

Final Learnings Report

November 2022

**Electricity  
Distribution**

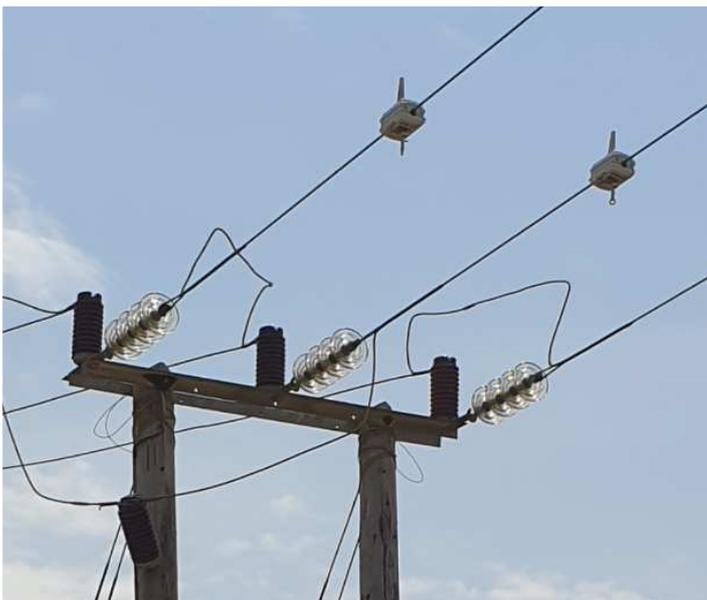
**Figure 5-1 MetySense 5000 sensor set on a feeder supplying St. Blazey 33/11kV substation**

The scope of NGED’s trial was to install 20 MetySense 5000 sensor sets. Each set consists of three sensor units (corresponding to one unit per phase) and a pole-mounted gateway unit. The gateway unit uses low powered radio to communicate with the line mounted sensors. It provides additional computing and signal processing capabilities, and acts as a base station for data transfer back to NGED’s NMS. Figure 5-1 shows one of the sensor sets we installed on a 33kV feeder supplying St. Blazey 33/11kV primary substation. Figure 5-2 shows an example of a pole mounted gateway that provides the telecoms connection to the NMS.

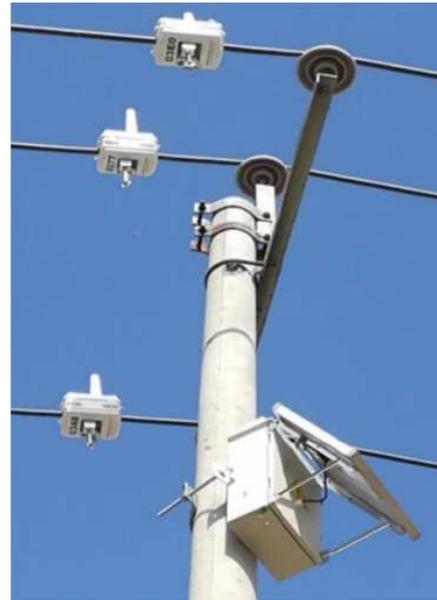
**Figure 5-2: Example of a pole mounted gateway unit**

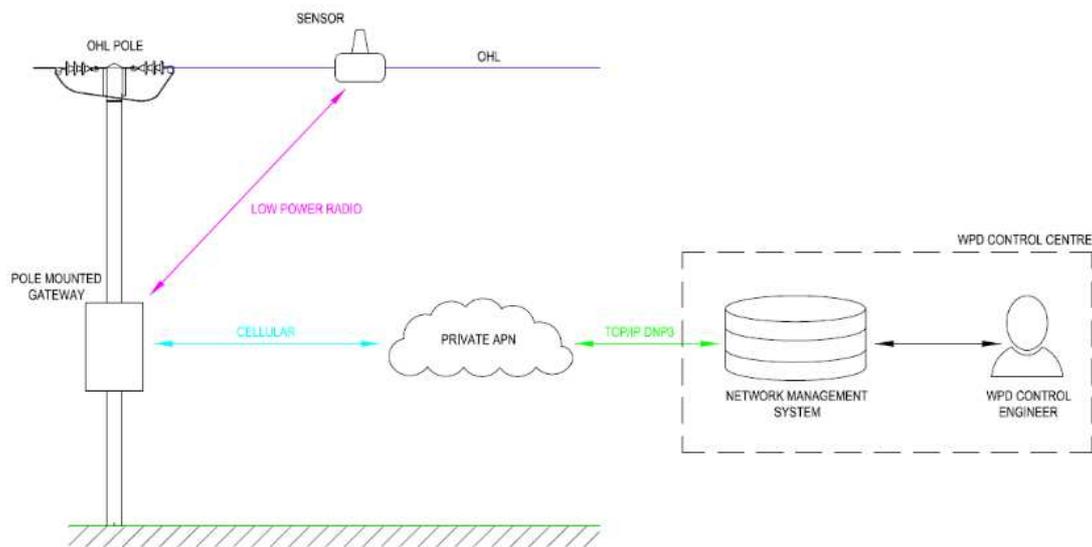
**Figure 5-3 Cellular telecoms system architecture**

The MetrySense sensors continually monitor their respective phase current and voltage waveforms. If a fault is detected, the three sensors immediately send waveform recordings and other data about the fault to the gateway. The gateway runs analysis algorithms on the complete 3-phase information to make a local decision about the fault. If a fault is confirmed, the fault data is communicated to central control either over the local cellular network, or over the Supervisory Control and Data Acquisition (SCADA) network. The project trialled both cellular and radio connected sensor sets to understand the merits of both systems. Figure 5-3 and Figure 5-4 show schematic diagrams of the two main system architectures used in this project.

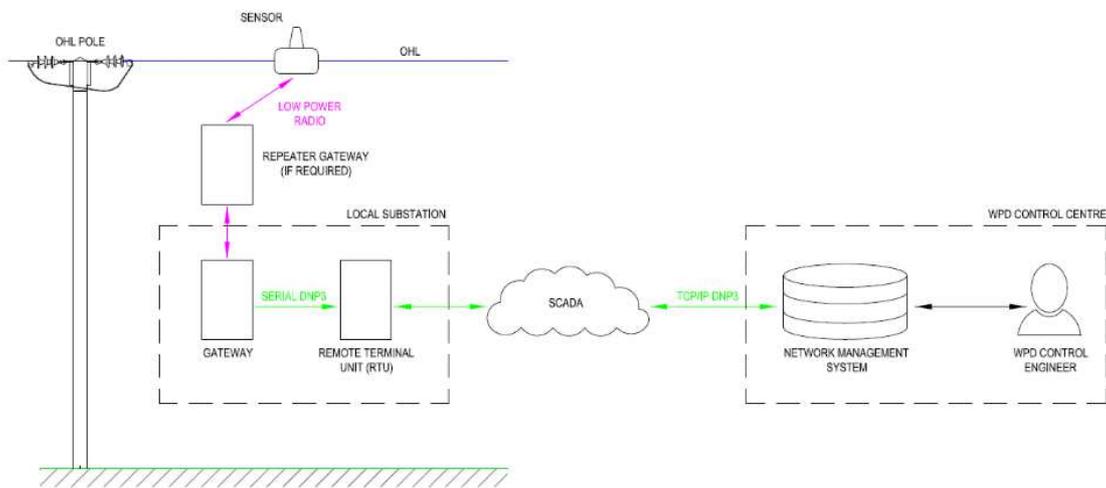
**Figure 5-4 Radio telecoms system architecture**

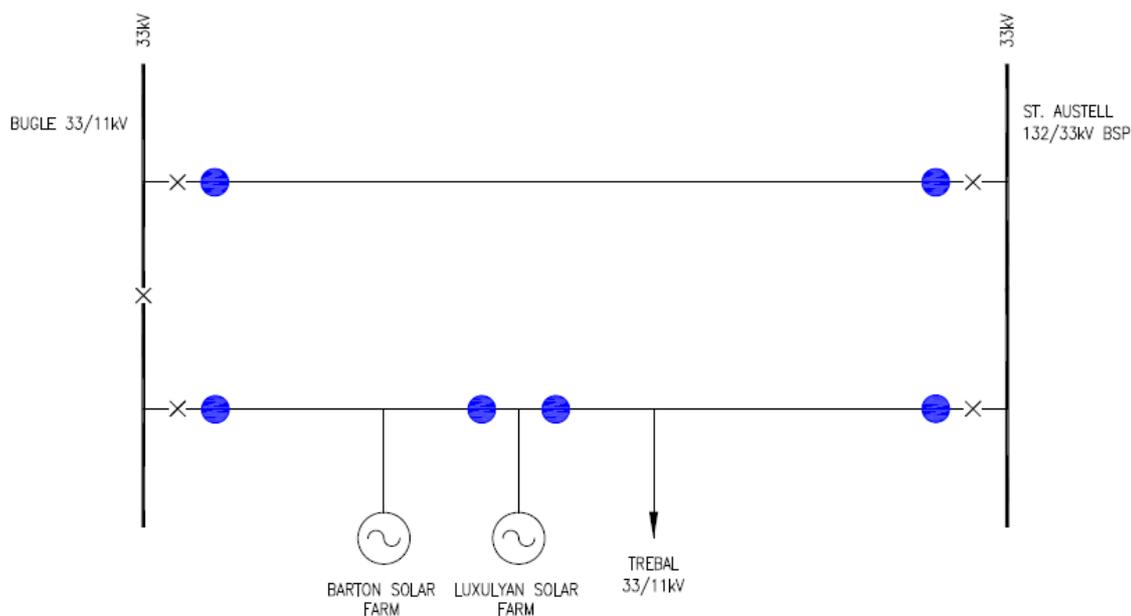
**Figure 5-5 Example of sensor location selection (blue circle) on 33kV network fed from St. Austell 132/33kV BSP**

Following the signal strength study, the sensor locations were strategically selected to optimise the area of 33kV network being monitored for fault detection. Typically, sensors were located at either end of a section of overhead line so that earth faults occurring along its span could be detected

and located efficiently. An example of the selection methodology applied to an extract of the 33kV trial area can be seen in Figure 5-5.

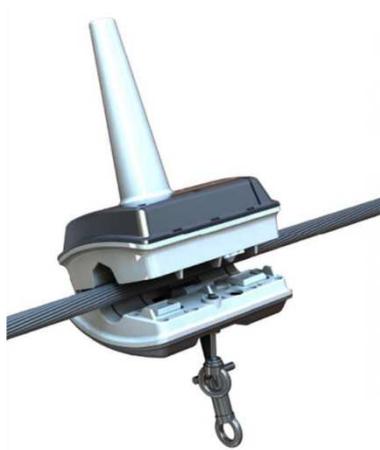
**Figure 5-6: MetrySense 5000 sensor clamping over the conductor**

The MetrySense 5000 sensor body has a clamshell design allowing the unit to be placed over the OHL conductor as shown in **Figure 5-6**. The device has a main screw on the base that tightens and fixes the clamp to the conductor. A secondary smaller screw on the base is required to secure the housing to the line. The screw attachments are shown in **Figure 5-7**. The sensor can be installed with a hot stick attachment or on the live line using insulating gloves. The MetrySense

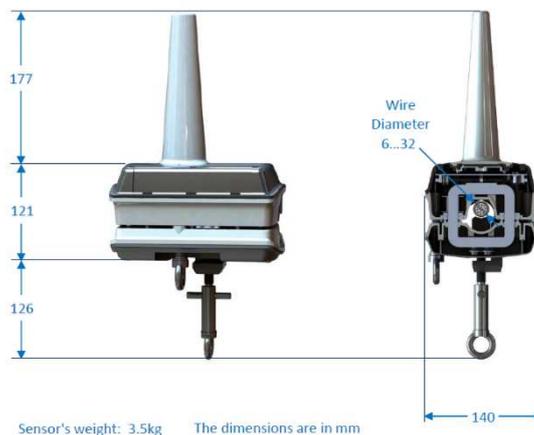
**Figure 5-7: Profile view showing main and secondary screws**

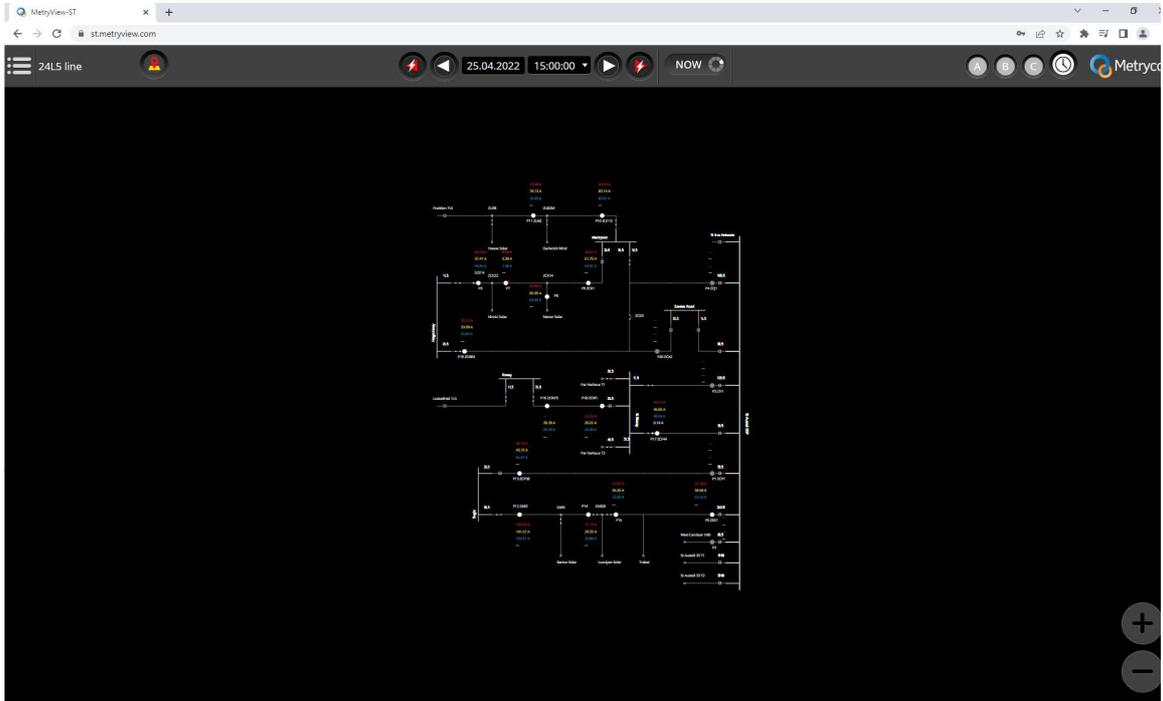
**Figure 5-8 Web-based MetryView GUI and SLD representation**

The data from the radio and cellular connected sensors interfaces with the MetryView software platform. This platform is Megger's proprietary system that analyses the data received from the remote sensor devices and allows visualisation of analysis results using a browser based Graphical User Interface (GUI) in real time. The MetryView system also provides the DNP3 data connectivity to the NMS in the control centre, so that fault detection signals can be displayed on control engineer mimic screens. **Figure 5-8** shows a screenshot of the MetryView GUI and corresponding Single Line Diagram (SLD) of the 33kV network fed from St. Austell.

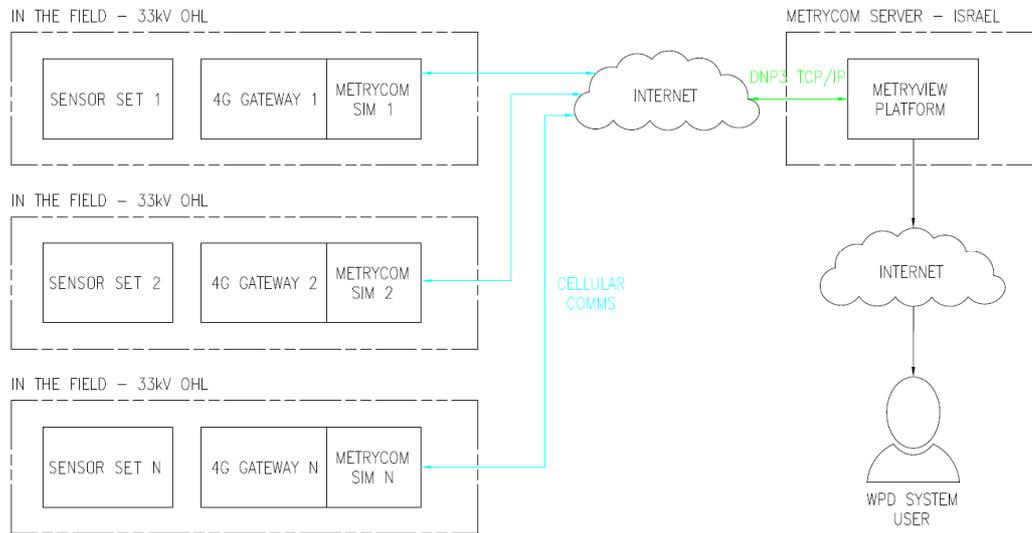
STAGE 1

Figure 5-9 Stage 1 works - cellular sensor data relayed to Megger server while local server is built

In its final design configuration, the MetryView software was hosted on a purpose-built server for the project trial, located behind the NGED firewall. The server was not available during the installation of the sensor sets at the start of the project, so sensor data was temporarily relayed directly to servers hosted by Megger to allow the trial to proceed. This Stage 1 work is shown diagrammatically in **Figure 5-9**. The NGED server is now fully constructed, and the cellular SIM cards have been replaced with NGED units capable of communicating to the NGED private Access Point Name (APN). This is shown diagrammatically in **Figure 5-10**. The sensor data has now been fully integrated with the NGED NMS to allow control engineers visibility of fault detection and location information.

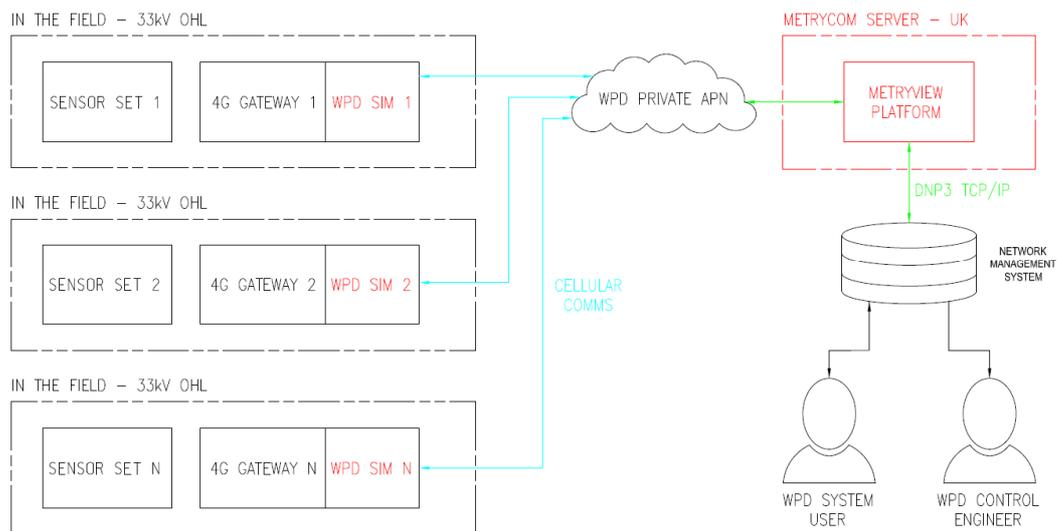
STAGE 2

Figure 5-10 Stage 2 works - cellular sensors migrated to Megger server after completion of build

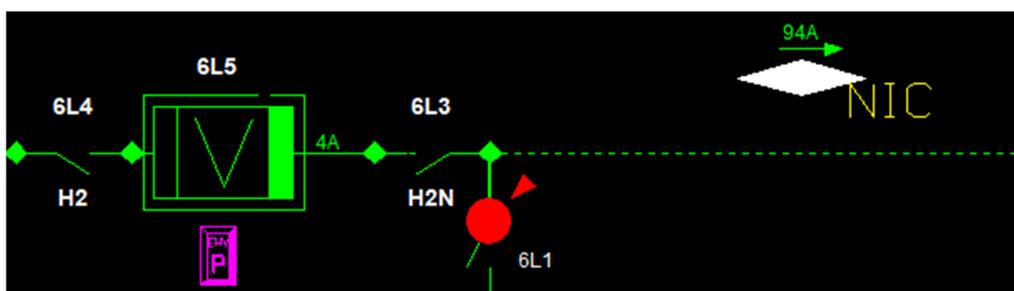
**Figure 5-11 Sensor mimic symbol (grey diamond) on the NMS**

A key project requirement was the ability for the NGED control engineers to easily locate an earth fault on their Human Machine Interface (HMI) from the real-time sensor data. This was facilitated by a DNP3 telecommunications channel between MetryView and the NMS indicated by the green arrow in **Figure 5-11**. The critical DNP3 data signals from the sensors were identified and mapped to the NMS. In addition, a mimic symbol for the sensor sets was developed in the NMS so that the control engineer could easily interpret the earth fault detection and direction of the fault current on the NMS mimic screens. **Figure 5-11** shows a screenshot of the mimic symbol (grey diamond) for a sensor set.

The diamond symbol represents a simple way of visualising real time current flow and fault data from the sensors, which enables the control engineer to clearly interpret the information on their HMI. The real time current magnitude and direction is shown by the green arrow above the diamond. The current magnitude is taken from the L2 phase sensor set and the direction is taken from a calculation of the average power factor from each sensor unit in the set. Table 5-1 summarises the different mimic symbol indications. A detailed description of the NMS interface for the sensors can be found in the “Alarms in Power ON v8” design document.

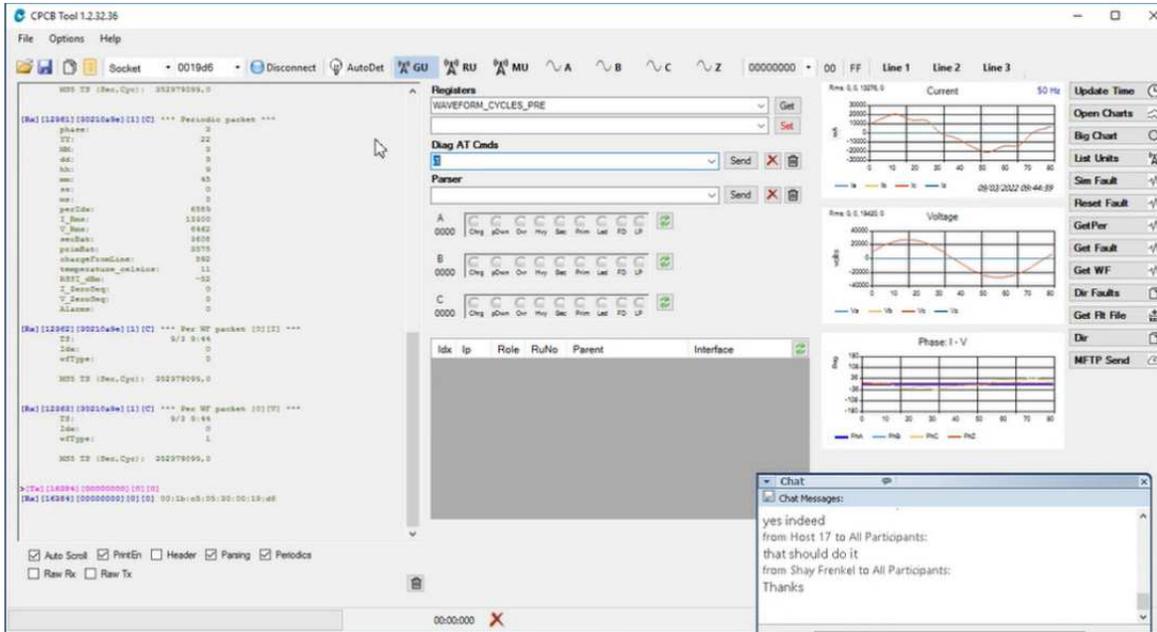
**Figure 5-12 Screenshot of the Megger simulation tool used for the DNP3 integration testing**

There were some analogue and binary data points that could only be triggered by simulating input conditions either by manually changing values in the MetryView database, or by automatically simulating waveform data and applying this directly to the sensor set under test. To efficiently achieve this, Megger were able to create a simulation tool to carry out the automatic generation of input parameters. A screenshot of the simulation tool is provided in Figure 5-12.

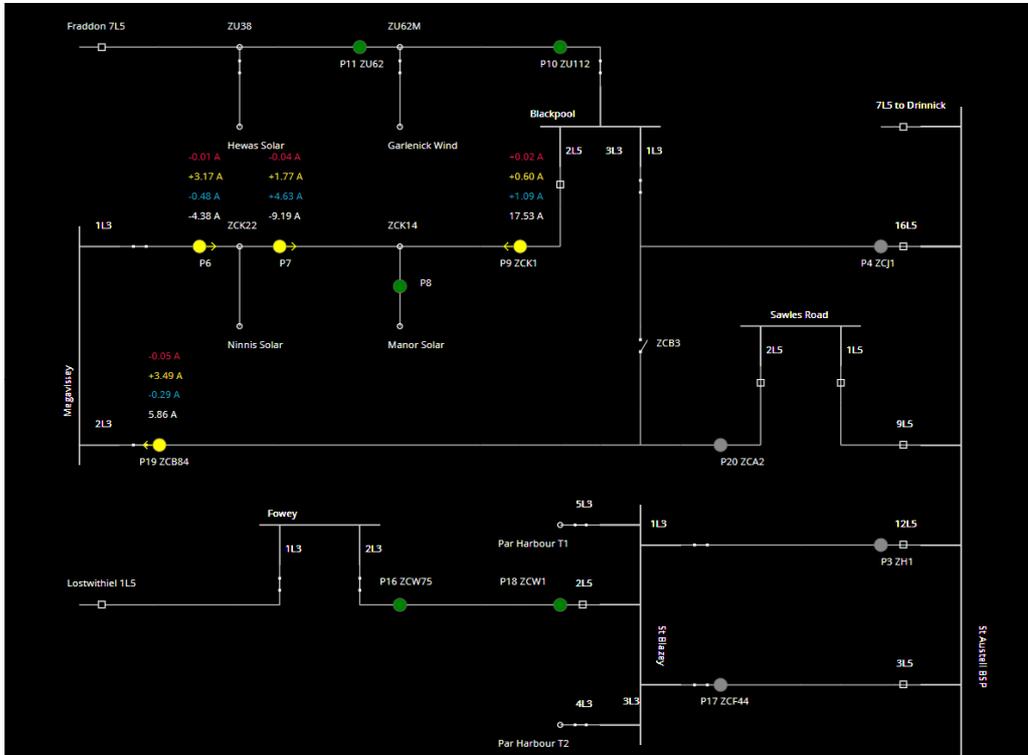
**Figure 6-13 MetryView screenshot showing transient earth fault on Blackpool 2L5**

At 11:59:10 14 June 2021 a transient earth fault was detected on the Blackpool 2L5 to Mevagissey 1L3 feeder, which also supplies Ninnis & Manor Solar Farms. Figure 6-13 shows the MetryView SLD for the fault event that was recorded by the system. Each circle on the diagram represents a discrete sensor set. The yellow circles correspond to the sensor sets that have detected the transient earth fault and their associated arrows show the direction of the fault current. The yellow colour also tells the user that the feeder remained energised and did not power down due to the fault.

On closer inspection in MetryView, it was apparent that Phase C had experienced a very short transient earth fault between P7 and P9 sensor sets, with fault currents flowing in from Mevagissey and Blackpool substation. **Figure 6-14** shows the data recorded by sensor set P9, which indicates that the fault occurred on Phase C with a 17.5A zero-sequence current flow. The Manor Solar Farm also discharged some current into the fault, but this was small in comparison. The fault was extinguished by the ASC and the feeder remained energised with no customer interruptions.

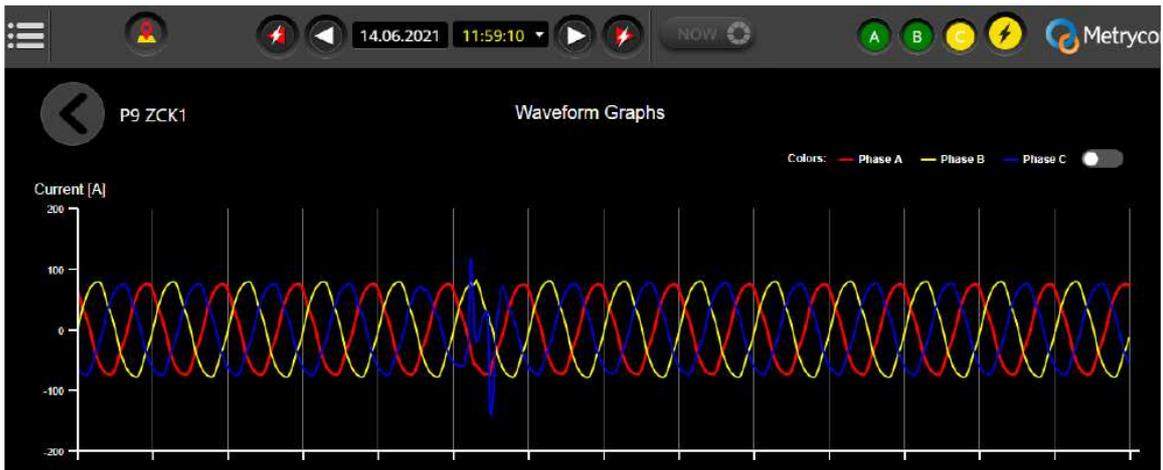
**Figure 6-15 MetryView screenshot of sensor set P9 transient earth fault on Phase C (blue trace)**

The fault waveform data shown in **Figure 6-15** shows the transient current during the fault on Phase C (blue trace) before being rapidly extinguished by the ASC. **Figure 6-16** and **Figure 6-17** show the waveform of zero-sequence active fault current at P9 and P7 respectively. Comparing the two waveforms clearly shows the transient current disturbances are 180° out of phase indicating that the transient fault occurred on the OHL between P7 and P9 sensor sets.

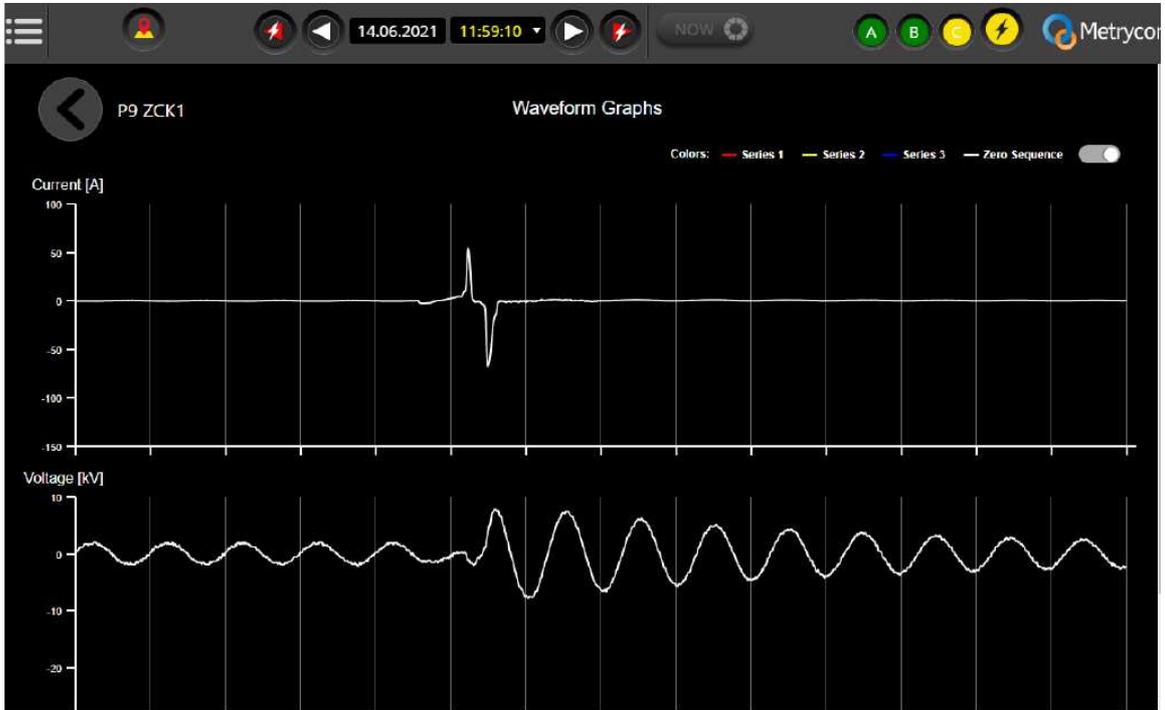
Figure 6-16 MetryView screenshot of sensor set P9 zero sequence current and voltage during transient earth fault

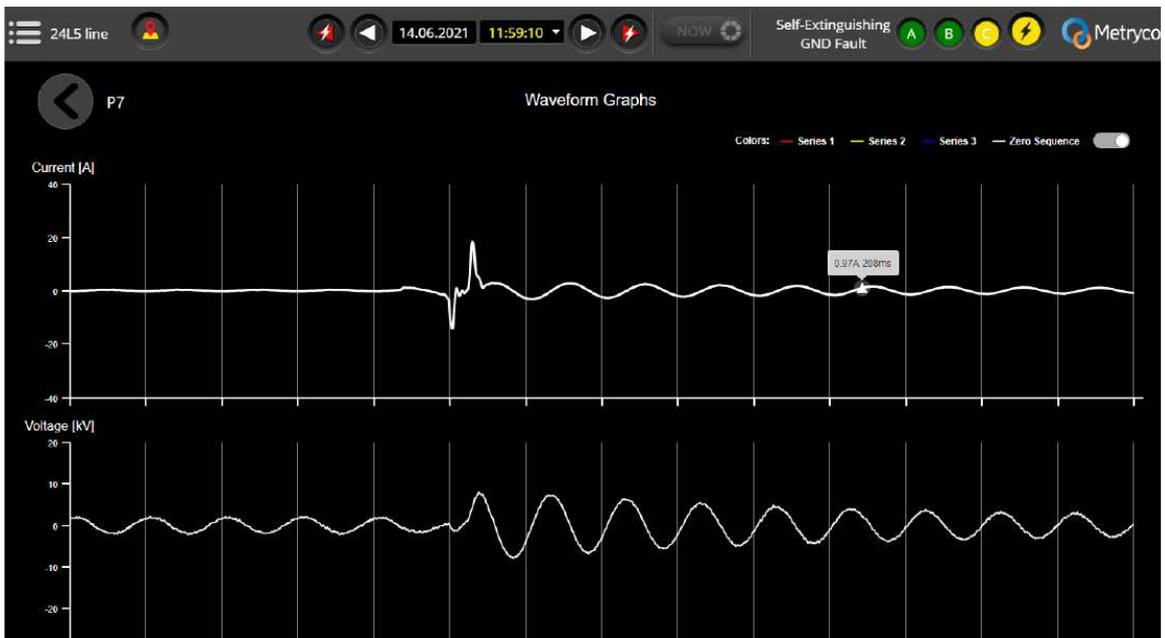
Figure 6-17 MetryView screenshot of sensor set P7 zero sequence current and voltage during transient earth fault

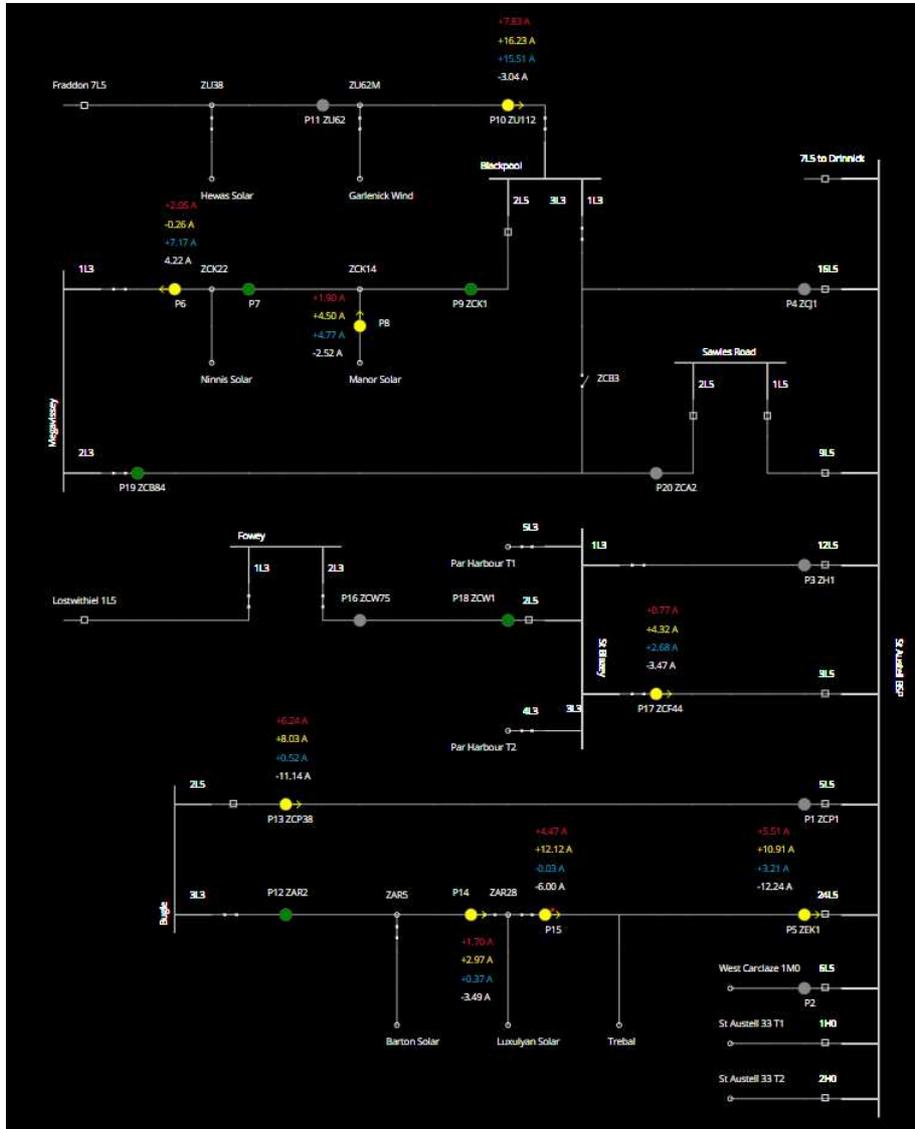
Figure 6- MetryView screenshot showing transient earth fault detected downstream of West Carclaze 1M0

At 04:51:59 14 March 2022 the system detected a large phase-to-earth fault downstream of P2 fed from 6L5 West Carclaze at St. Austell 33kV. Figure 6 6 shows the MetryView SLD for the fault event that was recorded by the system. This feeder supplies the West Carclaze 33kV Solar Park and the fault was confirmed to be linked to a 33kV cable joint failure on this cable section. NGED control engineers identified that the St. Austell BSP ASC had detected an earth fault, however, the local customer circuit breaker tripped and isolated the fault from the 33kV system.

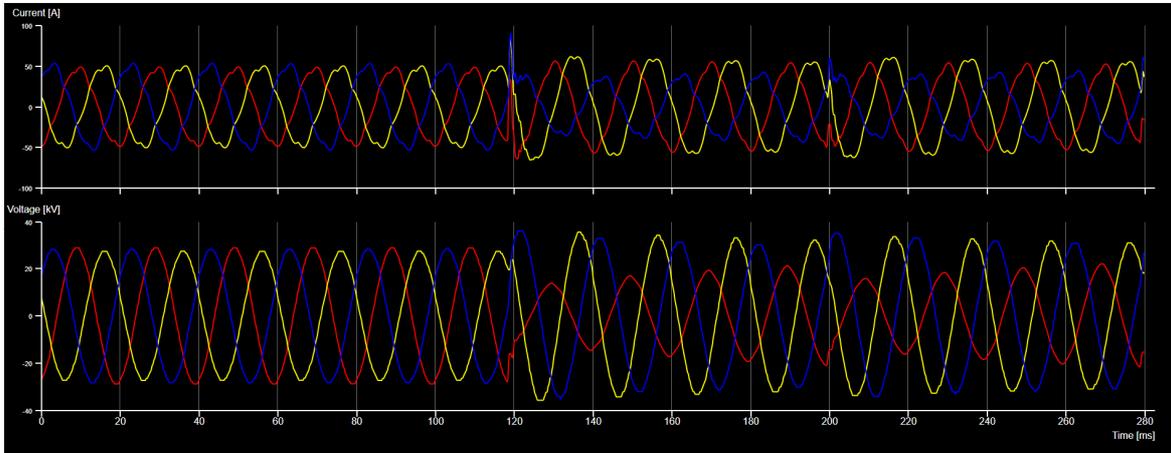
Figure 6- MetryView screenshot showing voltage and current waveforms from sensor set P5

The waveforms shown from the P5 sensor set in Figure 6 7 indicate a large fault on the Phase A (red trace). The arc is extinguished by the ASC and does not transition to a permanent fault. The zero-sequence waveforms are shown in Figure 6 8. These show that the initial transient current and voltage peaks are in the same direction, indicating that the fault current is in the backward direction relative to the sensor i.e., current flow is toward the St. Austell 33kV busbar. This was confirmed as the correct direction based on the cable fault location.

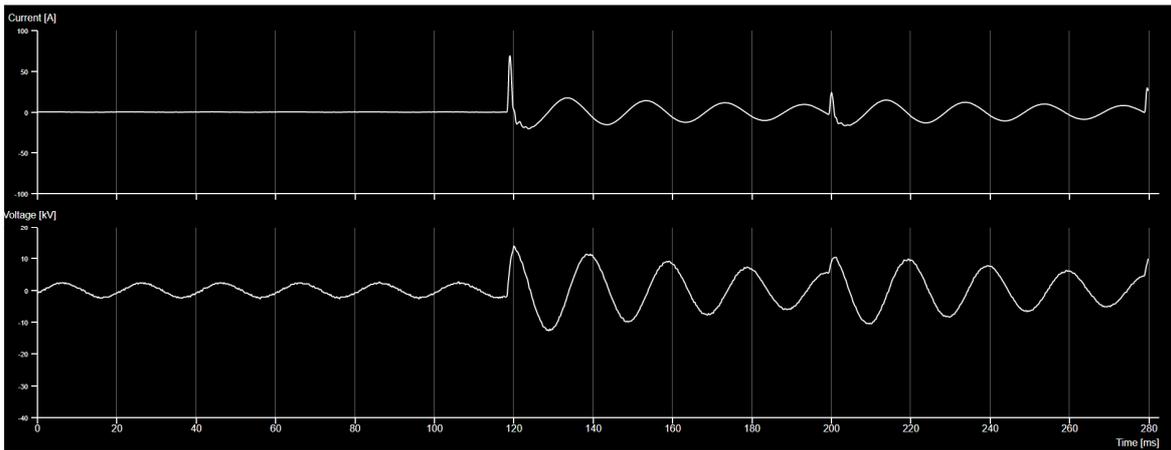
Figure 6- MetryView screenshot showing zero sequence voltage and current waveforms from sensor set P5

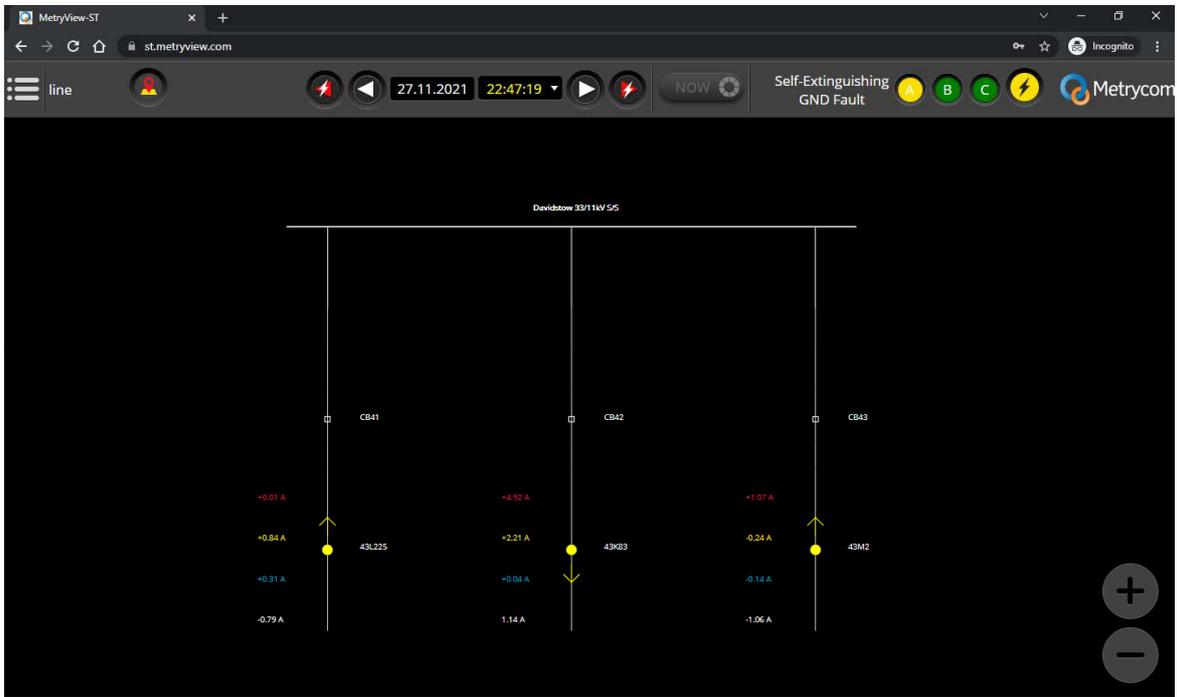
**Figure 6- MetryView screenshot showing transient fault directions for the fault downstream of CB42**

At 22:47 27 November 2021 sensor set 43K83 detected a persistent earth fault was on the Davidstow 11kV CB42. Metryview showed immediately that Phase A (red trace) had experienced a transient fault in the forward direction i.e. outwards from the 11kV busbar. Smaller reverse capacitive discharges were also shown on the sensors 43M2 and 43L225 confirming the direction of the fault. **Figure 6-** shows the transient fault directions recorded for all three sensor sets installed at Davidstow.

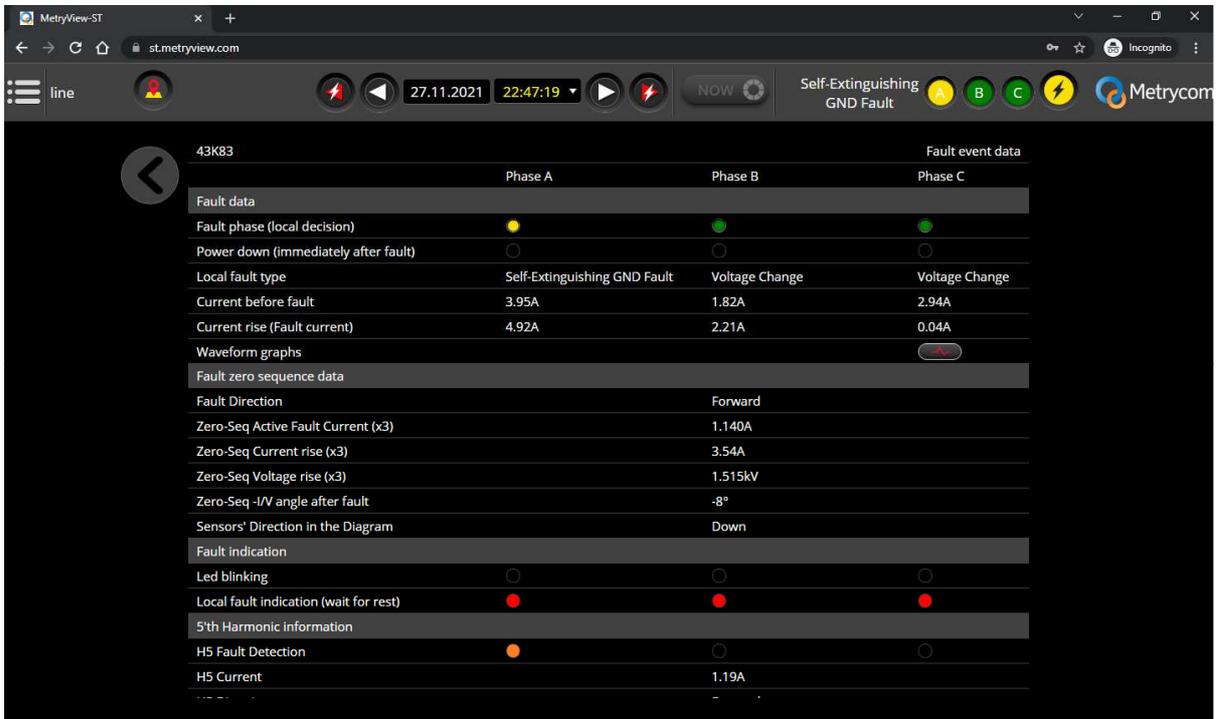
Figure 6- MetryView screenshot showing sensor set 43K83 fault data for the fault downstream of CB42

Interrogating the 43K83 sensor data in more detail showed that the active fault current was 1.14A. In addition, the fifth harmonic algorithm was also triggered. This is shown by the orange signal indication in **Error! Reference source not found..** The fault was not cleared by the ASC and therefore developed into a permanent or persistent earth fault. This is shown in **Figure 6-19.**

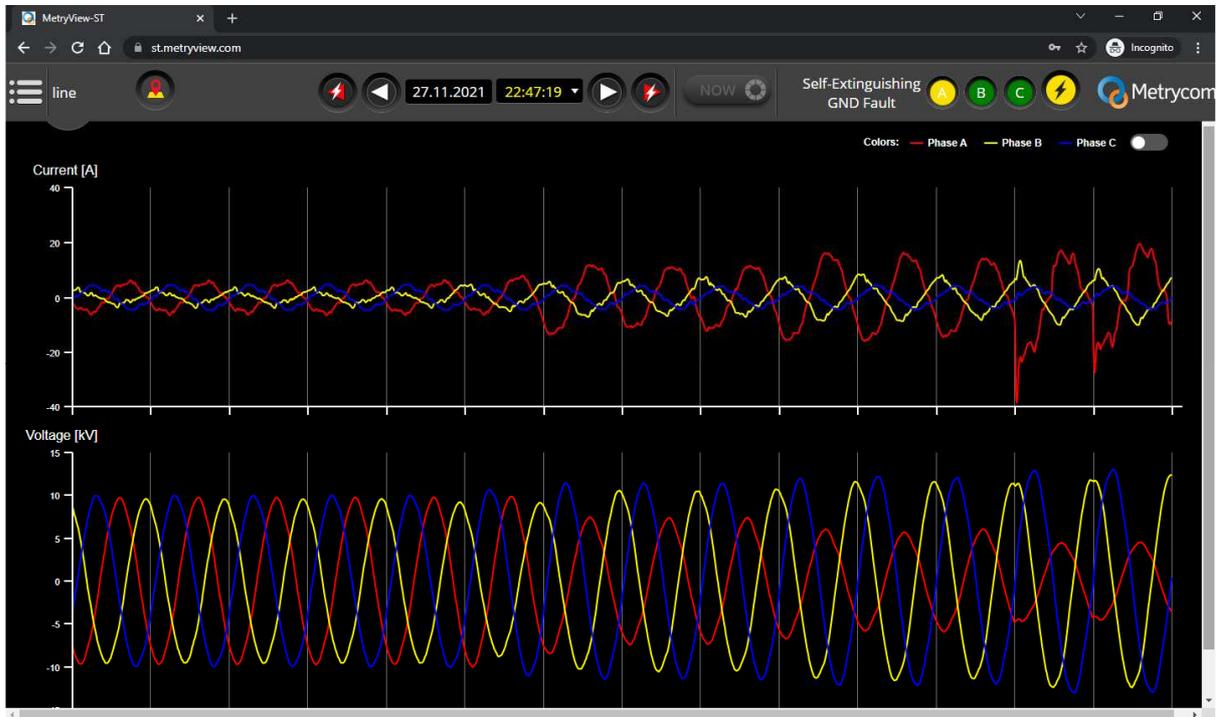
**Figure 6-18: MetryView screenshot showing persistent earth fault current and voltage waveforms for sensor set 43K83**

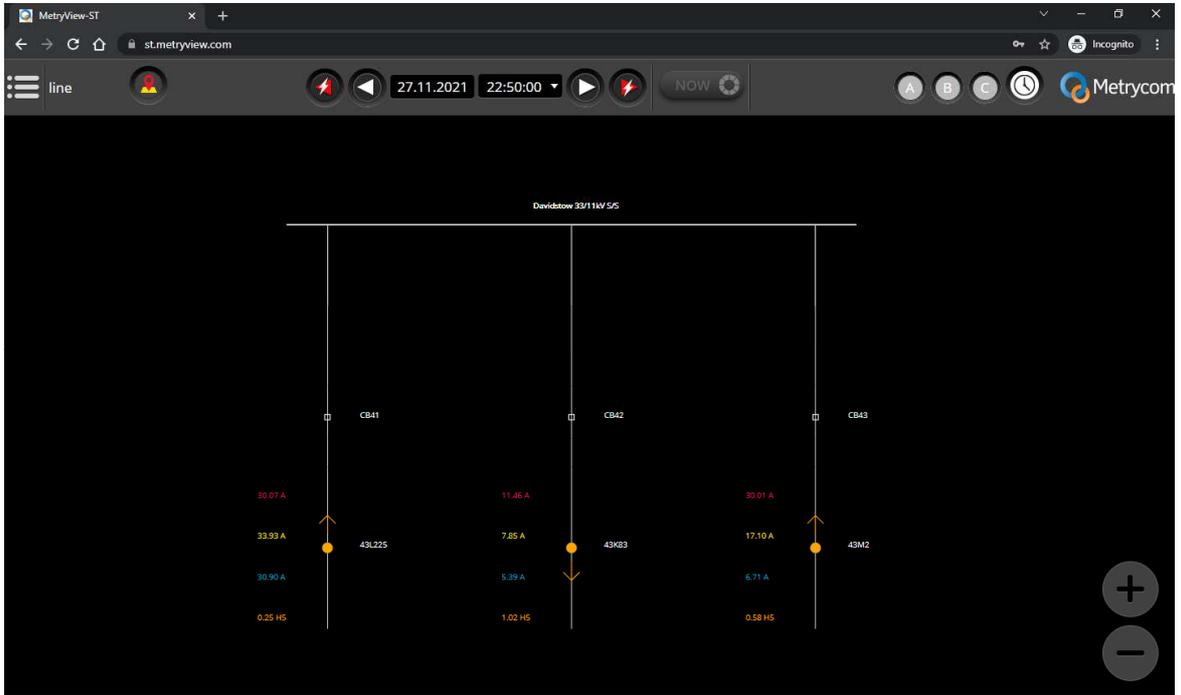
Figure 6- MetryView screenshot showing fifth harmonic earth fault direction for the fault downstream of CB42

The fault detected by 43K83 was critical to the validation of the fifth harmonic algorithm as there was no persistent earth faults during the trial on the 33kV network. The fifth harmonic algorithm triggered and correctly indicated the direction of the real-time earth fault current. This is shown diagrammatically in **Figure 6-** where the fifth harmonic current flow is shown by the orange arrows.
