ALARM - Automatic Location of Arc-faults through Remote Monitoring

Results and Learning from the Phase One Monitoring Period

September 2020

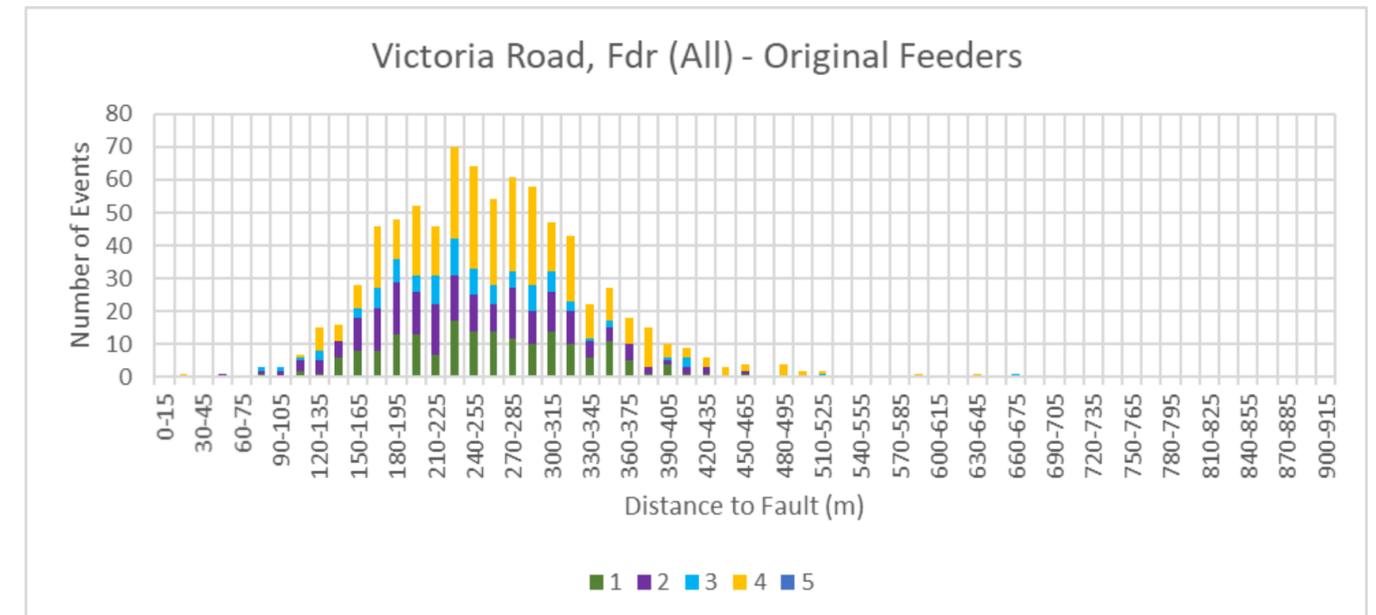
Pre-correction Data

- An issue has been identified where some captured events were given erroneous feeder allocation.
- The apparent coincidental initiation of pecking faults on all 4 feeders at Victoria Road (see chart) in from ~09/06/2020 prompted a review of input data and data processing. This demonstrated that a large proportion of (and probably virtually all) of the captured events were associated with only one feeder/defect.

- The cause of the issue has been identified, and a fix of applicable software processing has been put in place. A review of existing data has been undertaken to provide a corrected feeder identification where possible. It is concluded that despite this issue, underlying (corrected) indications are still credible and reliable.

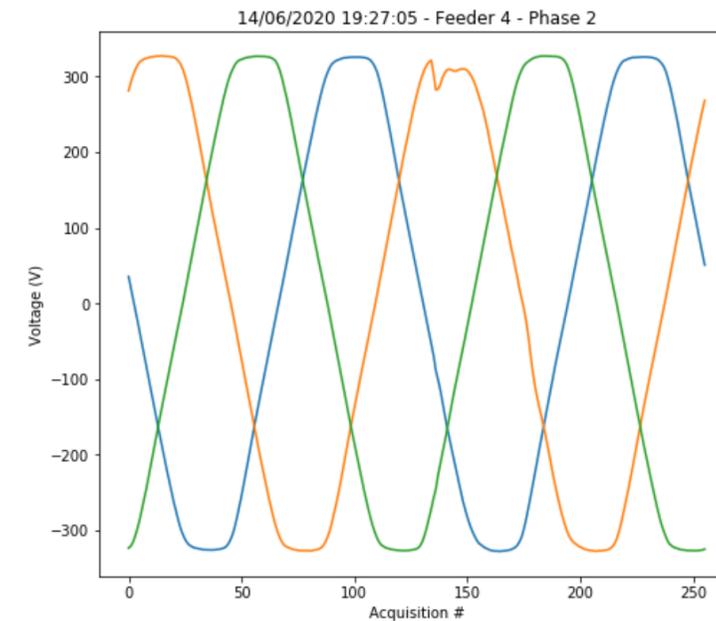
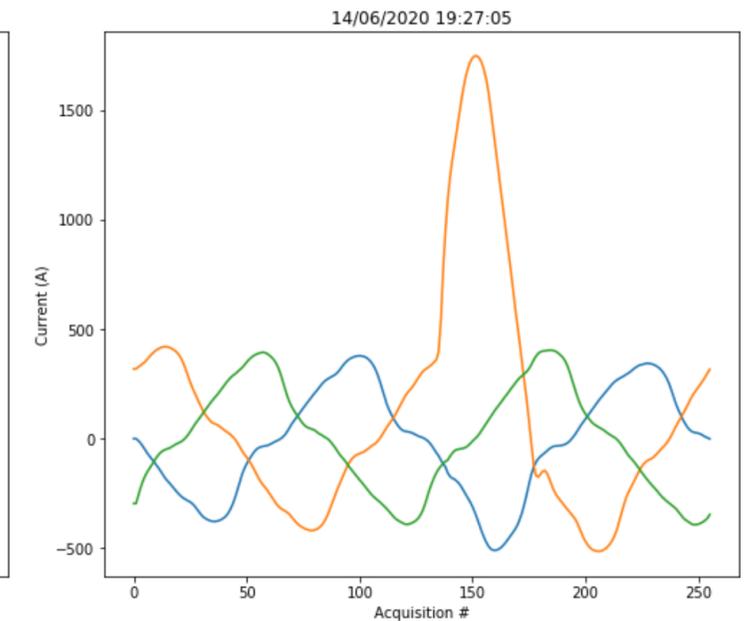
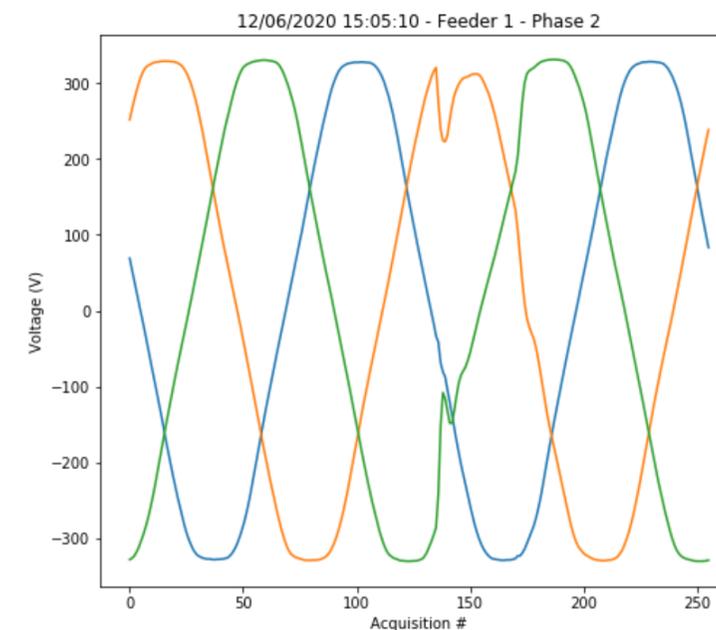
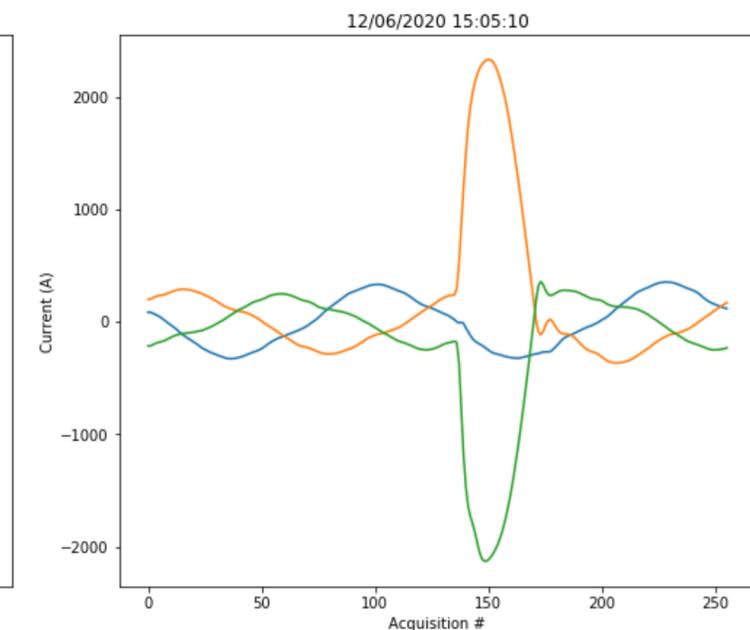
Typical Captured Waveforms

- Two types of event have been assessed.
- The upper chart shows a typical single phase conductor event (Fairefield Crescent - 4)
- The lower chart shows an event involving two phase conductors
- Both events see voltage disturbances corresponding to the triggering current events
- 98.3% of the events have involved a single phase conductor, and 1.7% have involved two phase conductors.

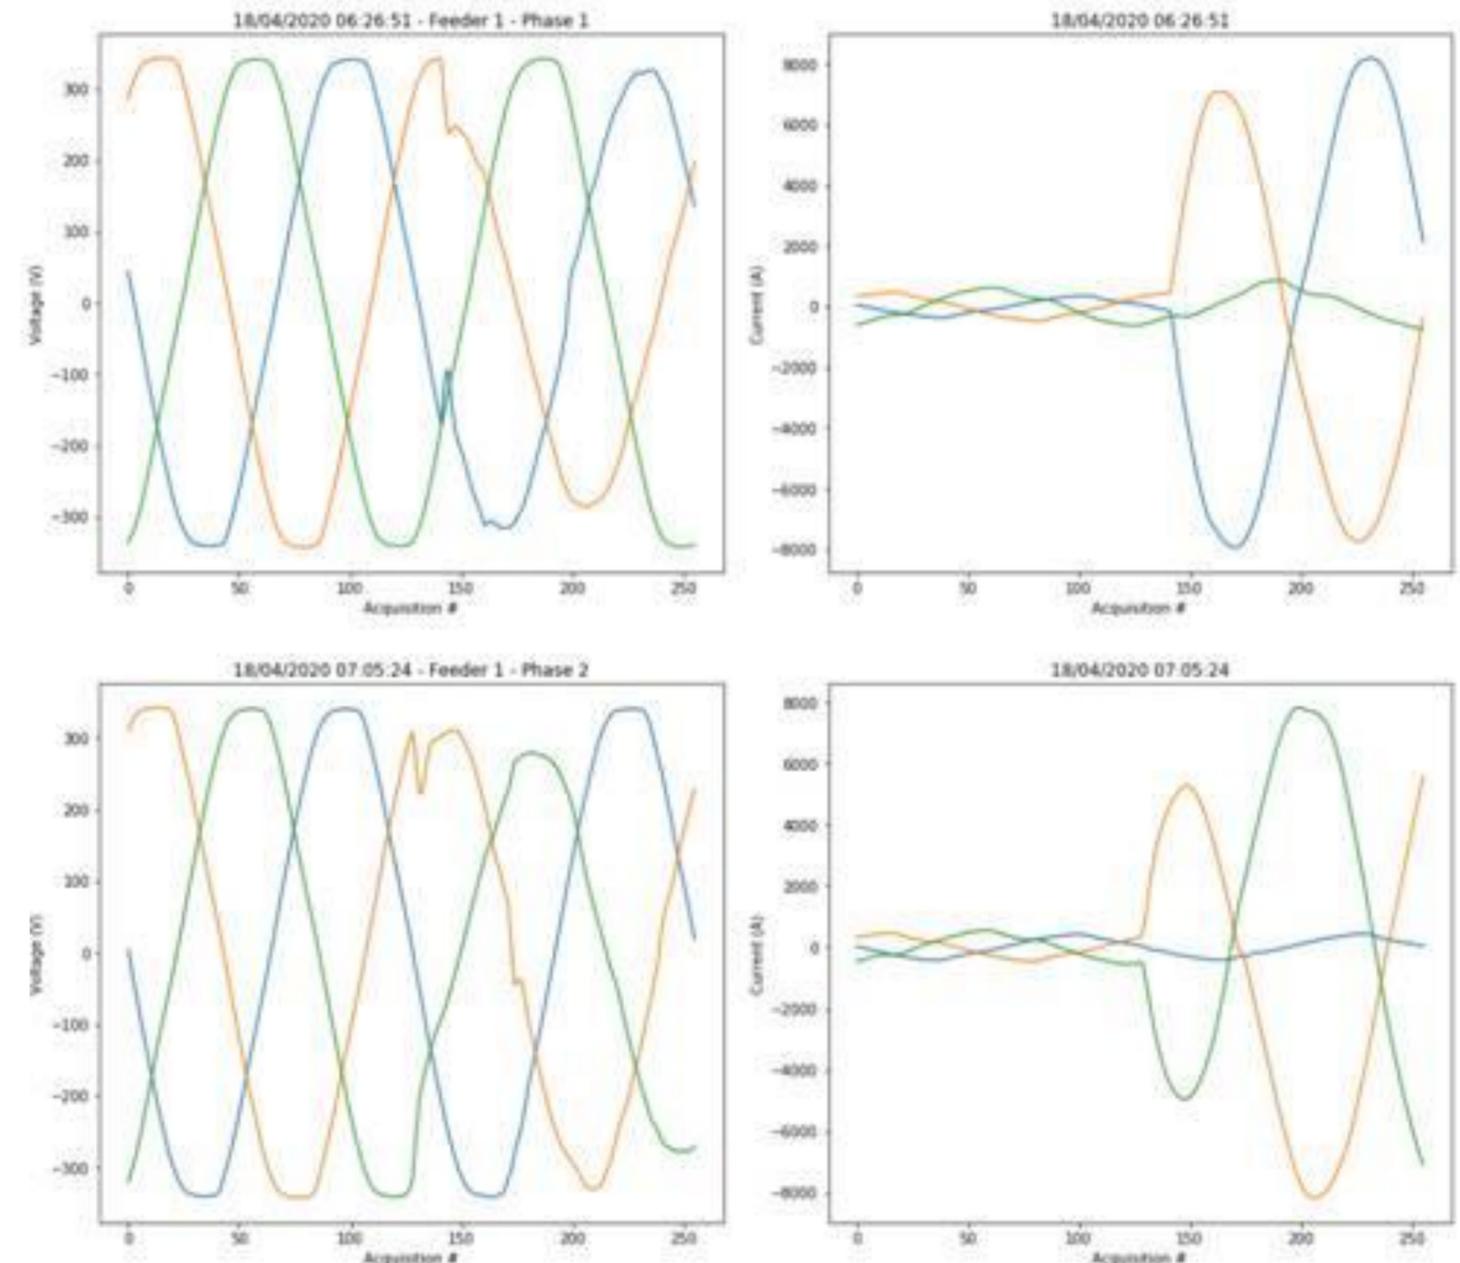
Fuse Operation Waveforms

- A small number of fuse operations have occurred on the monitored feeders, and some data from these has been captured.
- These fuse operating events display a continuing fault current, though with the Phase 1 hardware only one cycle is captured (Phase 2 hardware is expected to capture higher resolution data for longer periods).
- At present, distance to fault is not calculated for these events.

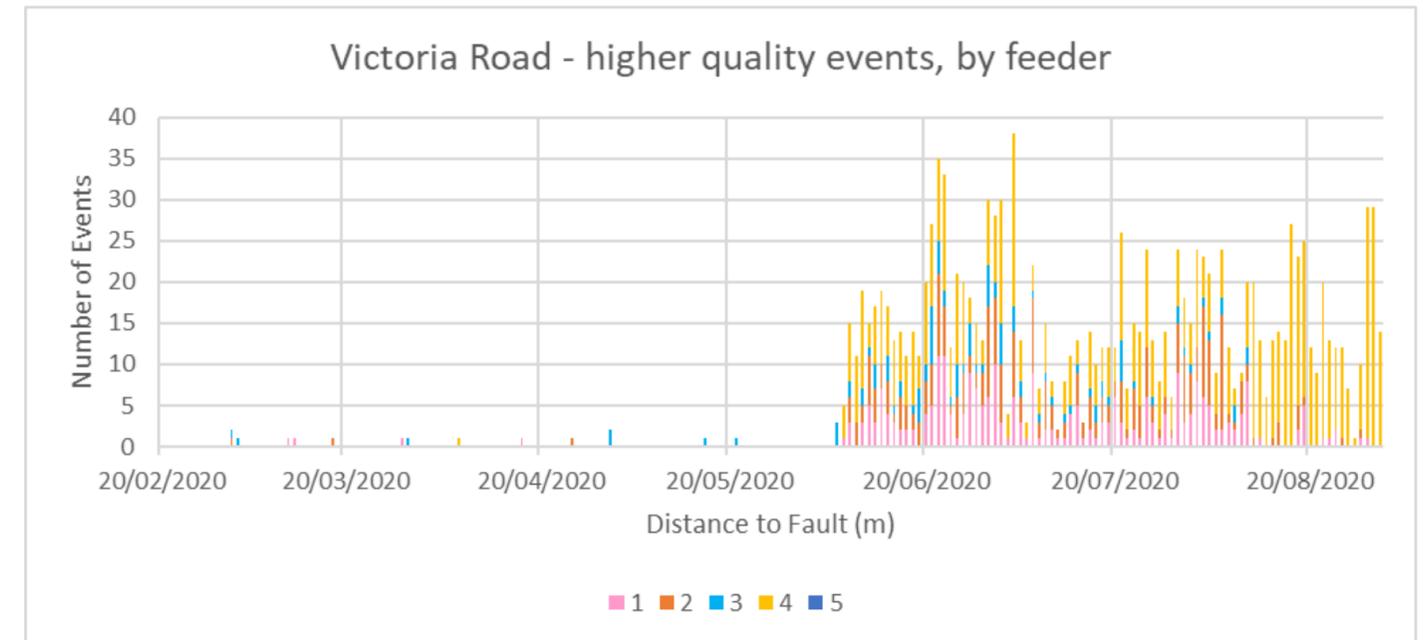
Pre-correction Data

- An example of pre- and post-correction event counts by feeder is shown here for Victoria Road. In this example a significant majority of events originally associated with Feeders 1-3 have been positively identified as actually being associated with Feeder 4, and the original identification has an additional corrected association applied.

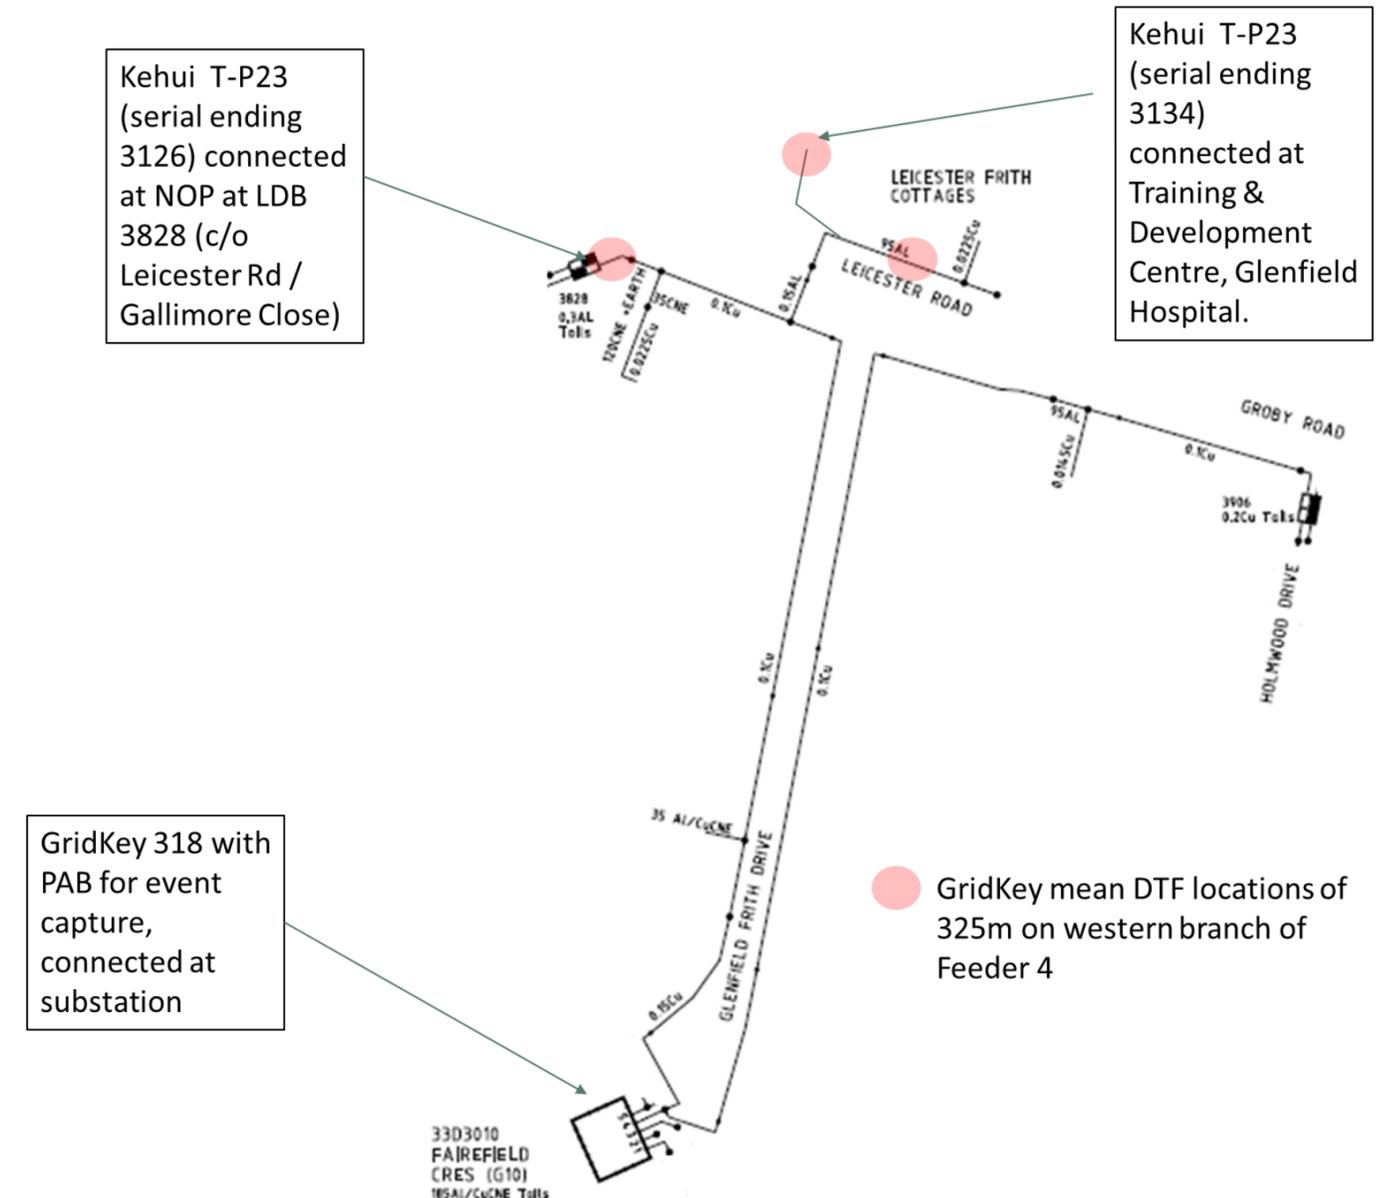
Location Results Validation

- Location validation work was originally intended to be undertaken during Phase 2 – Phase 1 results on a few site warrant bringing this work forward.
- Initial validation work has involved the use of an alternative fault location device(s), capable of detecting transient fault conditions, that does not use an impedance method. Time domain reflectometry-based (TDR) monitors are being used.
- It is hoped that later validation work will include the removal of an identified “faulty” component/section and demonstrate the future absence of “pecking” events.
- Early validation activities at a Milton Keynes site proved inconclusive due to TDR monitor placement challenges on the network – this site will be re-visited.
- Validation work at a Leicester site is now underway, with initial results corroborating GridKey indications along the western branch. This work continues.

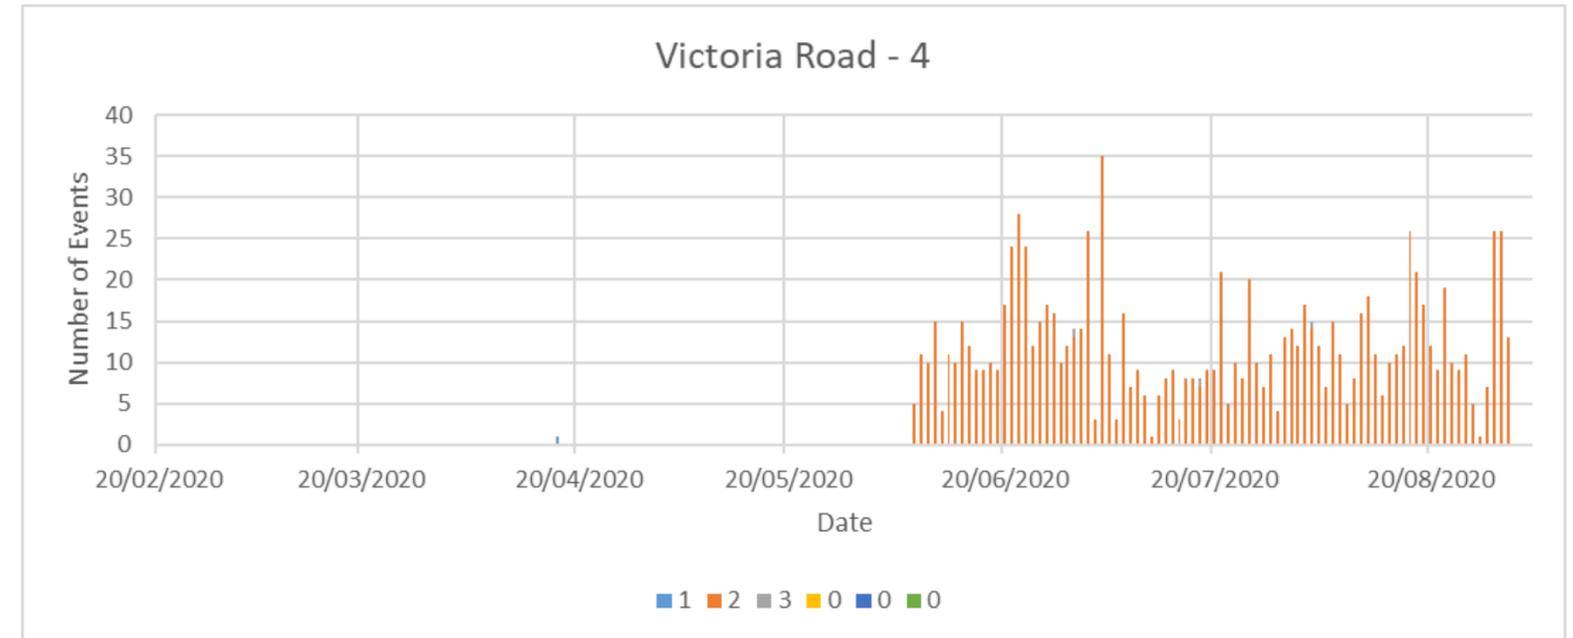
Captured Events (as at 31/08/2020)

Victoria Road feeder data prior to 11/08/2020 has been reviewed and corrected as far as possible, following the feeder identification issue described above. Event data collected after 10/08/2020 uses revised feeder identification software and is reported as collected.

Victoria Road WPD Feeder 4 has shown high activity from June to date, with only one feeder 4 attributed event before this.

The project is not aware of any fuse operations.

Overwhelmingly events have involved only phase 2.

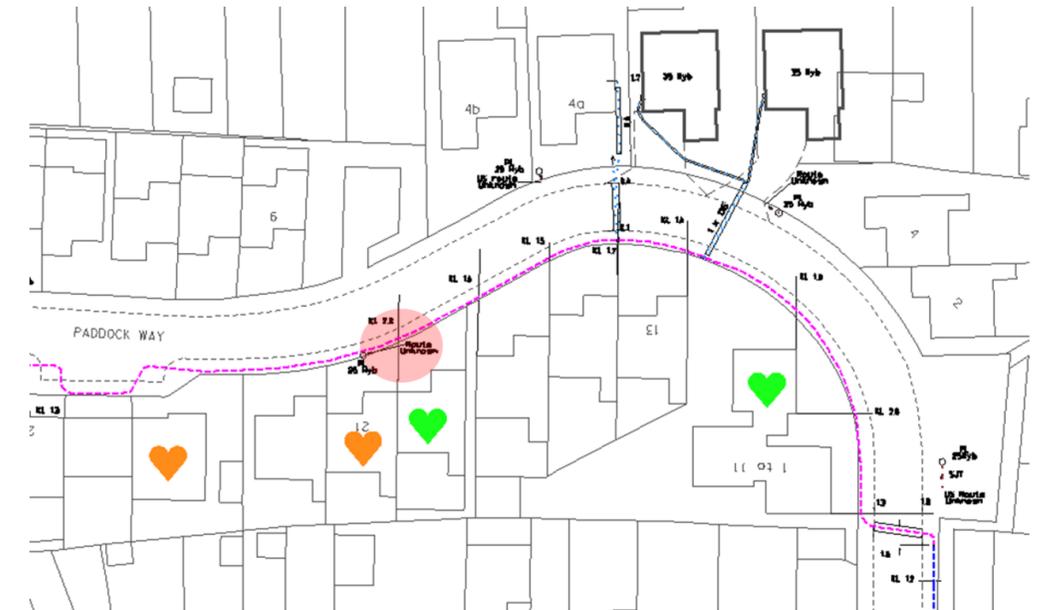
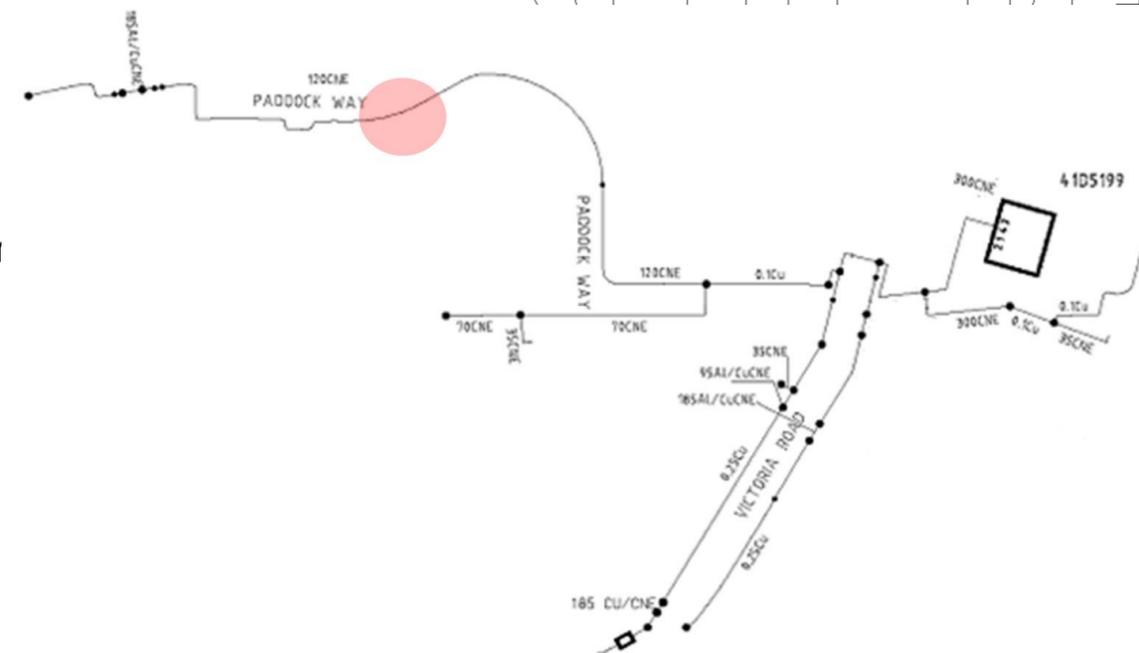
Indicated Location

Most frequent DTF (96 events) = 225-240m; Mean DTF (1040 events) = 266m
SD = 80m

Overwhelmingly the events involve L2.

Only one branch is longer than ~210m (branch serving Paddock Way).

These results are currently interpreted as a defect located at ~266m, adjacent to 19-21 Paddock Way.

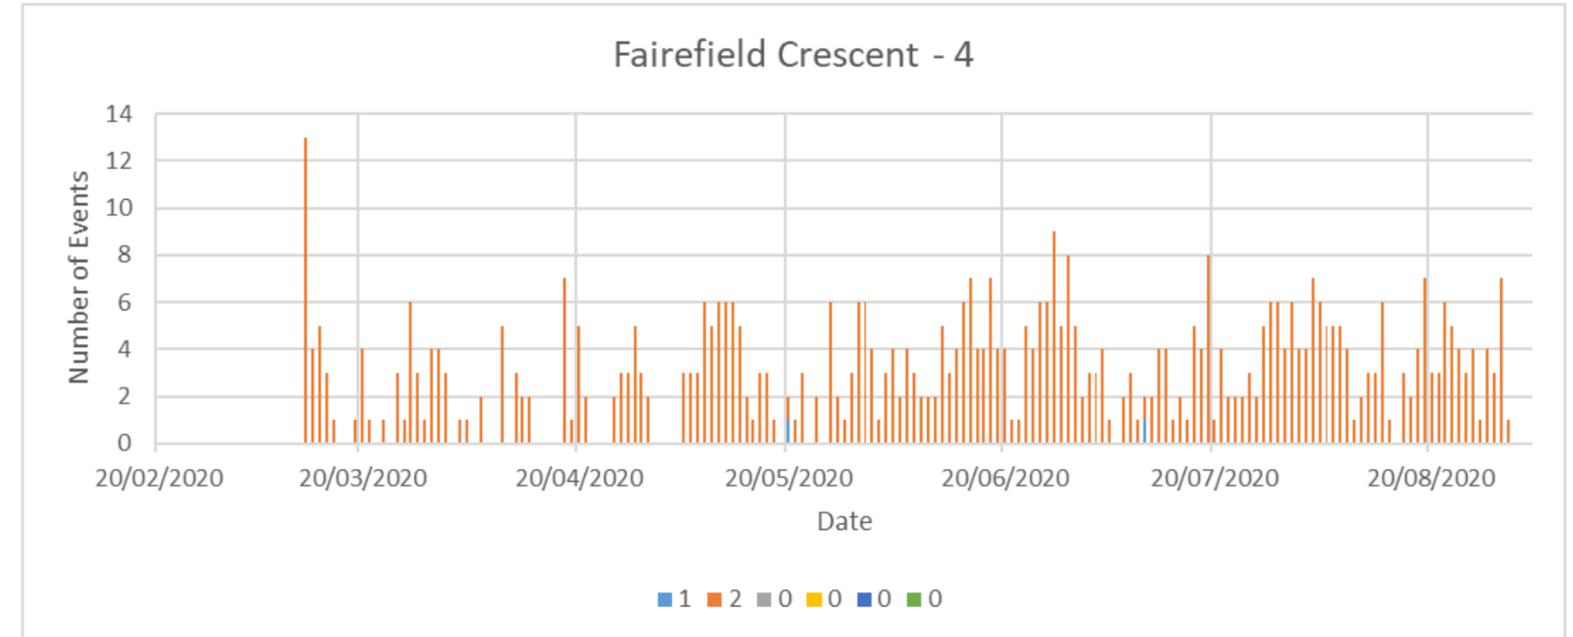
Captured Events (as at 31/08/2020)

Fairefield Crescent feeder data has been reviewed and corrected as far as possible following the feeder identification issue described above.

Fairefield Crescent Feeder 4 has been consistently active over the monitoring period.

The project is not aware of any fuse operations.

Overwhelmingly events have involved only phase 2.

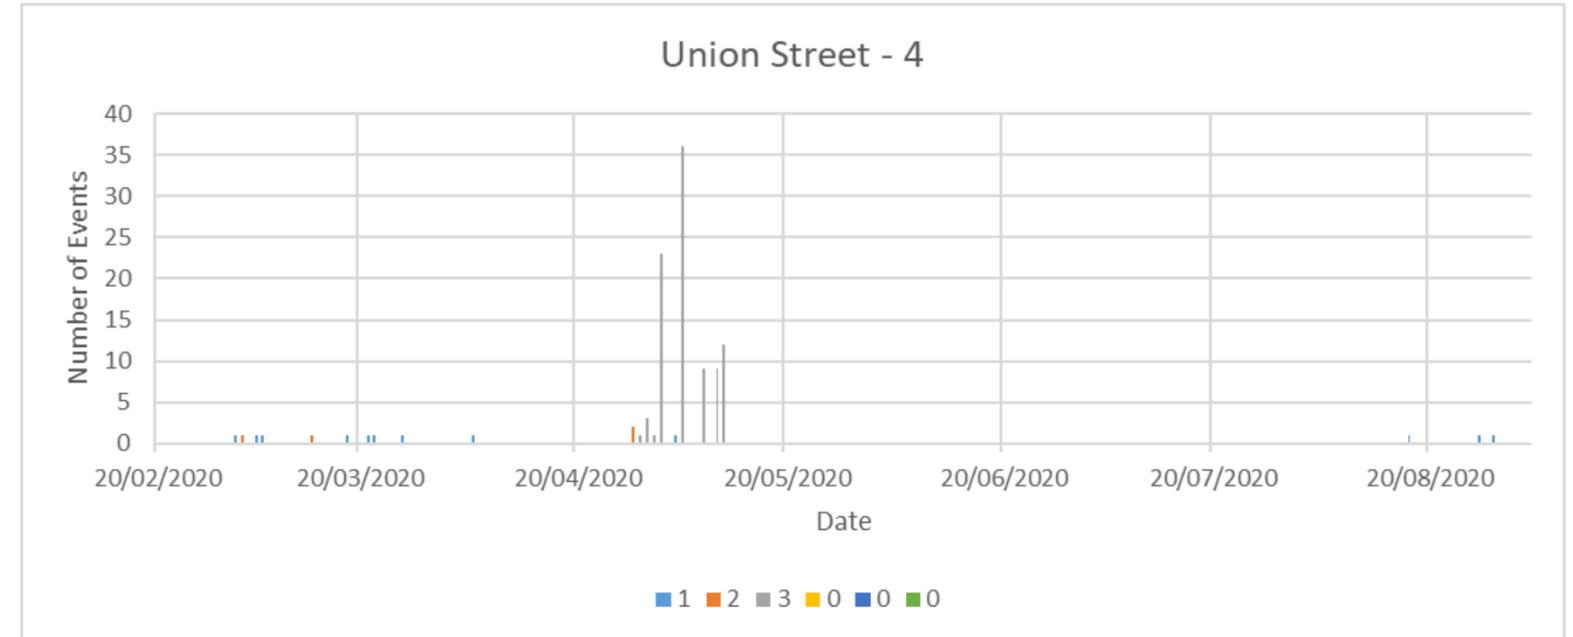
Captured Events (as at 31/08/2020)

Union Street feeder has been reviewed and corrected as far as possible following the feeder identification issue described above, with a relatively small number of changes being made.

Union Street WPD Feeder 4 was active during the first half of May, and relatively quiet since.

The project is not aware of any fuse operations.

Events have mostly involved only Phase 3.

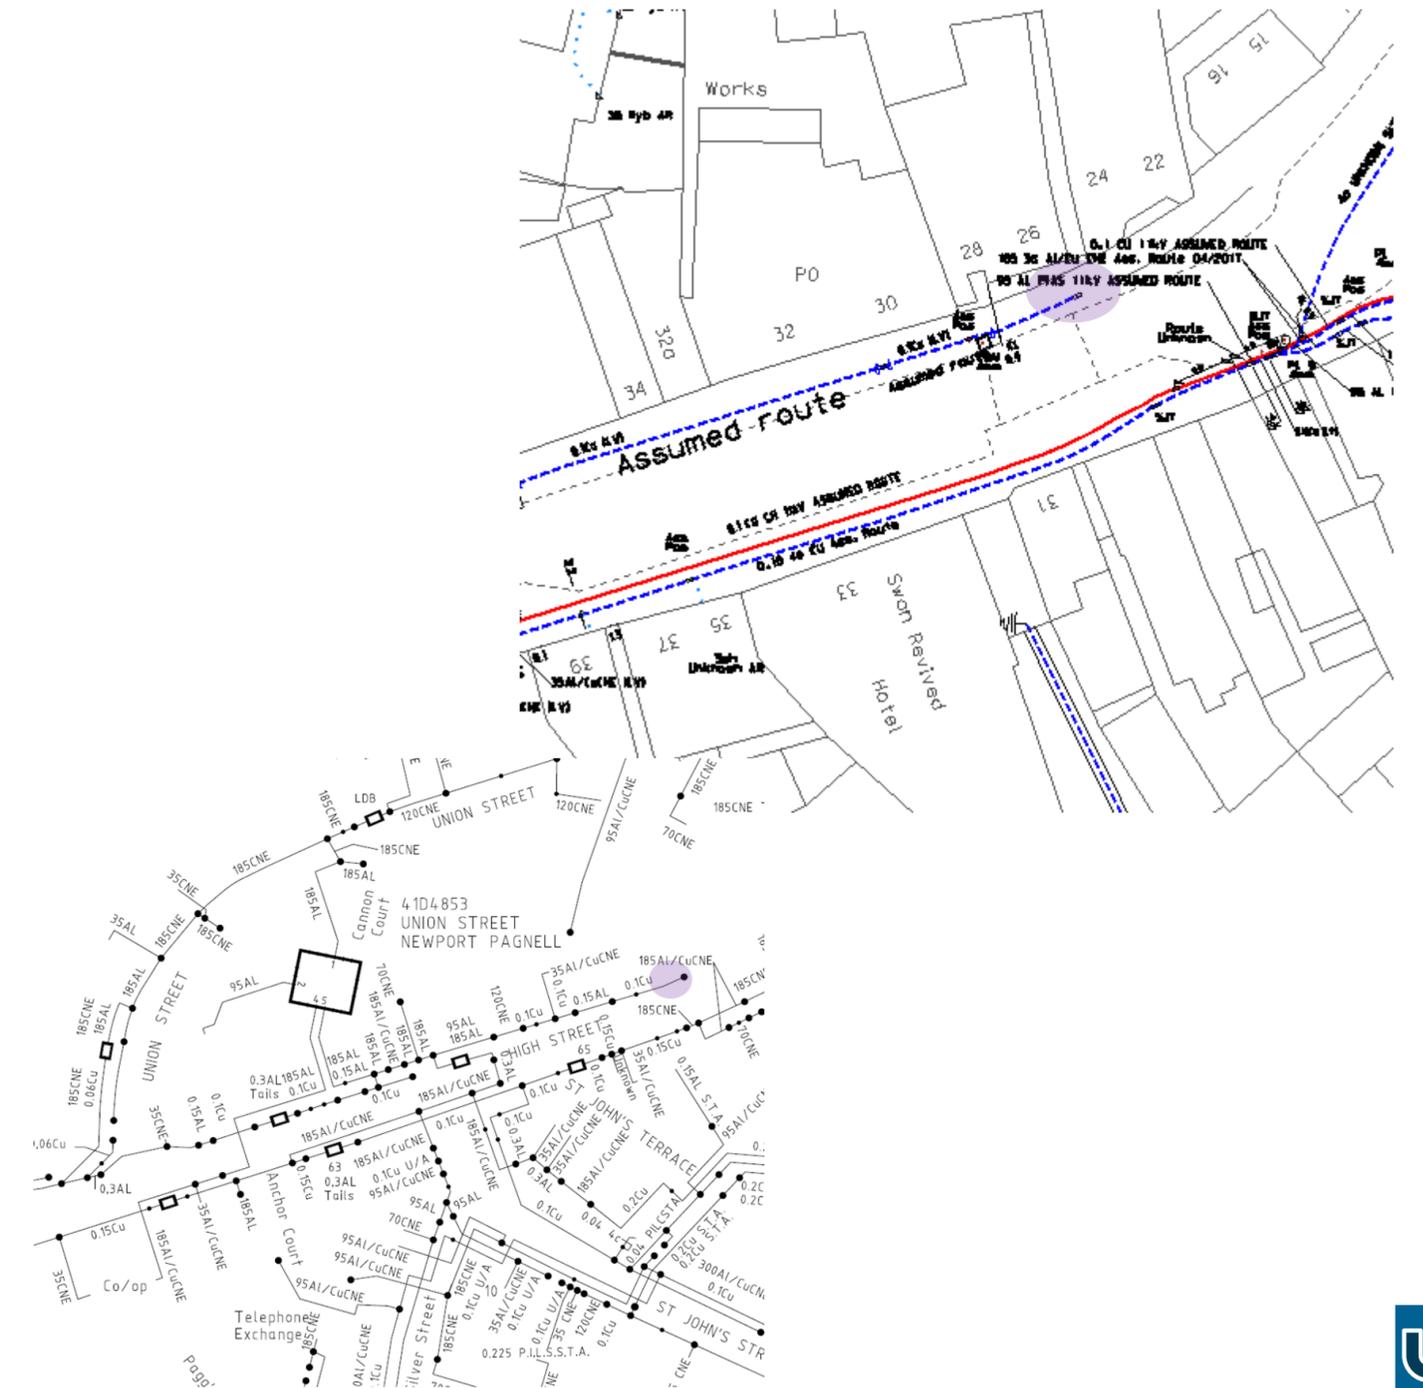
Indicated Location

Most frequent DTF (15) = 120-135m; Mean DTF (130 events) = 150m; SD = 45m

Most events involve L3 alone.

These results are currently interpreted as a defect located at ~153m
~160m is indicated on the network maps (shaded area).

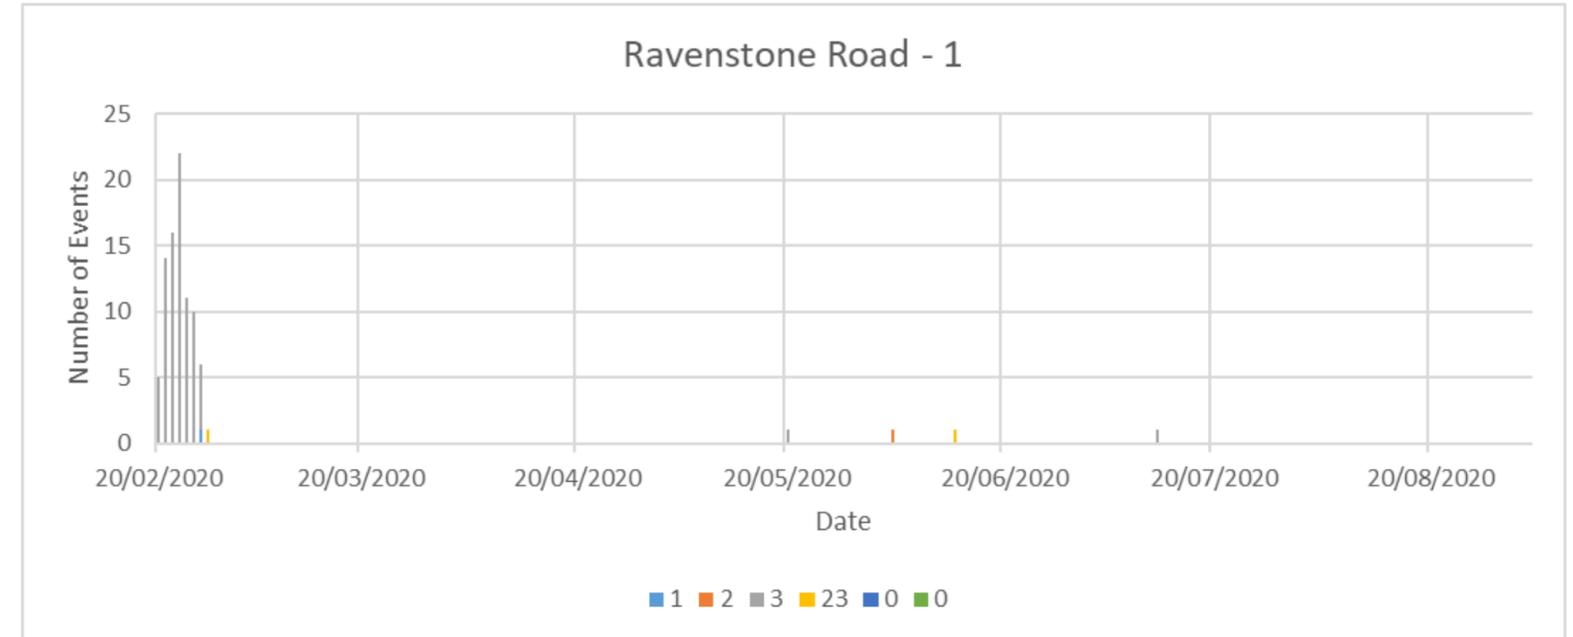
Captured Events (as at 31/08/2020)

Ravenstone Road feeder data has been reviewed following the feeder identification issue described above, with events from June onwards largely being re-attributed to Feeder 2.

Ravenstone Road Feeder 1 was highly active during the second half of February, and has been quiet since then.

The project is not aware of any fuse operations.

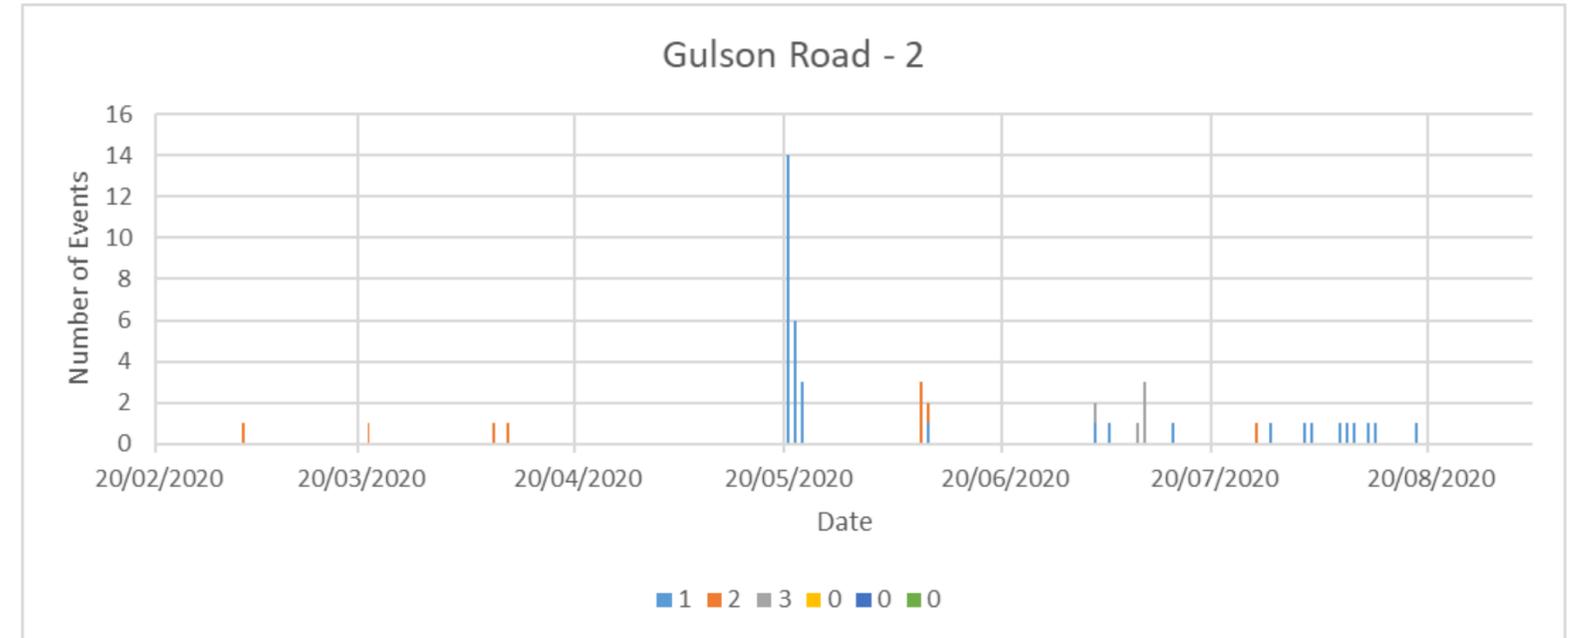
Captured Events (as at 31/08/2020)

Gulson Road feeder data has been reviewed following the feeder identification issue described above, with some correction of events to Feeder 1.

Gulson Road WPD Feeder 3 has shown sporadic activity over Phase One to date, with most events occurring 20-22 May. Events have mostly involved L1 only.

The project is not aware of any fuse operations on this feeder, though a potential location indication was proactively offered to the local team following activity 20-22 May.

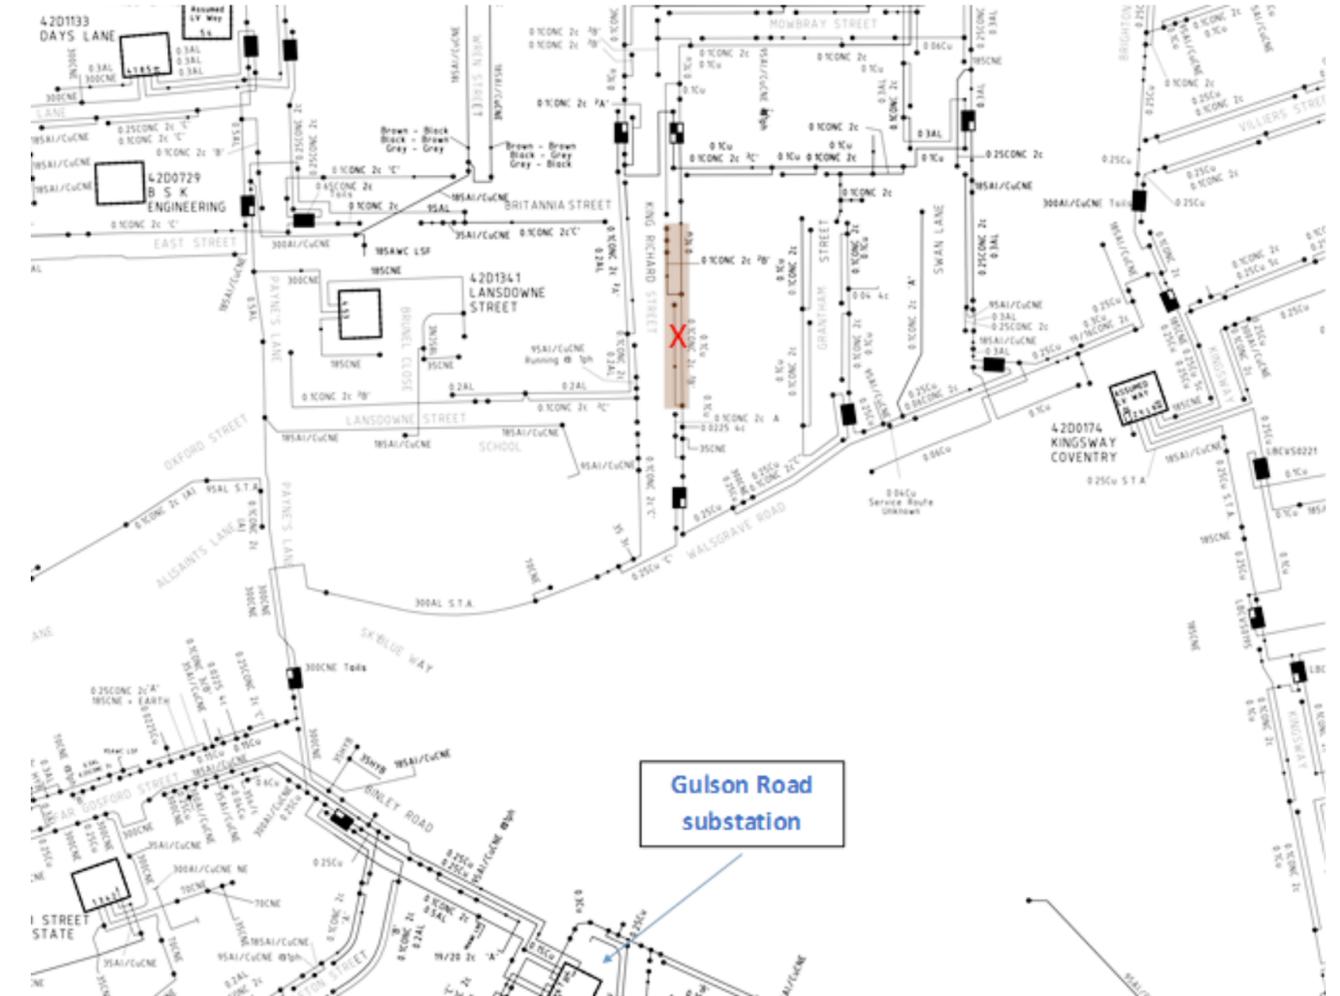
Indicated Location

Most frequent DTF (6 events) = 525-540m; Mean DTF (50 events) = 473m; SD = 124m

Most events (31) involve L1 alone.

If DTF assessment is limited to events 20-22 May, then Most Frequent DTF (5 events) = 510-540m; Mean DTF (23 events) = 503m; SD = 65m.

A location at around 510m was offered to the local team after 20-22 May events, and this remains a reasonable view. 510m is located adjacent to 28 King Richard Street (red cross). The wider potential location is shown in orange shading, from the branch adjacent to 22 King Richard Street, along to 36 King Richard Street.

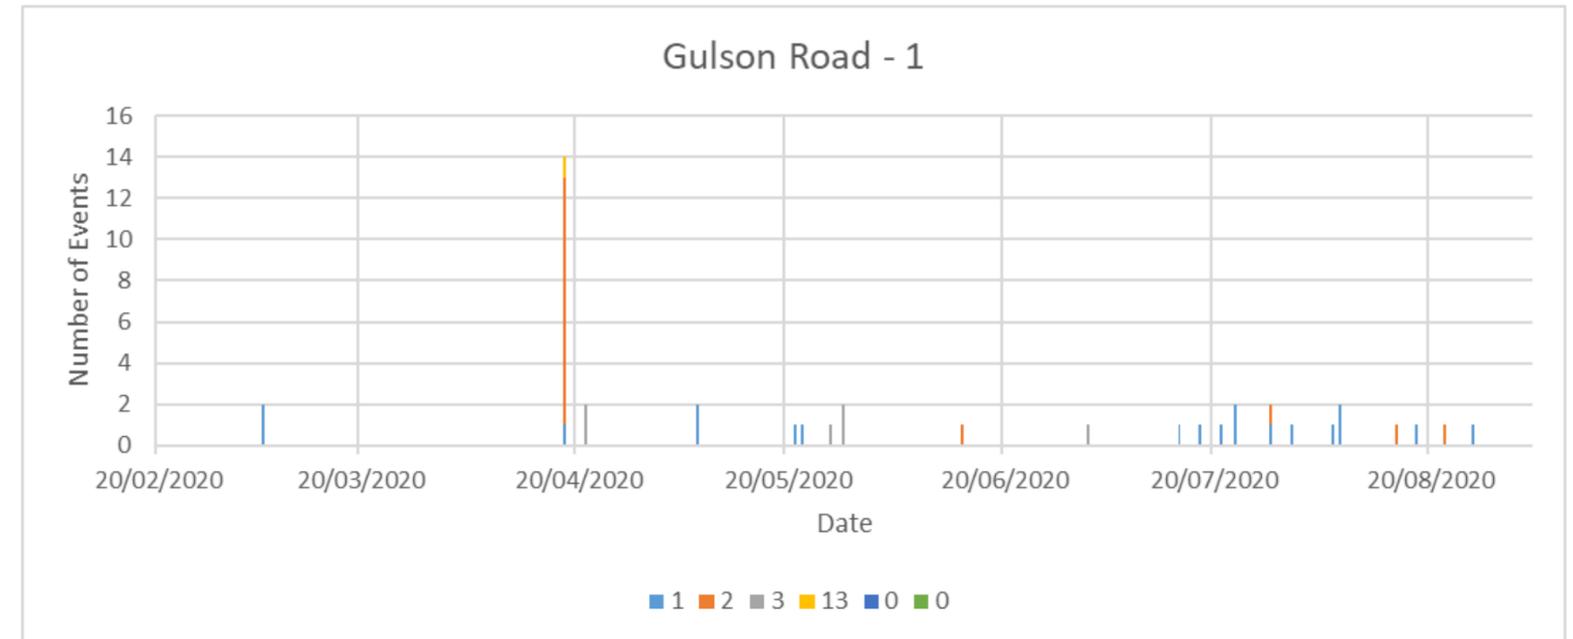
Gulson Road WPD Feeder 1 has shown limited activity other than 18th April, when a fuse operation occurred (07:27). Prior to the fuse operation there had been only three captured and analysed events.

Since 18th April, there have been 26 events, mostly L1 only (16), with L2 only (4) and L3 only (6).

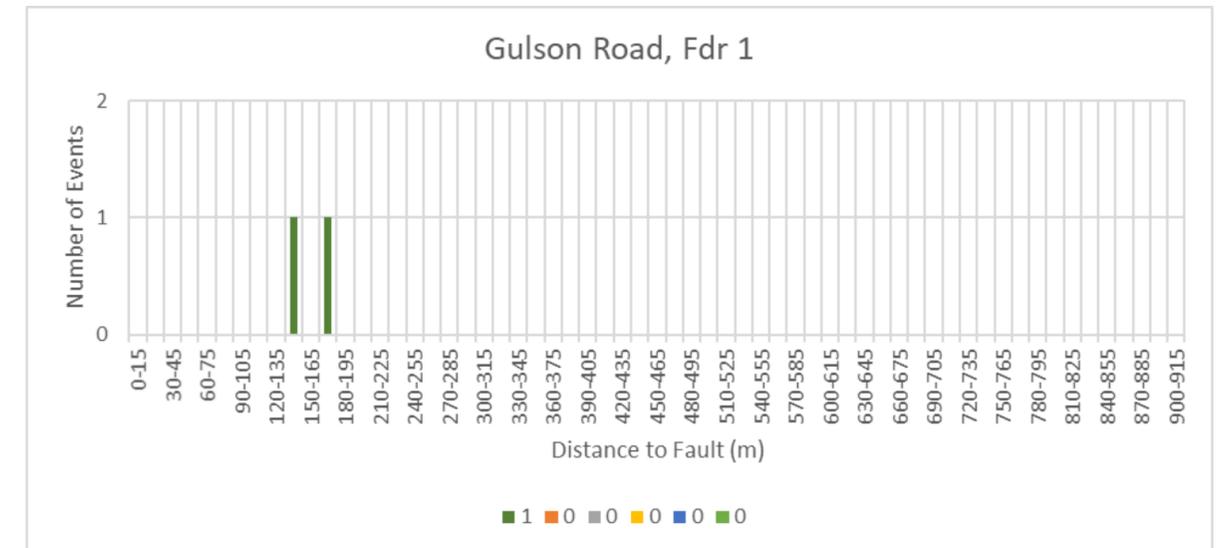
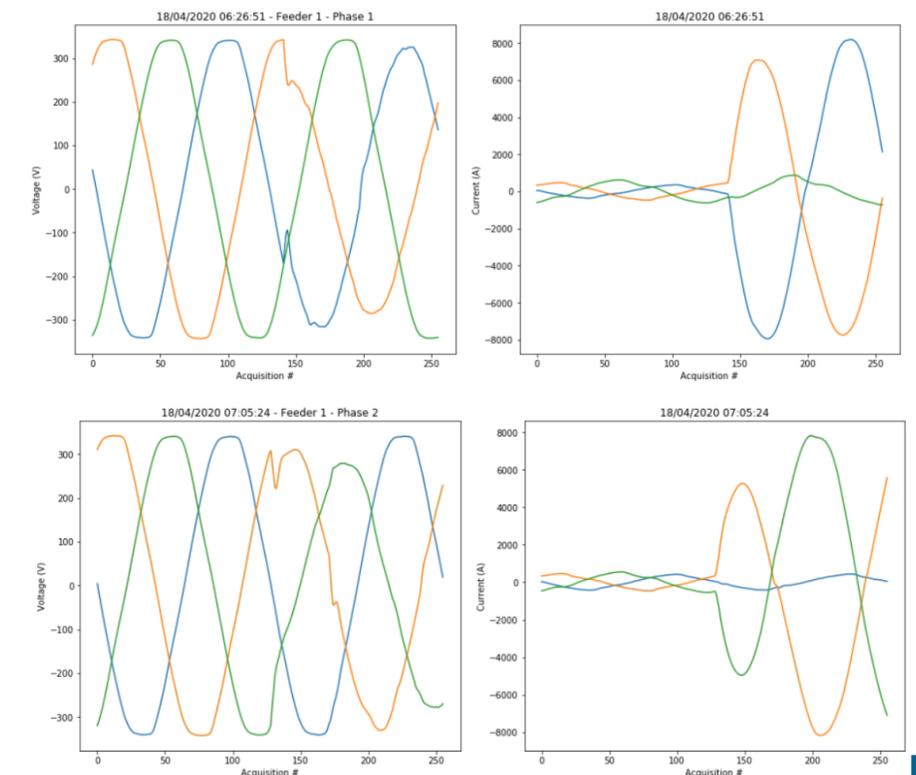
Fuse Op events 18/04/2020 - 2

Field fault location and repair took place on Sat 18th April, before any ALARM location data was analysed.

Retrospectively, distance assessment was undertaken using available data from before the 18/04, and for 18/04. This included a best-effort analysis of the fuse operation events.

- a most frequent pecking fault analysis distance of 180-210m, with significant noise/variation (see upper chart), however different phase conductor involvement clouds interpretation; and
- ~ 120m based on assessment of the fuse operation events (with limited cycles/data).

Given limited indication from the pecking fault analysis the fuse-op assessment ~120m was offered.

The actual repair location was ~200m (average of all pecking events up to and including 18/04 was 183m)

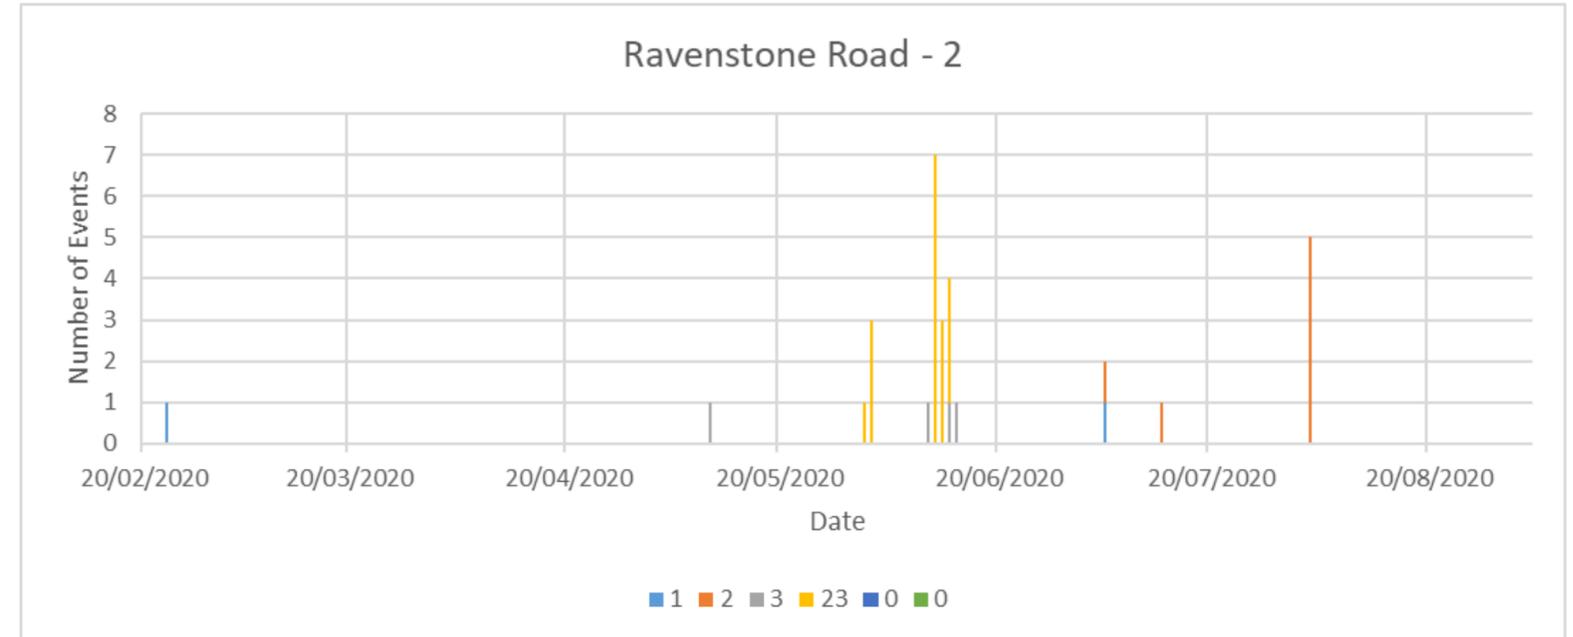
Ravenstone Road feeder data has been reviewed following the feeder identification issue described above, with events from June onwards largely being re-attributed to Feeder 2.

Ravenstone Road WPD Feeder 2 activity has been quite sporadic.

There has been one known transient fuse operation on 13/07/2020.

Most events have involved only phases 2-3.
