ALARM - Automatic Location of Arc-faults through Remote Monitoring

Results and Learning from the Phase One Monitoring Period

September 2020

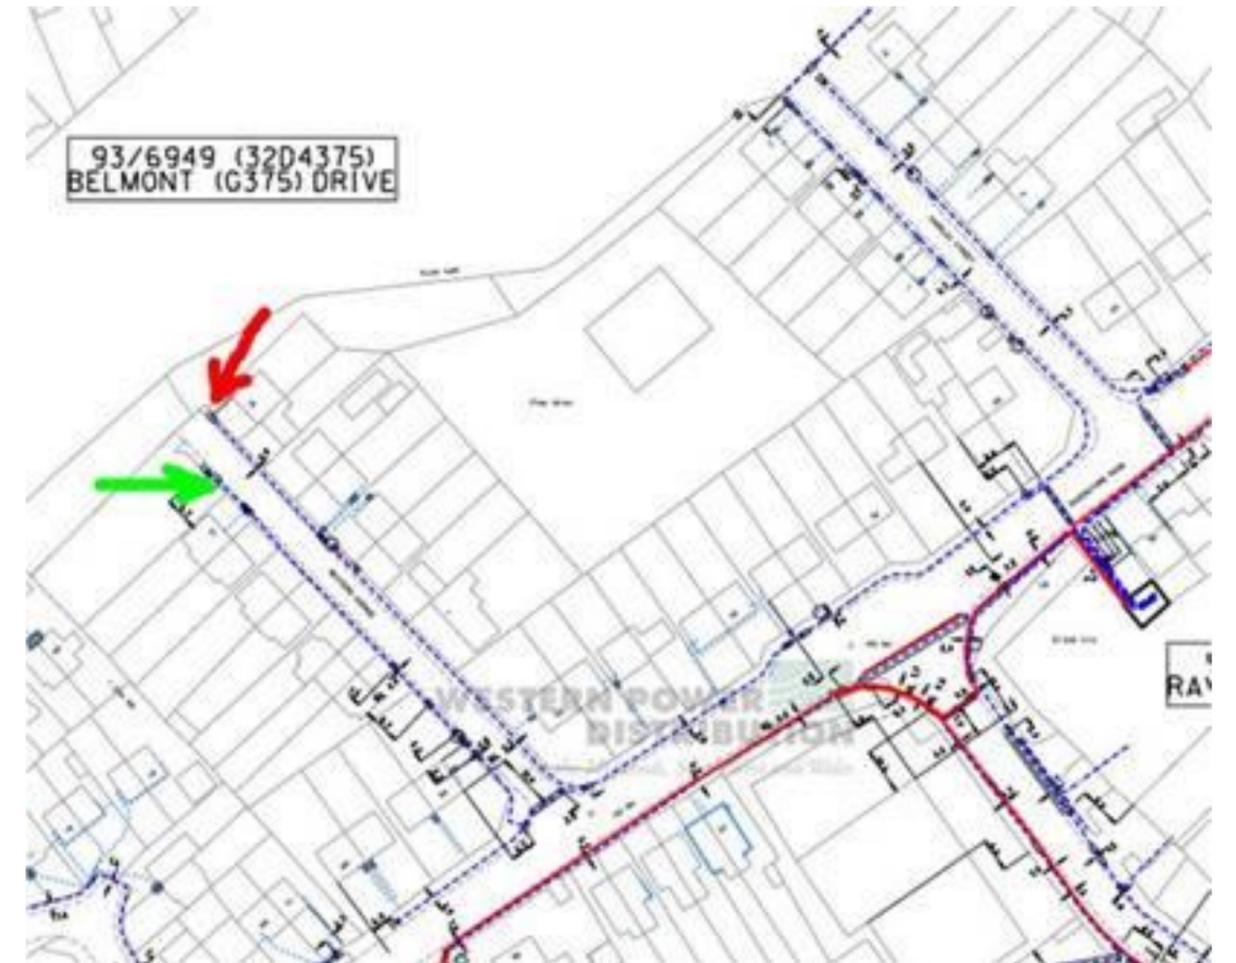
Applying this DTF indication to the branched structure of Ravenstone Road Fdr 2 (Western Ave.), 292m suggests that the fault is at the end of one of the branches running down Western Avenue (red and green arrows in the drawing below, red arrow=264m, green arrow=271m).

These potential locations have been shared with the local team, following the fuse operation on 13/07/2020.

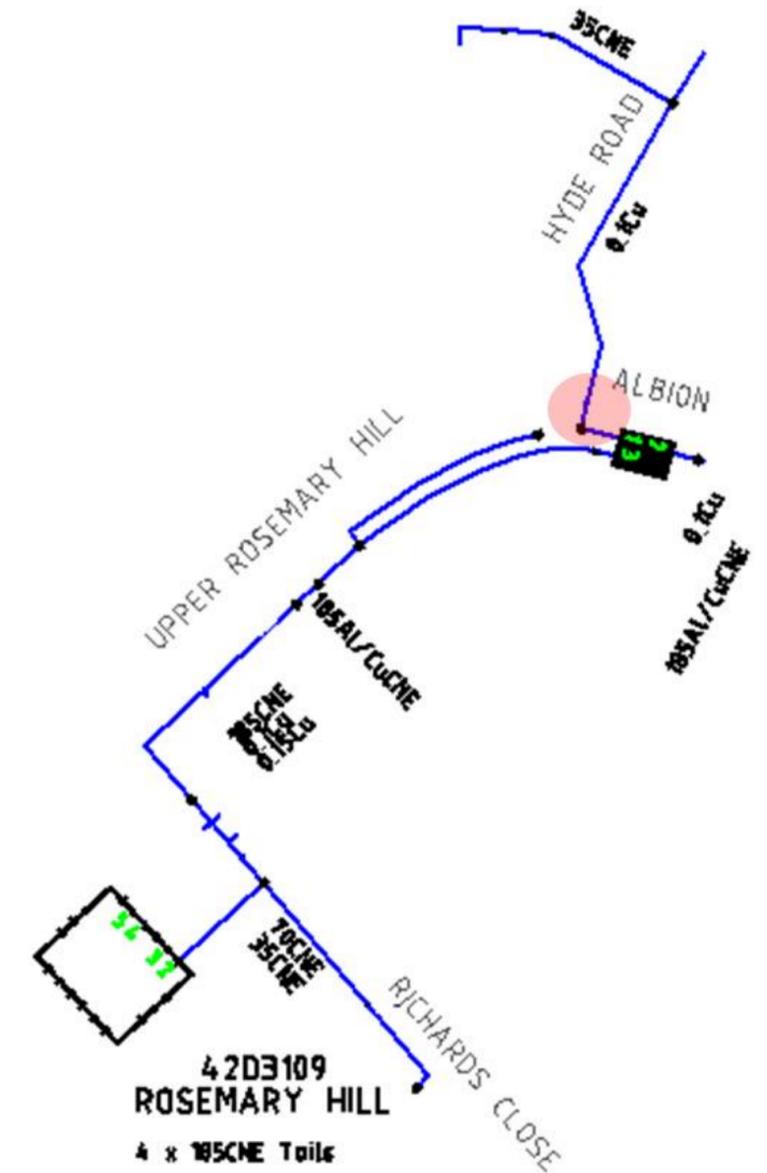
Most frequent DTF (5 events) = 150-165m; Mean DTF (27 events) = 168m; SD = 39m

These results are currently interpreted as a possible defect located at ~168m. The joint at ~161m is shown on the network schematic.

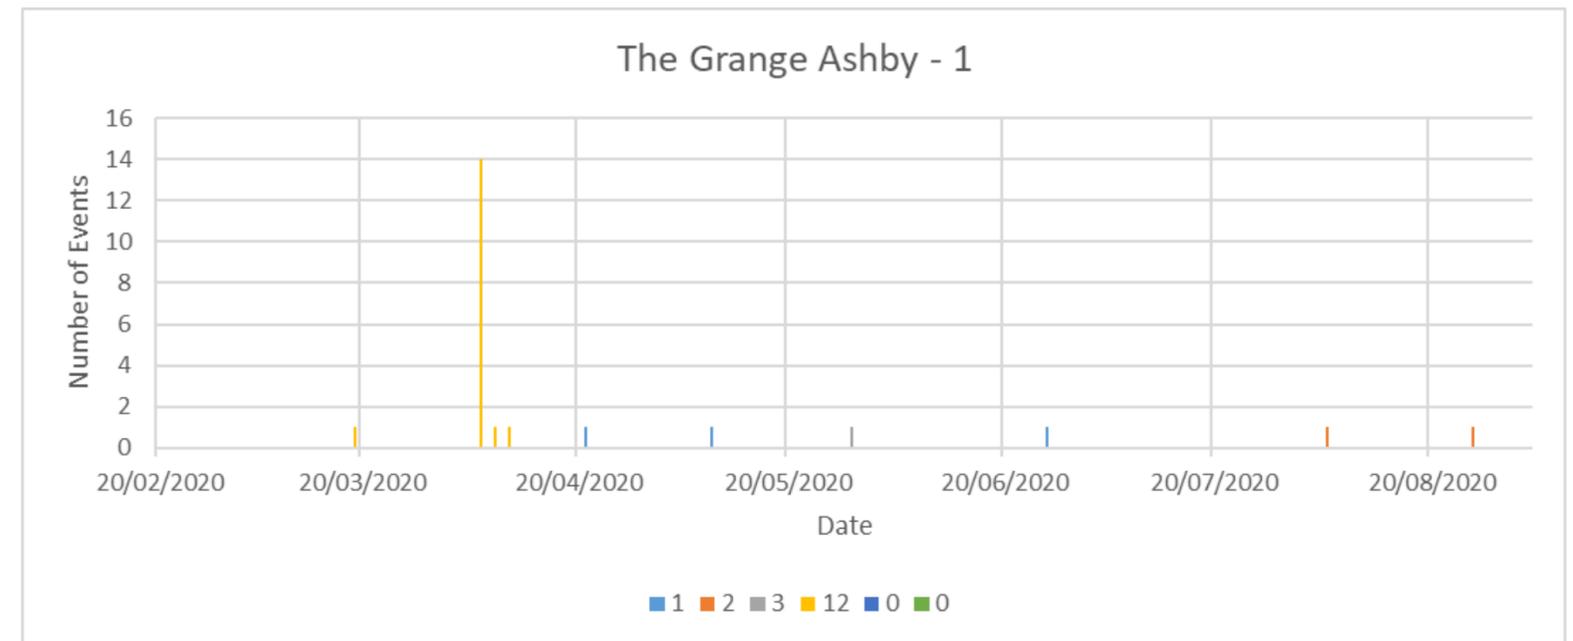
The Grange feeder data has been reviewed following the feeder identification issue described above. One change of feeder association has been made.

The Grange WPD Feeder 1 showed high activity on 06/04/2020, with limited numbers of events before and after this.

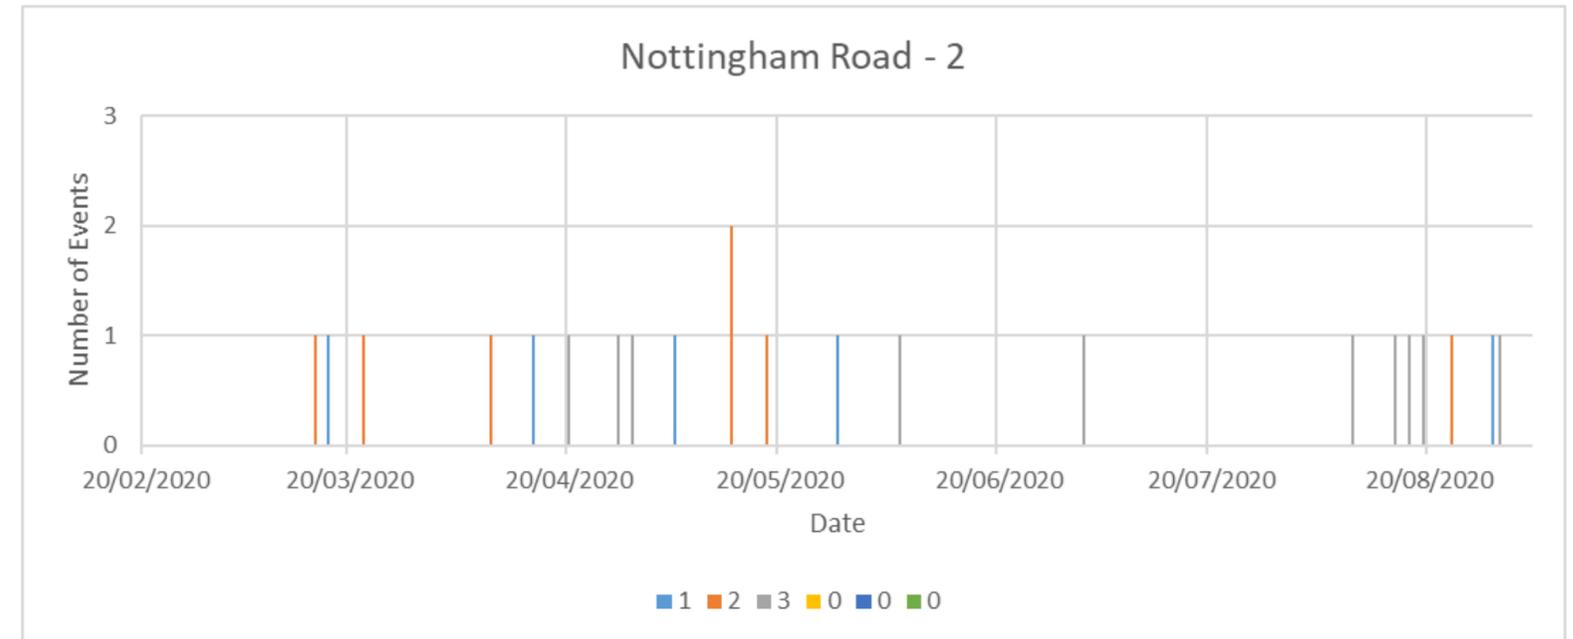
Nottingham Road feeder data has been reviewed following the feeder identification issue described above. Some events have been corrected to Feeder 3.

Nottingham Road Feeder 2 showed shown low levels of activity broadly through the monitoring period. Indications are that these events have occurred across all three phases.

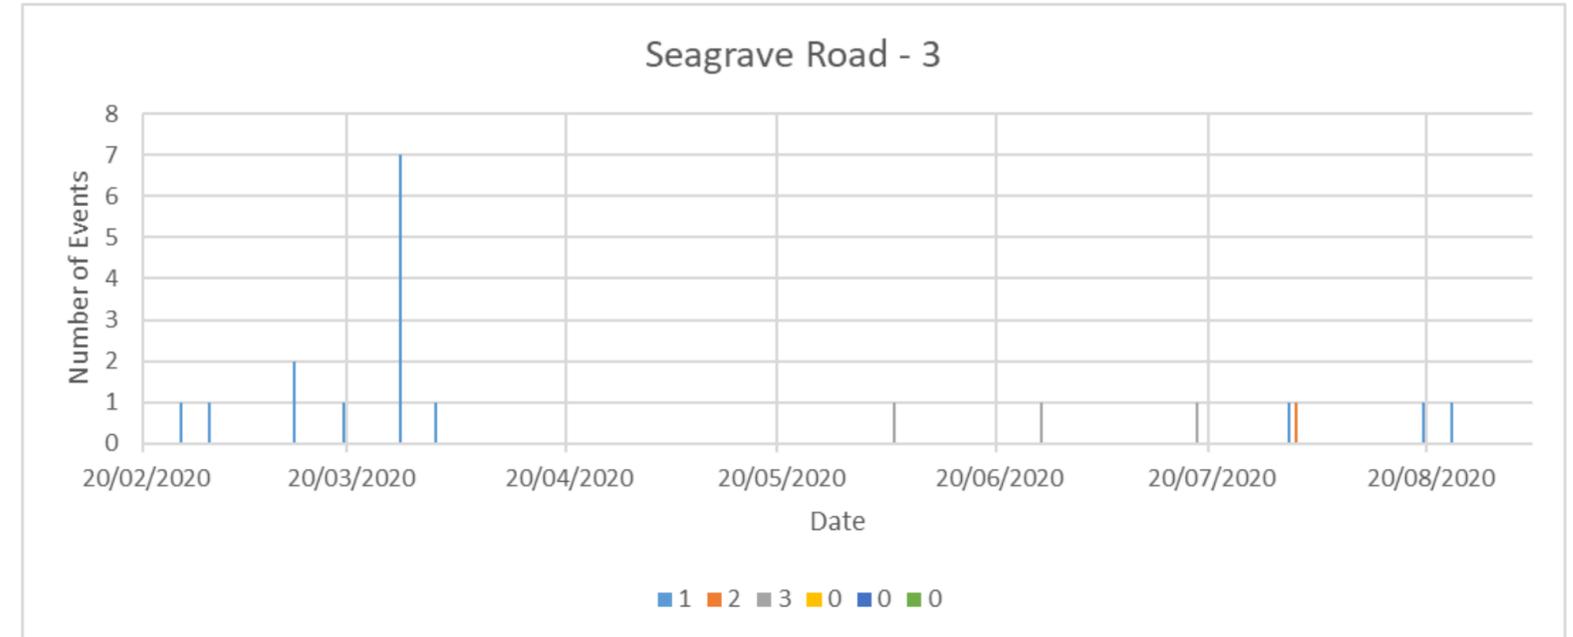
Seagrave Road feeder data has been reviewed following the feeder identification issue described above. Some events have been corrected to Feeder 3.

Seagrave Road Feeder 2 showed shown low levels of sporadic activity through the monitoring period.

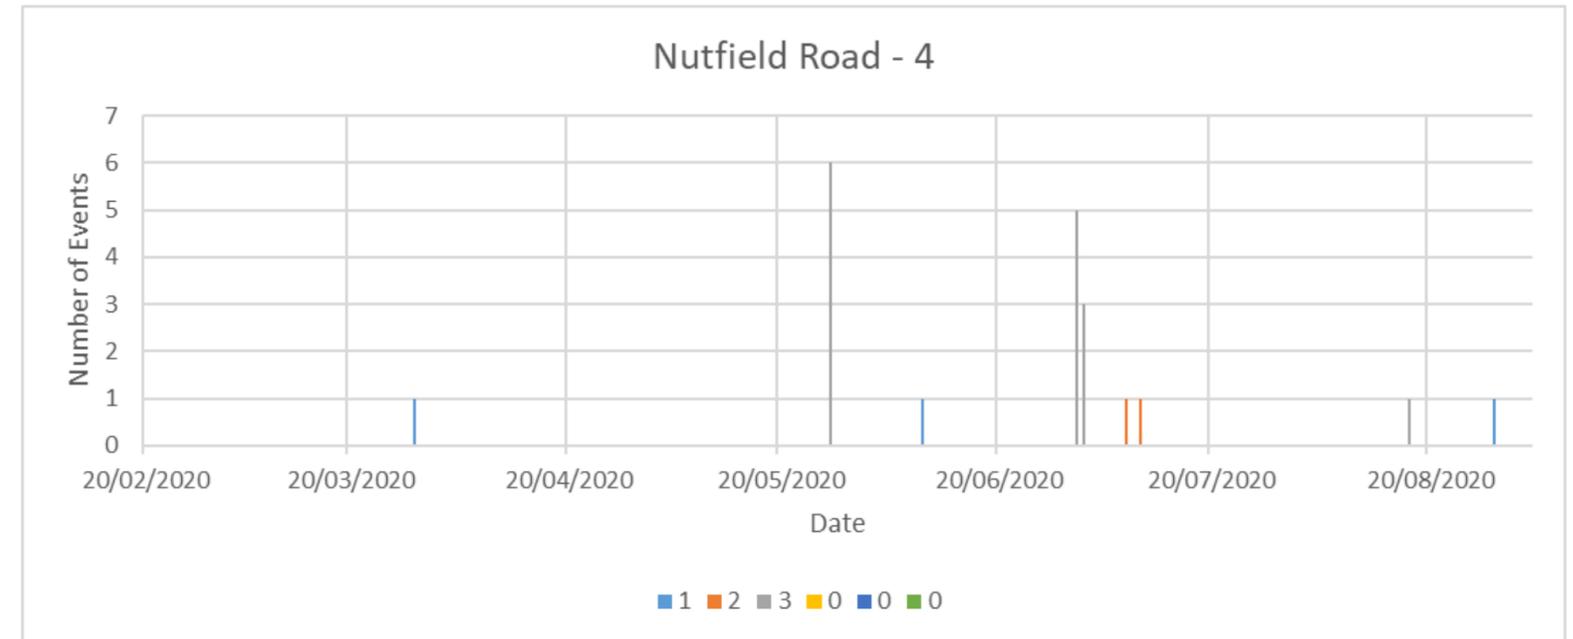
Nutfield Road feeder data has been reviewed following the feeder identification issue described above, with some correction of events to from Feeder 2 to Feeder 4.

Available data suggests intermittent levels of activity for Nutfield Road Feeder 4. 15 of the events are associated with L3.
