STDL – Smart Grid – Energy Automation
So-La Bristol (Western Power Distribution)

SoLa BRISTOL – Domestic Property Visits 15.11 – 18.12

6.1 Visit Report – Sola BRISTOL Property Visit – 15.11.13

6.2 Visit Report – Sola BRISTOL Property Visit – 04.12.13

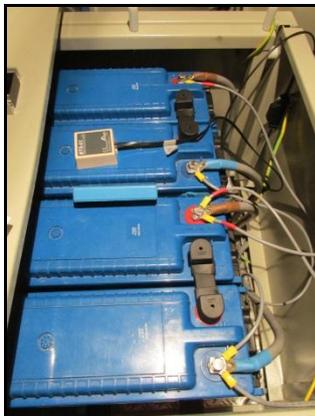
Battery Charging

On arrival at the property SW & MD situated the single phase 24V40A PES charger, which SW had provided, on the 1st floor landing of the property.

SW & AS then built DC cables to connect the charger to the battery which was in the loft space. Both battery strings were wired in parallel (as is the case during normal operation) and the charger was switched on – initially in Float mode (27.3V / 10A). The charger was switched to Boost mode (31.2V / 15A) after 1 hour.

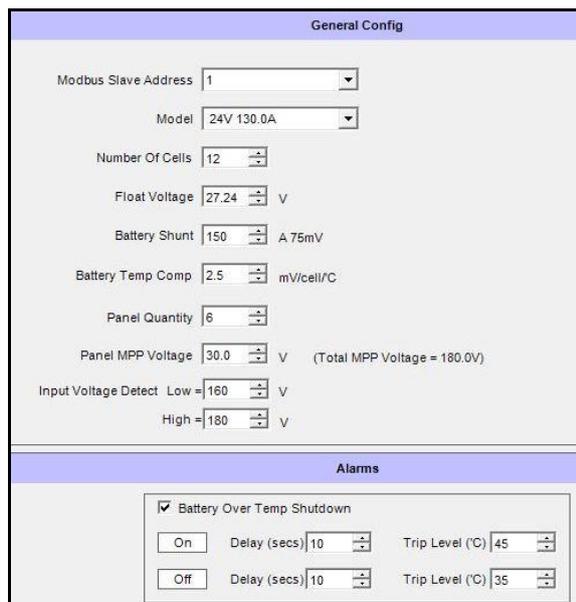
When SW subsequently interrogated the configuration of the DC/DC converter it was noted that the configuration was set to 6 panels, as this is the number of panels installed at the property. This gave a MPP control voltage of 180V (6 x 30V) which is close to the PV input voltage low threshold of 160Vdc.

General Config			
Modbus Slave Address	1		
Model	24V 130.0A		
Number Of Cells	12		
Float Voltage	27.24	V	
Battery Shunt	150	A 75mV	
Battery Temp Comp	2.5	mV/cell/C	
Panel Quantity	6		
Panel MPP Voltage	30.0	V	(Total MPP Voltage = 180.0V)
Input Voltage Detect	Low = 160	V	
	High = 180	V

The new firmware (SC2.07.0) has had routines added which will prevent any unsolicited access to the calibration data. A “double key” method has been implemented which the Modbus user must utilise to open access to the calibration data. Therefore, once the new firmware had been loaded into the DC/DC converter this issue will be removed.
